CLIENT	CANADIAN NATURAL RESOURCES LTD		
FACILITY	CECIL LAKE FIELD LSD a6-08-85-17 W6M		
ITEM	VERTICAL SEPARATOR		
BY: NB	DATE: 2008/06	DWG.# 12

**CLIENT:** CANADIAN NATURAL RESOURCES  
**EQUIPMENT:** VERTICAL SEPARATOR  
**CRN#:** H3189.213  
**PROV REG:** A 2713539  
**TESTED ON STREAM**

GENERAL INSPECTION FORM						
District: Ft St. John, BC			Skid No. Inlet Separator Building			
Facility: Cecil Lake Field			Location (LSD): a6-08-85-17 W6M			
Vessel Name & Equipment Number: Vertical Separator						
Orientation: Vertical						
Status: Not in Service			Regulatory Inspection			
PRESSURE VESSEL NAMEPLATE DATA						
"A" or "G" or "S" (Sask.) or BC Registration Number. A 2713539			CRN Number H-3189.213			
Vessel serial number: PE 3440			Size: 24in x 60in			
Shell thickness: 9.5 mm			Shell material: SA 106 B			
Head thickness: 10.9 mm /10.6 mm			Head material: SA 516 70			
Tube wall thickness:			Tube material:			
Tube diameter:			Tube length:			
Channel thickness:			Channel material:			
MAWP	Shell: 275 psi		Operating pressure	Shell: 0 to 1000 psi		
	Tubes:			Tubes:		
Design Temp.	Shell: 100 °F		Operating temperature	Shell:		
	Tubes:			Tubes:		
X-ray: RT-1			Heat treatment: HT			
Code

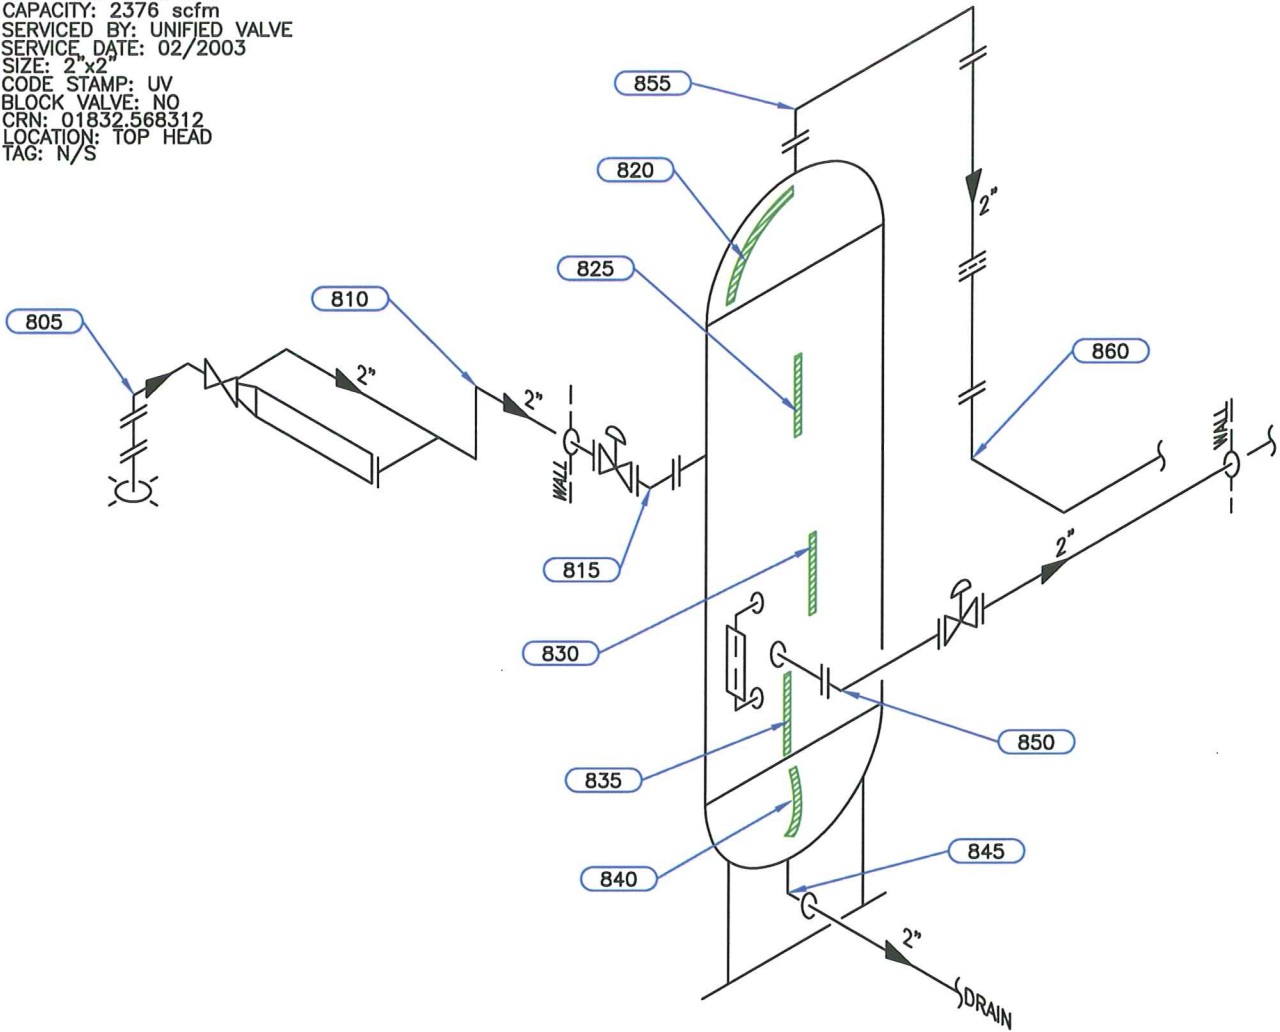
MFG: CONSOLIDATED  
 MODEL: 1970C2  
 SERIAL: 70C725  
 SET PRES: 1793 kPa  
 CAPACITY: 2376 scfm  
 SERVICED BY: UNIFIED VALVE  
 SERVICE DATE: 02/2003  
 SIZE: 2" x 2"  
 CODE STAMP: UV  
 BLOCK VALVE: NO  
 CRN: 01832.568312  
 LOCATION: TOP HEAD  
 TAG: N/S

Tb Pb	THICKNESS DATA						Sb Ten	Lg Ten	Ag mm/py	Fb Db
		Fb	Ct	C.A.	Nm.					
<b>820</b>										
Dp	<b>TOP HEAD</b>									
	2008 6									
MnTb	9	9.3	4.6	1.6	10.9				L	2008
Ag	9.3					0	0		L	2008
Ap										
<b>825</b>										
Dp	<b>UPPER SHELL</b>									
	2008 6									
MnTb	9.9	7.9		1.6	9.5				L	
Ag	10.2					0	0		L	
Ap										
<b>830</b>										
Dp	<b>MID SHELL</b>									
	2008 6									
MnTb	9	7.9		1.6	9.5				L	
Ag	9.4					0	0		L	
Ap	2008/06 MIN SCAN AT MID BAND									
<b>835</b>										
Dp	<b>LOWER SHELL</b>									
	2008 6									
MnTb	9.3	7.9		1.6	9.5				L	
Ag	9.6					0	0		L	
Ap										
<b>840</b>										
Dp	<b>BOTTOM HEAD</b>									
	2008 6									
MnTb	9.3	9		1.6	10.6				L	
Ag	9.6					0	0		L	
Ap										
<b>845</b>										
Dp	<b>2"90°NOZE</b>									
	2008 6									
MnTb	5.9	3.9		1.6	5.5				L	
Ag	6.2					0	0		L	
Ap

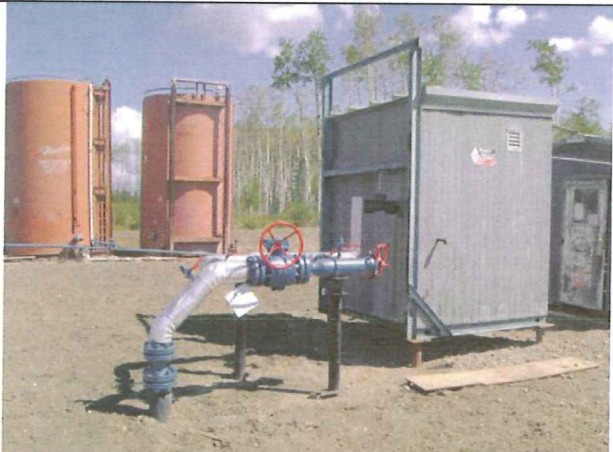
<p>Overview - Skid</p>
<p>LSD</p>

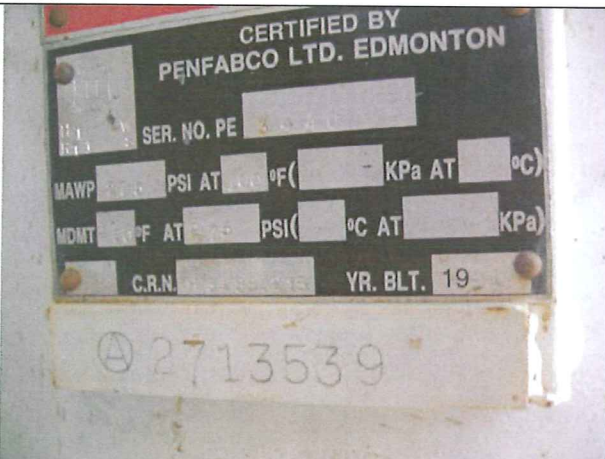
<p>CERTIFIED BY PENFABCO LTD. EDMONTON</p> <p>SER. NO. PE [ ]</p> <p>MAWP [ ] PSI AT [ ] °F ( [ ] - KPa AT [ ] °C)</p> <p>MDMT [ ] °F AT [ ] PSI ( [ ] °C AT [ ] KPa)</p> <p>C.R.N. [ ] YR. BLT. 19 [ ]</p> <p>ⓐ 2713539</p> <p>Data Plate</p>
