**PRESSURE VESSEL
VISUAL INSPECTION
REPORT**

Report #: **156816-KK-14**
 Inspect Date: 05/07/2012
 Page: 1 of 11
 Insp. Co. Job #: 156816

Insp. Comp: Matrix_Inspection District: St Albert - South Field: Hobbema-1775
 Location: Hobbema Field Unit / Skid #: N/A LSD: 14-09-044-24W4M
 Jurisdiction #: A0404024 Equip Tag #: N/A Serial #: VS-8302
 CRN #: N7751.2 Nat'l Bd #: N/A Year Built: 1997
 Manufacturer: Argo Sales Equipment Description: Other: Separator
 Status: In Service - Equip. Type: Vessel: Separator Service: Sweet
 MAWP Shell: 1440 Psi @ 100 °F Volume: N/A Code Stamp: Y N
 MAWP Tube: N/A @ N/A Height/Length: N/A Insulated: Y N
 MDMT: -20 °F RT: RT-2 Size/Diameter.: 20 in. O.D. PWHT: Y N
 Support: Skirt Vessel on Original CNRL Inventory List: Y N Manway: Y N
 C.A.: 1.6 mm Coated: No Clad: No J.E.: N/A Remote Access: -

VESSEL DESCRIPTION: Separator

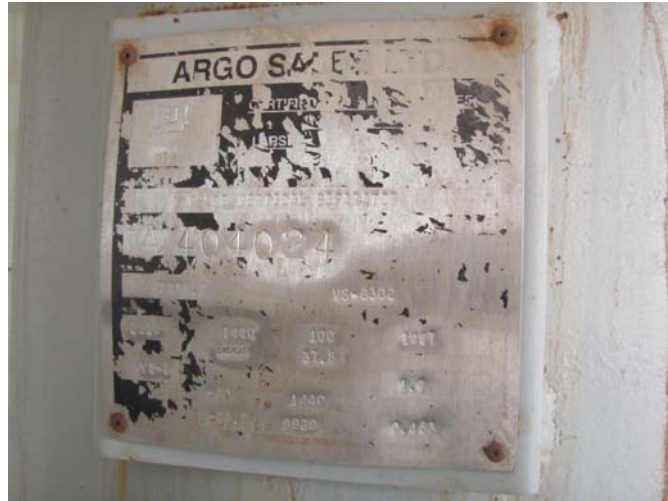
Nameplate is secure and hard to read, and contains little information.
 The vessel is secure and level, with properly aligned piping and external attachments.
 The paint is in fair condition, with scale and minor surface corrosion noted.
 The vessel to roof interface is leaking.
 There is no access inside the bottom skirt due to the configuration of vessel placement and piping.
 The attached piping is in good condition with isolated areas of surface corrosion.

01-A0404024 Data Plate

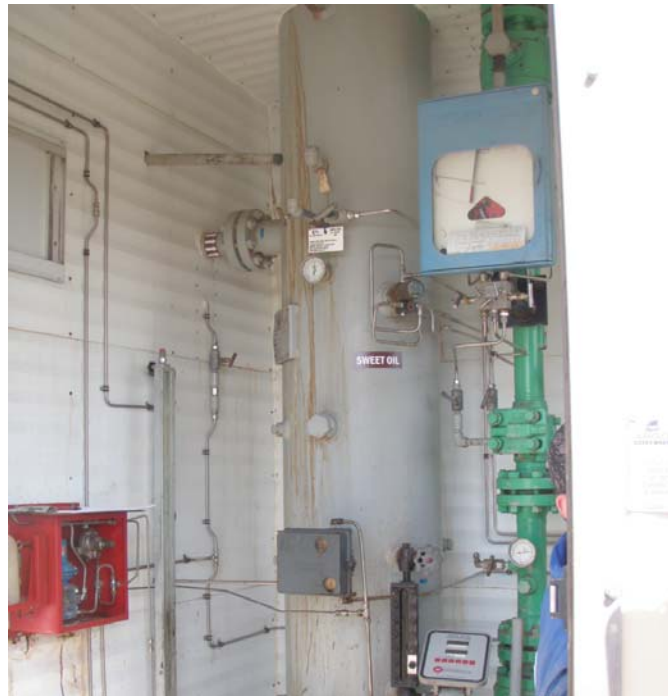
02-A0404024 Overview Inside

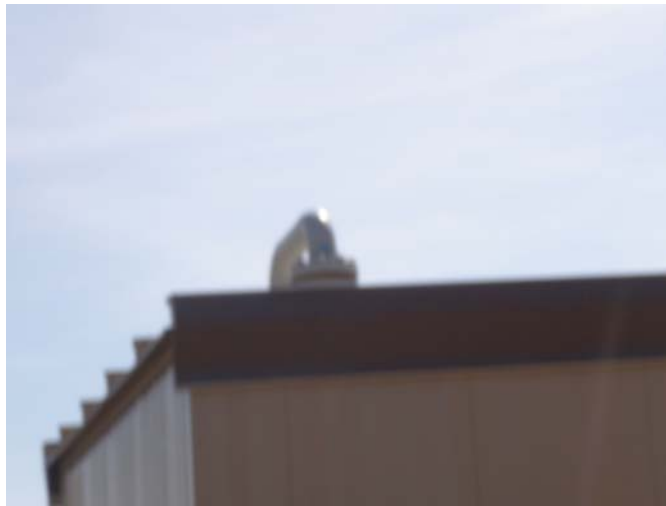
03-A0404024 Overview Outside

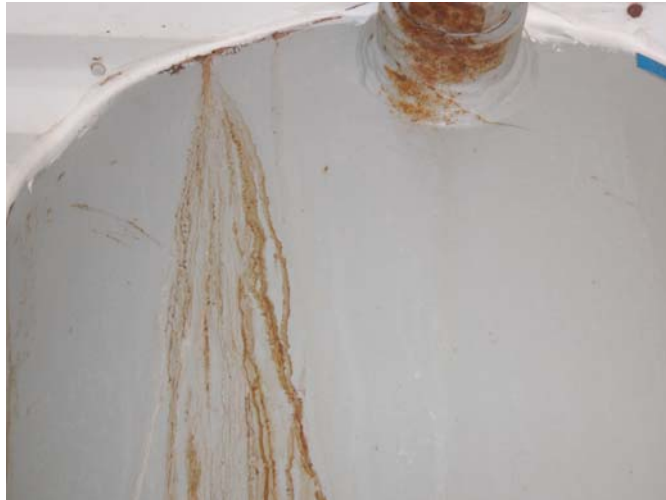
Vessel to roof interface leaks. Surface corrosion on shell from leaking interface. No hand hole access to bottom head or drain in skirt. Overall good condition.

04-A0404024 Staining at Roof Interface

Reseal the vessel to roof interface.
 Monitor the surface corrosion on the shell.
 Consider cutting an access hole in the bottom skirt to allow access for bottom head and drain inspection.
 Clean and maintain buildings and packages to prevent further surface corrosion and potential degradation.
 Ensure PSV's are serviced, installed, and rated correctly before putting this equipment back into service post TAR.

Monitor paint. Reseal the vessel to roof interface. Consider curtting an access hole in the bottom skirt to allow bottom head and drain access. Ensure PSV connected / rated correctly prior to post TAR startup.

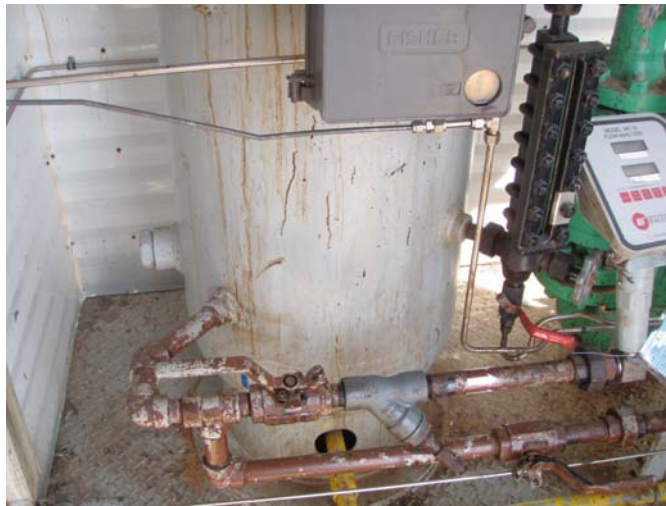
05-A0404024 Staining on Sgell from Instrument Leaks
