**PRESSURE VESSEL
VISUAL INSPECTION
REPORT**

Report #: **156816-KK-18**
 Inspect Date: 05/09/2012
 Page: 1 of 12
 Insp. Co. Job #: 156816

Insp. Comp: Matrix_Inspection District: St Albert - South Field: Hobbema-1775
 Location: Hobbema Field Unit / Skid #: N/A LSD: 10-09-044-24W4M
 Jurisdiction #: A0432472 Equip Tag #: N/A Serial #: V9716
 CRN #: N0978.21 Nat'l Bd #: N/A Year Built: 1997
 Manufacturer: Chadco Equipment Description: Other: Separator
 Status: In Service - Equip. Type: Vessel: Separator Service: Sweet
 MAWP Shell: 1480 Psi @ 100 °F Volume: N/A Code Stamp: Y N
 MAWP Tube: N/A @ N/A Height/Length: 8 Ft. Insulated: Y N
 MDMT: -20 °F RT: RT-2 Size/Diameter.: 20 in. O.D. PWHT: Y N
 Support: Skirt Vessel on Original CNRL Inventory List: Y N Manway: Y N
 C.A.: 0.125 in. Coated: No Clad: No J.E.: N/A Remote Access: -

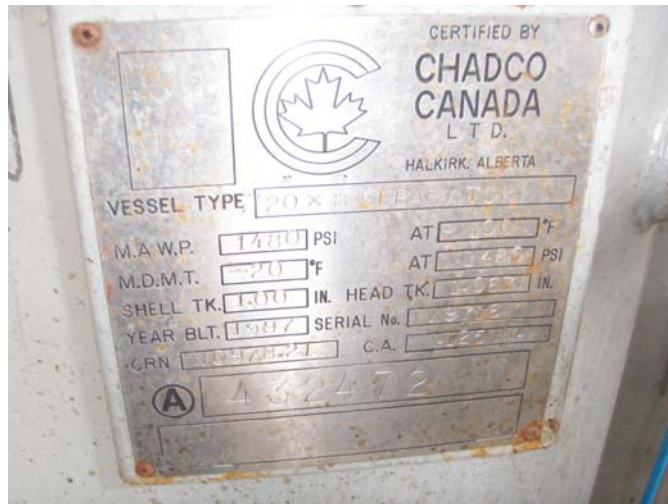
01-A0432472 Data Plate

Nameplate is secure and easy to read, but contains little information.
 The vessel is secure and level, with properly aligned piping and external attachments.
 The paint is thick and rough in some locations.
 There is product staining noted on the shell and building floor.
 The weep hole on the repad for the inlet has corrosion noted and should be monitored for under pad issues.
 The attached piping is in good condition with isolated areas of surface corrosion.
 The vessel piping to roof interface is in good condition.
 The PSV discharge to wall interface requires sealant.
 The building has product staining noted on the floor.
 The PSV is removed for service at the time of the inspection.
 The plumbing for the PSV appears to be in good condition, and of adequate size and proper rating.
 The PSV service data has been supplied from the service company to update the static information in this report.
 The overall condition of this vessel is good.

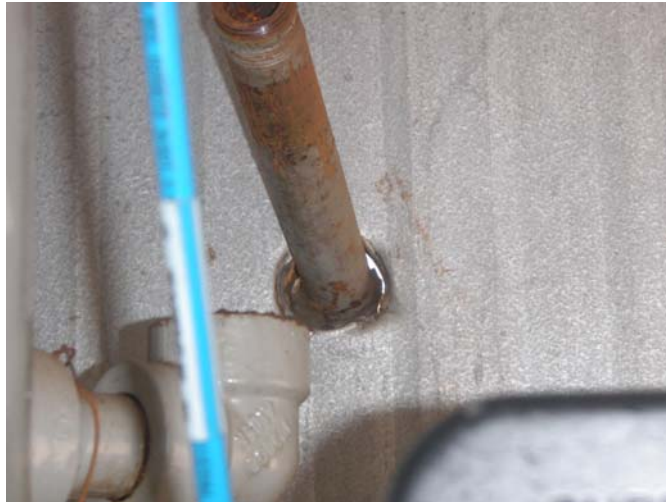
04-A0432472 PSV Discharge to Wall Interface

0.035" erosion losses noted on bottom drain nozzle. Product staining on shell and building floor. Inlet repad weep hole corrosion noted. PSV discharge pipe to wall interface requires sealant. Thick / rough paint. Building is dirty.

Repair product leaks, and clean building and vessel.
 Reseal the PSV discharge to wall interface.
 Monitor the corrosion at the inlet repad weep hole to ensure no progression.
 Clean and maintain buildings and packages to prevent further surface corrosion and potential degradation.
 Ensure PSV's are serviced, installed, and rated correctly before putting this equipment back into service post TAR.

Monitor the drain nozzle erosion with UT. Repair product leaks. Reseal PSV discharge to wall interface. Monitor weep hole corrosion for progression. Clean the vessel and building. Ensure PSV connected / rated correctly prior to post TAR startup.

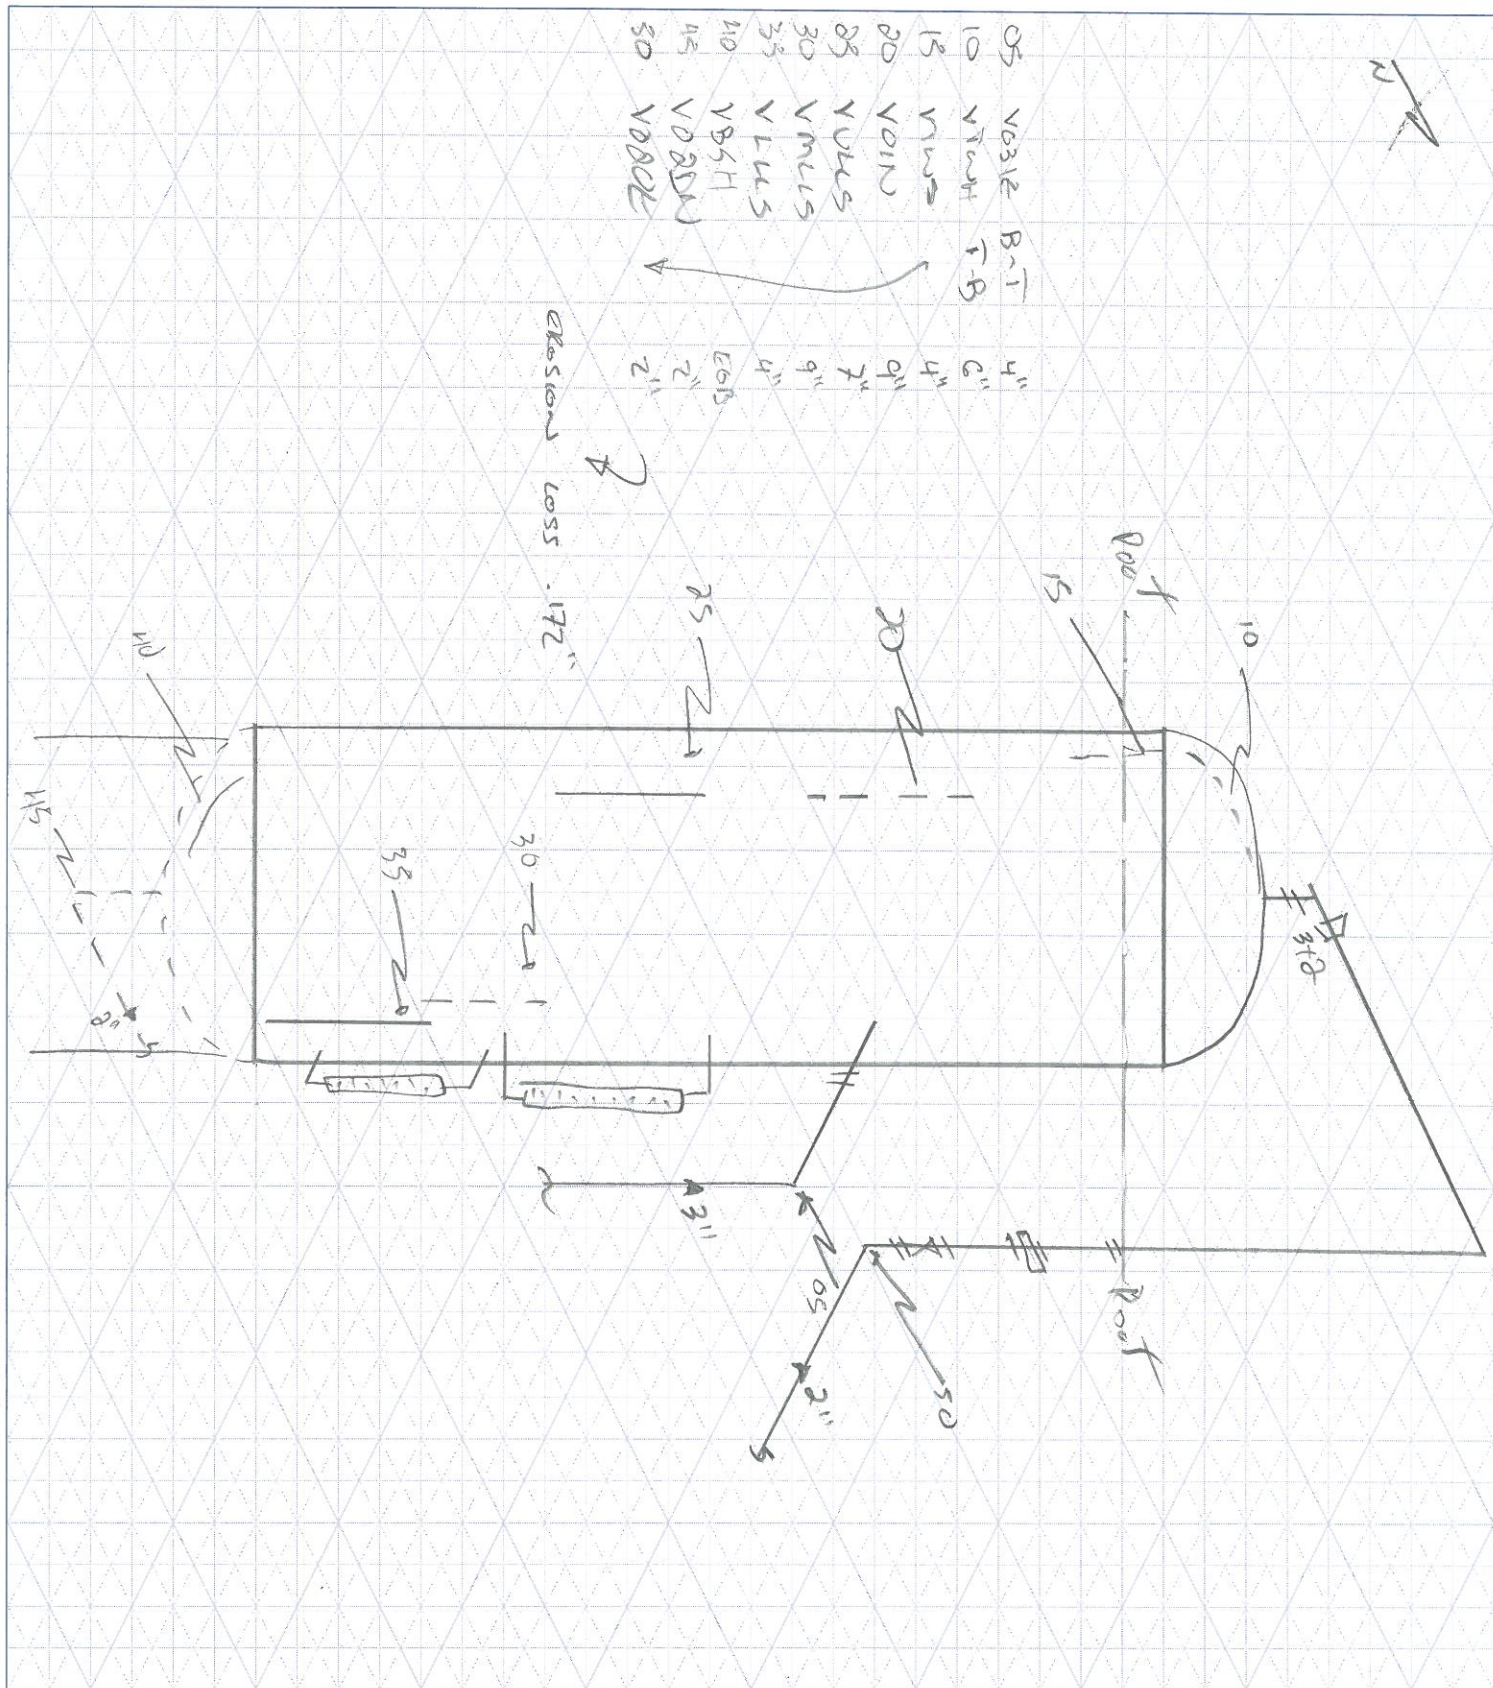
CUSTOMER: CNRL FACILITY: 12-09 Hobbema Field LSD: 10-09-044-04W4M
 P & ID: _____ DRAWN BY: KK DATE: 05-09-12 DRAWING NO. 156216-KK-18

A UT corrosion survey was performed at the time of the inspection by IRISNDT using DMS2 SN 020448.
 Typical locations on the vessel heads, shell, and attachments were selected for the UT survey.
 The bottom drain nozzle (0.218" Nom) shows mild erosion losses (0.172" Min).
 No thickness values of concern were noted during the UT survey.
 See attached UT values and drawing for complete details.

PNT1	PNT2	PNT3
LOC 5	0.292	0.276	0.276
LOC 10	1.085	1.168	1.085
LOC 15	1.008	1.011	1.004
LOC 20	1.016	1.023	1.012
LOC 25	1.018	1.020	1.016
LOC 30	1.029	1.022	1.015
LOC 35	1.012	1.012	1.010
LOC 40	1.176	1.067	1.067
LOC 45	0.388	0.414	0.386
LOC 50	0.223	0.196	0.172
