EQUIPMENT DEFICIENCY SUMMARY

District:	Fort St John	Facility	Beavertail/Rigel	Location/LSD	A-028-A/094-A-15
Equipment Name	SEPARATOR			Prov Reg No.:	3163496
Serial No.:	3675	Equip No.:	N/S	National Board No.:	N/S

PRESSURE EQUIPMENT DATA REPORT

ULTRASONIC CORROSION SURVEY REPORT

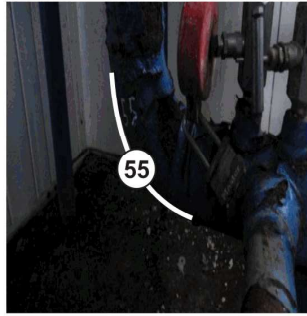
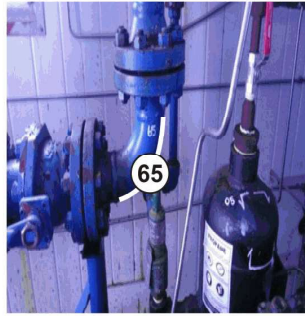
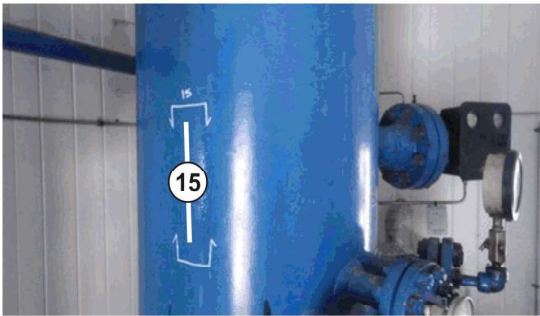
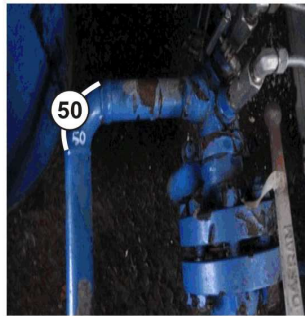
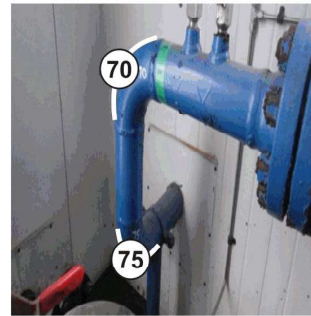
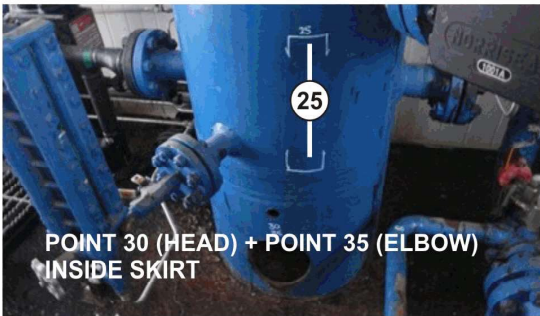
EXAMINATION ILLUSTRATION

POINT DATA (INCH)					SURVEY READINGS				CALCULATIONS			
POINT NUMBER	TYPE	NOM.	C.A.	NOM-CA	DATE	LOW	AVG	T Req (inch)	short term corr	long term	remaining life	Flag
05	HEAD	0.6860	0.1250	0.5610	Nov 3/18	0.749	0.757	0.476	0.0000	0.0000	198.0	NO COMMENTS
10	SHELL	0.6250	0.1250	0.5000	Nov 3/18	0.646	0.648	0.486	0.0000	0.0000	198.0	NO COMMENTS
15	SHELL	0.6250	0.1250	0.5000	Nov 3/18	0.652	0.654	0.486	0.0000	0.0000	198.0	NO COMMENTS
20	SHELL	0.6250	0.1250	0.5000	Nov 3/18	0.643	0.650	0.486	0.0000	0.0000	198.0	NO COMMENTS
25	SHELL	0.6250	0.1250	0.5000	Nov 3/18	0.640	0.646	0.486	0.0000	0.0000	198.0	NO COMMENTS
30	HEAD	0.6860	0.1250	0.5610	Nov 3/18	0.735	0.758	0.476	0.0000	0.0000	198.0	NO COMMENTS

POINT DATA (INCH)							SURVEY READINGS				CALCULATIONS			
POINT NUMBER	TYPE	SIZE	SCH	NOM.	Mill Tol./CA	NOM-CA	DATE	LOW	AVG	T Req (inch)	short term corr	long term corr rate	remaining life	Flag
35	90L 2 XXS	2.00	XXS	0.4360	0.0545	0.3815	Nov 3/18	0.403	0.412	0.043	0.0014	0.0014	250.2	NO COMMENTS
Comments: CORROSION NOTED														
40	90L 2 XS	2.00	XS	0.2180	0.0273	0.1908	Nov 3/18	0.161	0.192	0.043	0.0025	0.0025	47.5	LOW RDG IS > 10% BELOW NOM-CA BUT > Tmin
Comments: CORROSION NOTED AT BOTTOM OF ELBOW														
45	90L 2 XS	2.00	XS	0.2180	0.0273	0.1908	Nov 3/18	0.198	0.213	0.043	0.0009	0.0009	177.9	NO COMMENTS
50	90L 1.5 XS	1.50	XS	0.2000	0.0250	0.1750	Nov 3/18	0.172	0.176	0.034	0.0012	0.0012	112.8	NO COMMENTS
55	90L 3 XS	3.00	XS	0.3000	0.0375	0.2625	Nov 3/18	0.292	0.298	0.063	0.0003	0.0003	656.0	NO COMMENTS
60	90L 3 XS	3.00	XS	0.3000	0.0375	0.2625	Nov 3/18	0.284	0.298	0.063	0.0007	0.0007	316.5	NO COMMENTS

65	90L 3 XS	3.00	XS	0.3000	0.0375	0.2625	Nov 3/18	0.276	0.296	0.063	0.0010	0.0010	203.4	NO COMMENTS
70	90L 3 XS	3.00	XS	0.3000	0.0375	0.2625	Nov 3/18	0.258	0.267	0.063	0.0018	0.0018	106.4	NO COMMENTS
75	90L 3 XS	3.00	XS	0.3000	0.0375	0.2625	Nov 3/18	0.284	0.293	0.063	0.0007	0.0007	316.5	NO COMMENTS

LOCATION	Nom - CA	Low RDG	Avg RD	TMin	UT Flag	RECOMMENDATION	QUALITY ACTION	RESULT
40 90L 2 XS	0.19	0.16	0.19	0.04	LOW RDG IS > 10% BELOW NOM-CA BUT > Tmin	CONSIDER REDUCING THE INSPECTION INTERVAL.	OWNER TO DETERMINE	Concern

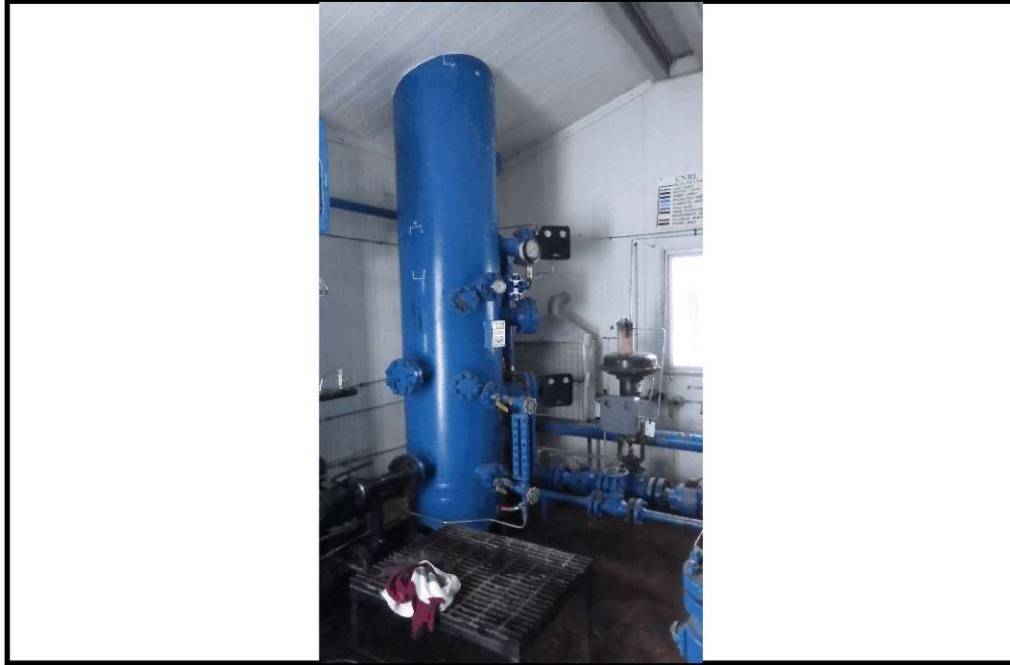
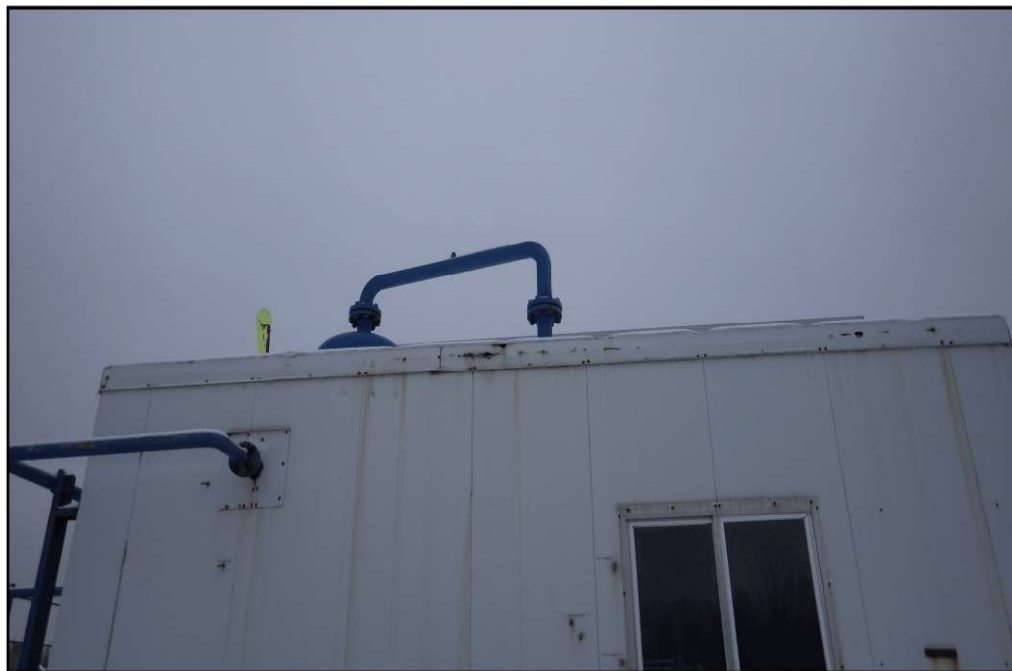
OVERALL

General Minor :<0.020 external corrosion was found on BTM Head
MINOR EXTERNAL CORROSION (OXIDATION) LOCATED ON BOTTOM HEAD.
General Minor :<0.020 external corrosion was found on BTM Piping
MINOR EXTERNAL CORROSION (OXIDATION) LOCATED ON INLET & DRAIN PIPING AND FLANGES.

Pressure Gauge is acceptable, Temp Gauge is acceptable, Level Gauge is acceptable,
Grounding: No Grounding is Concern,

NO VISIBLE GROUNDING.

DEFICIENCY	RECOMMENDATION	QUALITY ACTION	RESULT
Grounding: No Grounding is Concern,	NCR	CAR	Concern

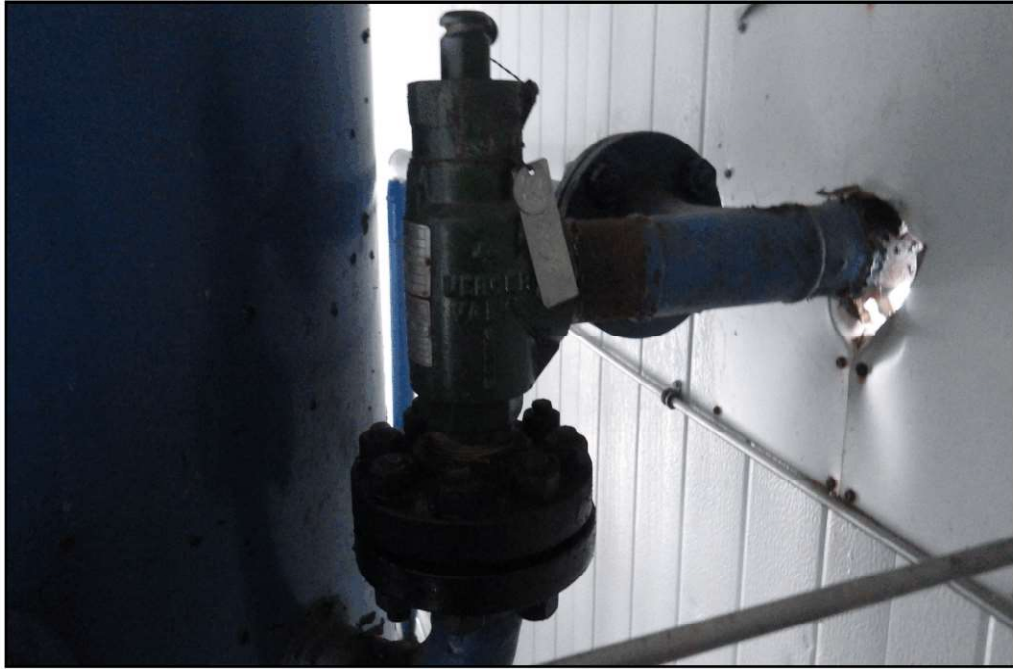
SERVICE DATE	PSV service is past due.

LEAKS	INLET:	Leakage found at psv inlet connection

DEFICIENCY	RECOMMENDATION	QUALITY ACTION	RESULT
Leakage found at psv inlet connection	REMOVE EQUIPMENT FROM SERVICE AND TIGHTEN PSV INLET TO STOP THE LEAKAGE	NCR	Concern
PSV service is past due.	SERVICE PSV	NCR	Reject

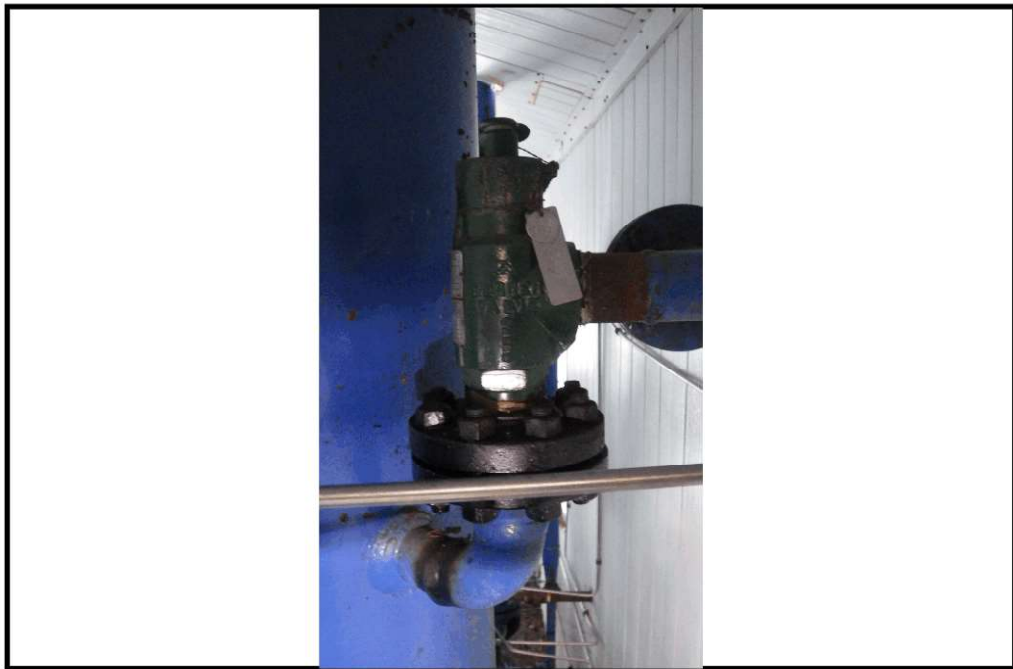
WEEPING

Minor leak was found on Piping Bolted ,
details :Weeping from Connection
