PRESSURE VESSEL
VISUAL INSPECTION
REPORT

Report #: **156732-MD-39**
Inspect Date: 06/06/2012
Page: 1 of 17
Insp. Co. Job #: 156732

Insp. Comp: Matrix Inspection District: Grande Prairie - North Field: North Hamburg
 Location: 11-27-097-09W6 Unit / Skid #: 16715 LSD: 11-27-097-09W6
 Jurisdiction #: A3004667 Equip Tag #: N/A Serial #: 1369 V202
 CRN #: M5051.2 Nat'l Bd #: N/A Year Built: 1994
 Manufacturer: Plains Oil Ltd Equipment Description: Other: Inlet Separator
 Status: In Service - Equip. Type: Vessel: Separator Service: Sweet
 MAWP Shell: 9300 kPa @ 93 °C Volume: _____ Code Stamp: Y N
 MAWP Tube: _____ @ _____ Height/Length: 16 Ft. Insulated: Y N
 MDMT: -28 °C RT: RT-1 Size/Diameter.: 60 in. O.D. PWHT: Y N
 Support: Saddle Vessel on Original CNRL Inventory List: Y N Manway: Y N
 C.A.: 1.59 mm Coated: N/A Clad: N/A J.E.: 1.00 Remote Access: - Winter Road

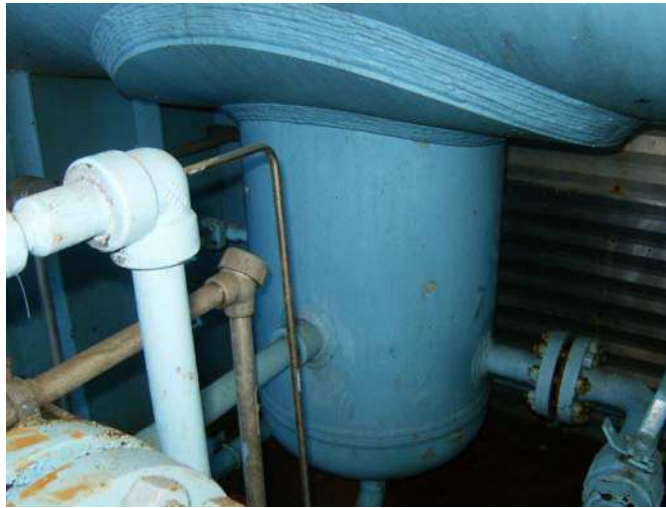
03 boot overview

The weep holes are open on the boot drain reinforcement pad with no evidence of leaks noted at the time of inspection

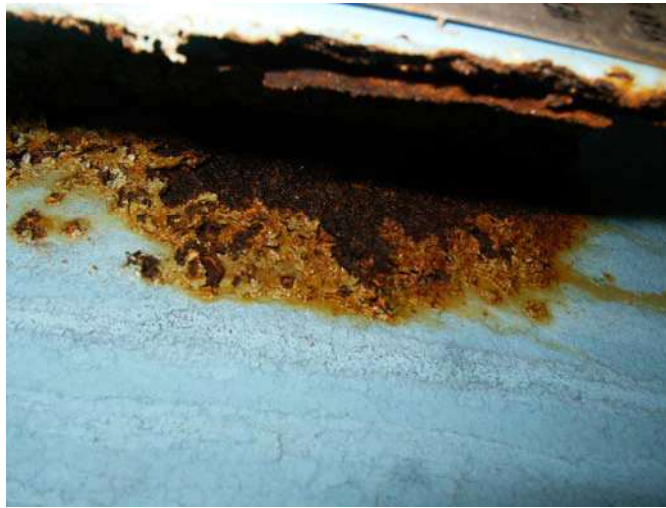
The coating is chipped and flaked exposing the base metal to mild surface corrosion with evidence of shallow pitting noted. the maximum measured pit depth was 0.017" behind the nameplate on the shell

05 corrosion behind nameplate

Clean loose coating and touch-up to aid in corrosion protection

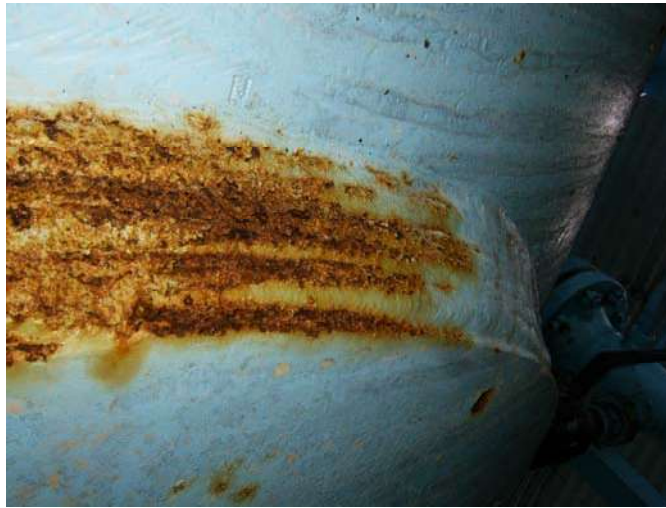
07 coating deterioration

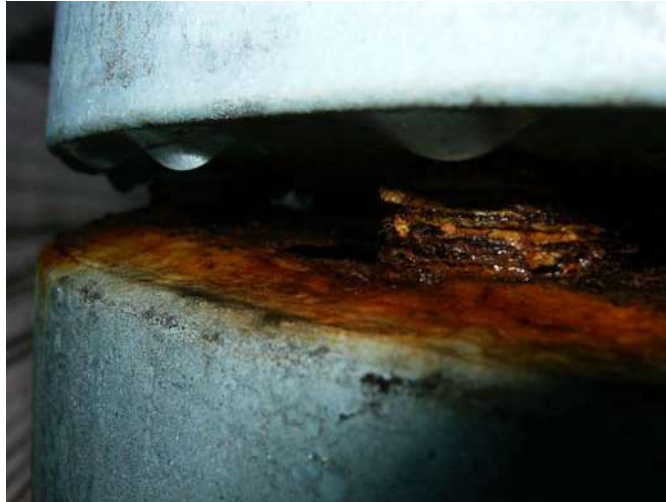
Mild surface corrosion noted throughout the heads, shells, nozzles, piping and between the flanges.

08 corrosion between flanges

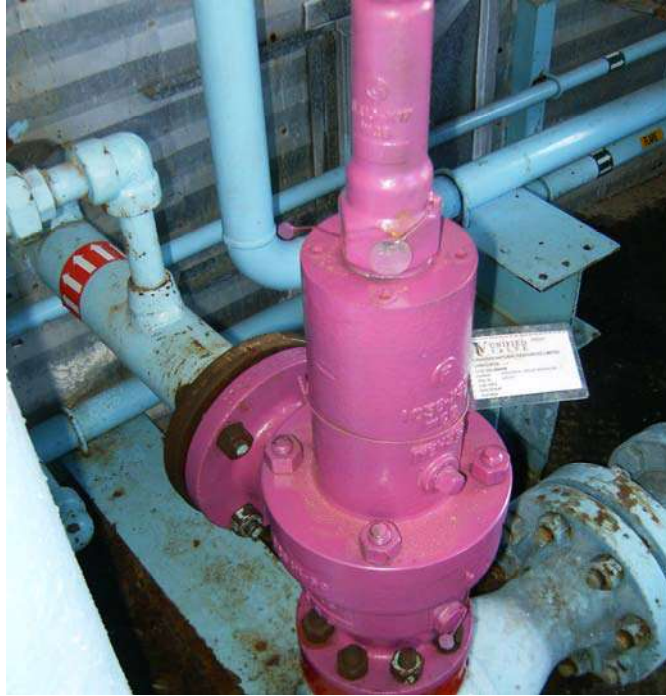
09 PSV overview

Set pressure is well below the MAWP

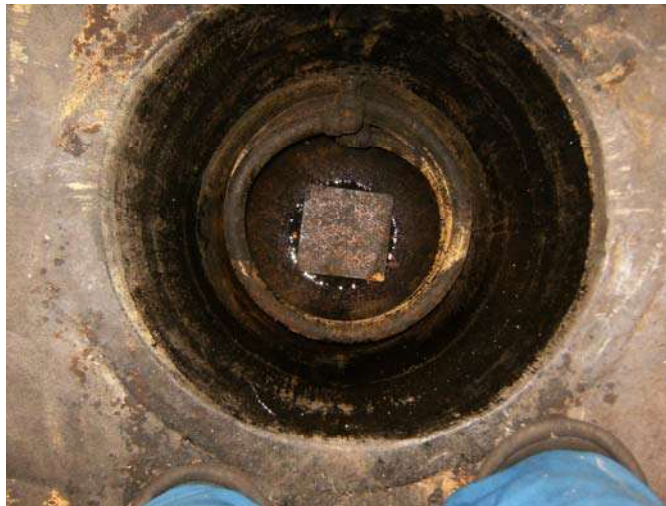
The coil inside the boot was found to be in good condition

11 boot & coil overview

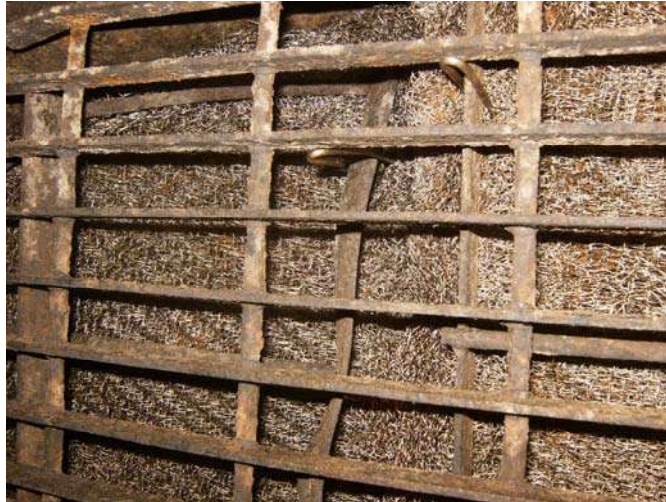
13 bent supports

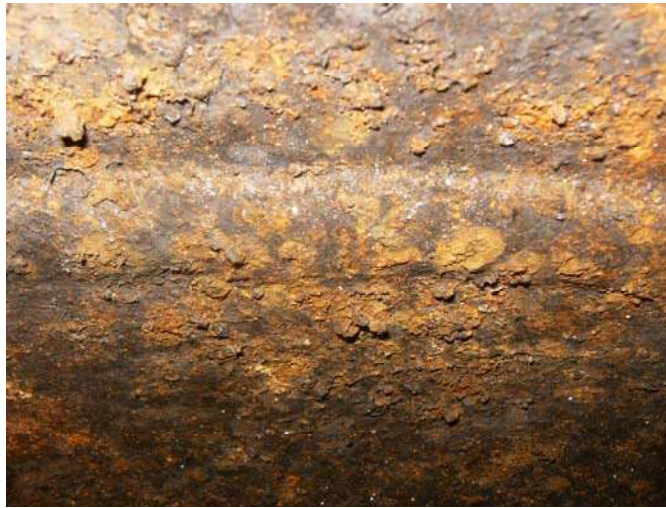
There is scale (tubercle) formation noted in the vapour section of the shell. A random area had been cleaned to bare metal with no pitting recorded

14 scale in vapour section

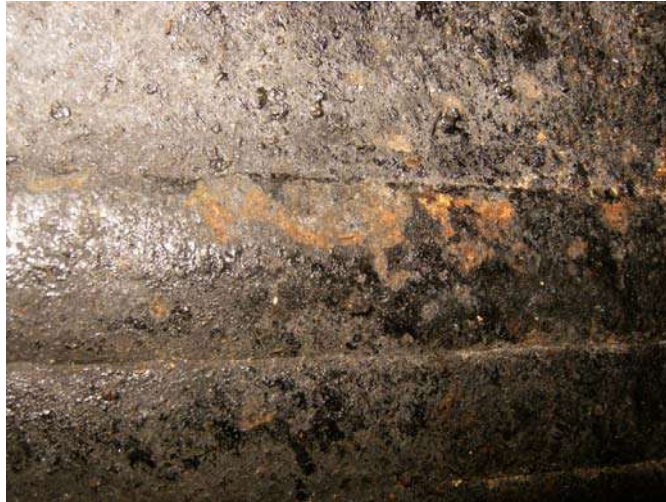
There was minor pitting noted on the shell to head circ seam 6 o'clock position no greater than 0.015" deep (within corrosion allowance)

15 minor pitting on seam

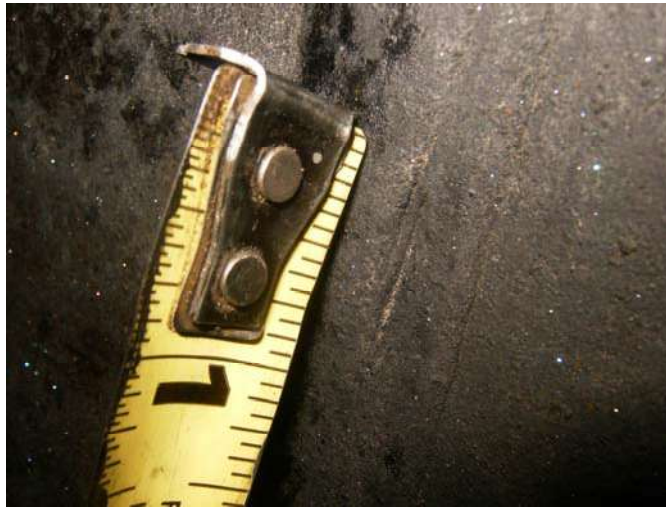
There is a shallow ~ 0.022" deep gouge noted adjacent to the shell circ weld approximately 1.00" long

16 gouge adjacent to weld

Consider to lightly remove sharp edges on the gouge to reduce fatigue risks

Clean loose coating and touch-up to aid in corrosion protection
Replace pressure gauge with one that is within range of the MAWP
TA 2012 - Consider carefully removing the sharp edges from the gouge
