**PRESSURE VESSEL  
VISUAL INSPECTION  
REPORT**

Report #: **156732-MD-38**  
 Inspect Date: 06/07/2012  
 Page: 1 of 14  
 Insp. Co. Job #: 156732

Insp. Comp: Matrix Inspection District: Grande Prairie - North Field: North Hamburg  
 Location: 11-27-097-09W6 Unit / Skid #: 16970 LSD: 11-27-097-09W6  
 Jurisdiction #: A0444297 Equip Tag #: N/A Serial #: 2418 V201  
 CRN #: K1554.12 Nat'l Bd #: N/A Year Built: 1999  
 Manufacturer: Plains Oil Ltd Equipment Description: Other: Oil Feed Drum  
 Status: In Service - Equip. Type: Vessel: Separator Service: Sweet  
 MAWP Shell: 9300 kPa @ 93 °C Volume: \_\_\_\_\_ Code Stamp:  Y  N  
 MAWP Tube: \_\_\_\_\_ @ \_\_\_\_\_ Height/Length: 20 Ft. Insulated:  Y  N  
 MDMT: -28 °C RT: RT-1 Size/Diameter.: 96 in. O.D. PWHT:  Y  N  
 Support: Saddle Vessel on Original CNRL Inventory List:  Y  N Manway:  Y  N  
 C.A.: 3.2 mm Coated: N/A Clad: N/A J.E.: 1.00 Remote Access:  - Winter Road

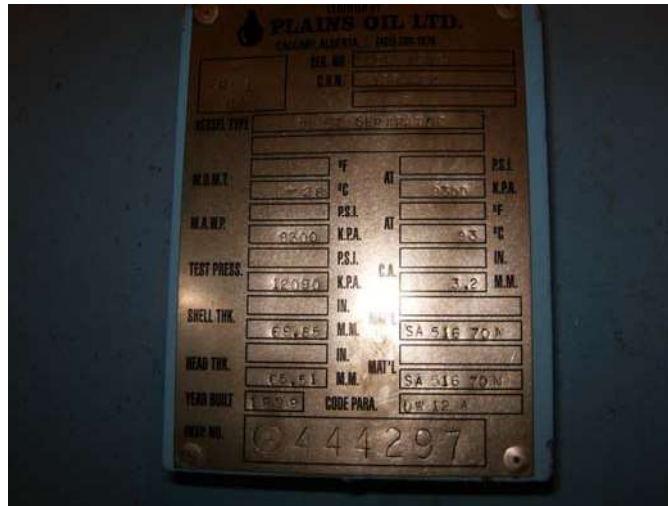
01 nameplate

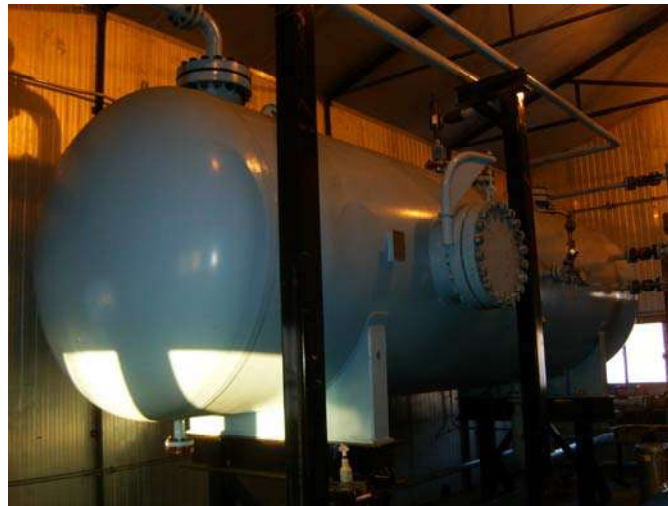
02 overview

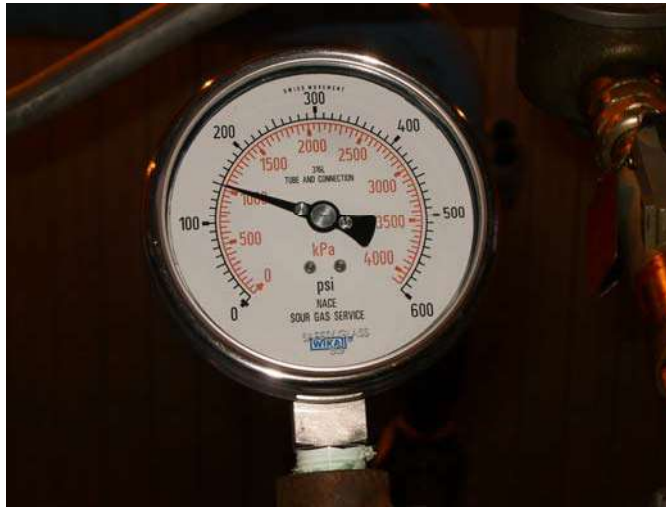
The pressure gauge is not within range of the MAWP

03 not within range

Confirm with operations that the pressure does not exceed gauge rating, replace as required

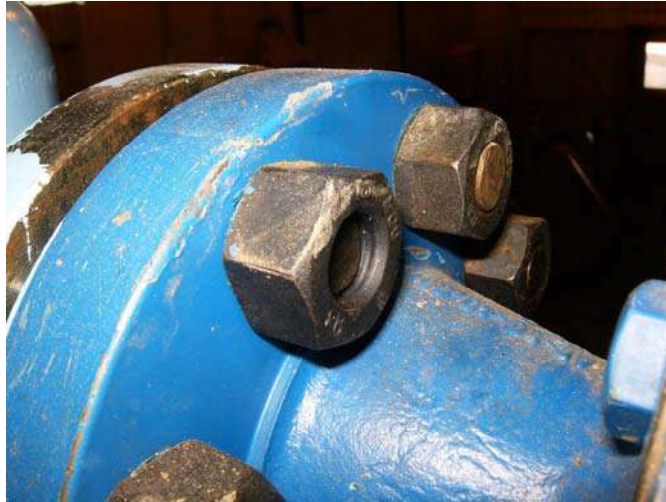
Float cell flanged connections have lack of thread engagement in multiple locations

04 lack of thread engagement

Ensure full thread engagement on Float cell flanged connections

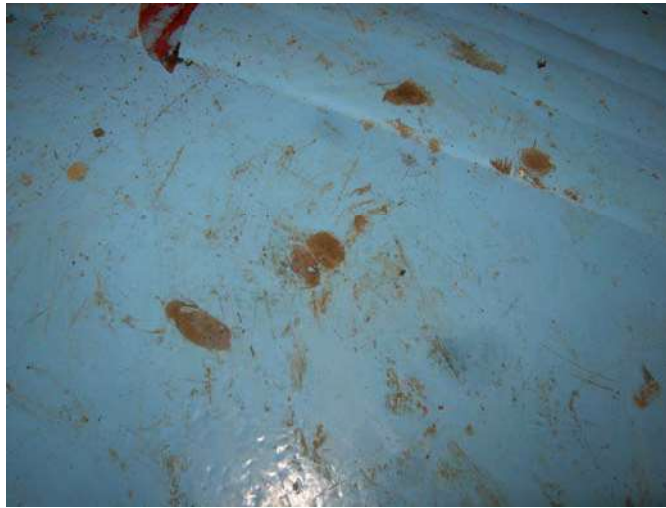
The coating is chipped and flaked exposing the base metal to very minor surface corrosion

**05 coating deterioration**

Clean loose coating and touch-up to aid in corrosion protection

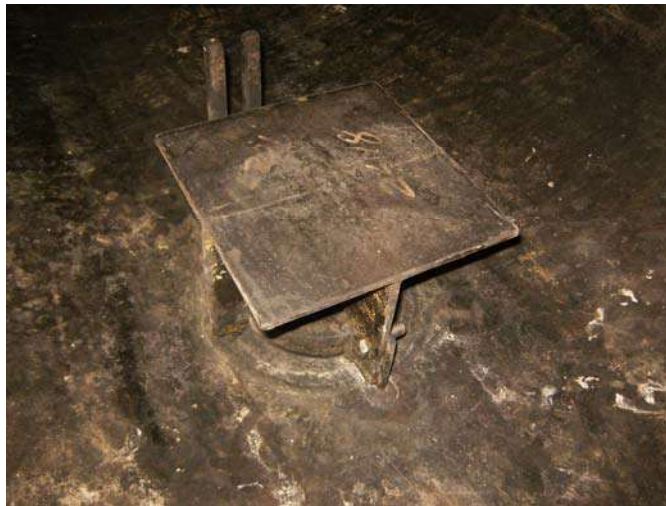
07 vortex breaker

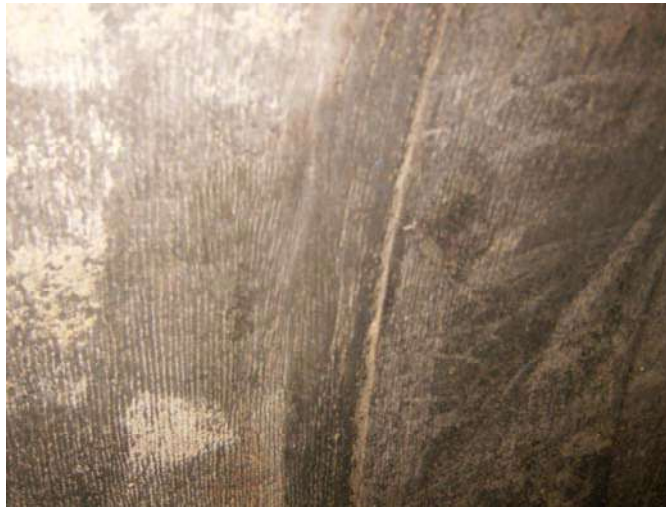
There is some mill scale (up to 0.062" deep) noted throughout the shell and heads of the vessel that resemble finger print markings

**08** finger print

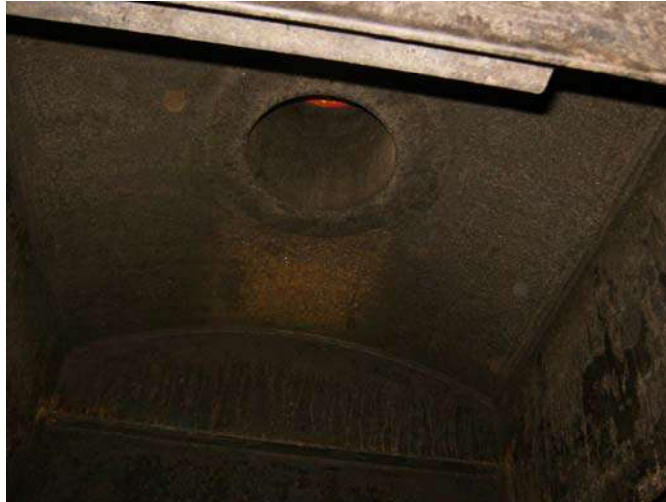
There are iron oxides forming on the outlet nozzle and a white crystallization forming in the vapour section of the shell

**09** iron oxides

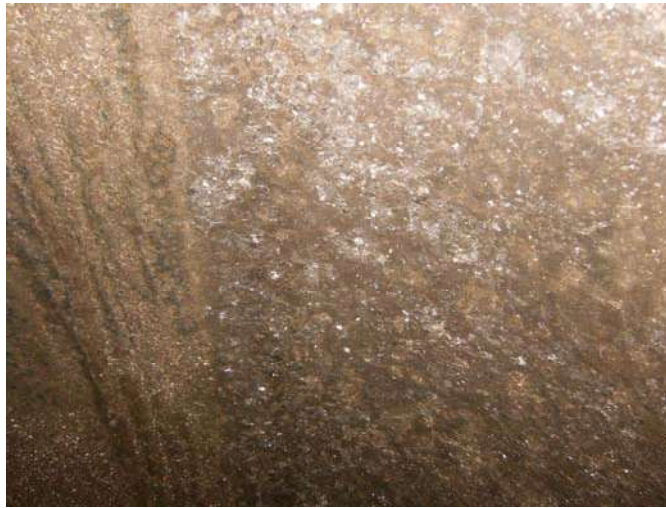
**10 vapour section crystallization**
