EQUIPMENT DEFICIENCY SUMMARY

District:	Fort St John	Facility	Beavertail/Rigel	Location/LSD	C-084-A/094-A-15
Equipment Name	SEPARATOR			Prov Reg No.:	0487741
Serial No.:	VS-11687	Equip No.:		National Board No.:	N/A

PRESSURE EQUIPMENT DATA REPORT

ULTRASONIC CORROSION SURVEY REPORT

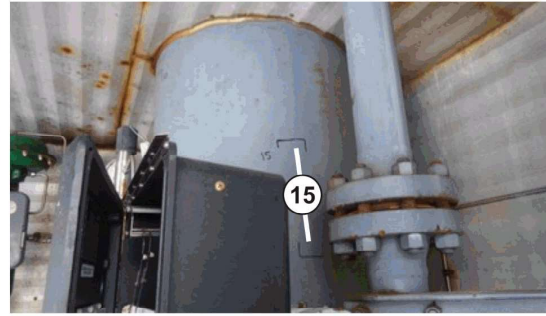
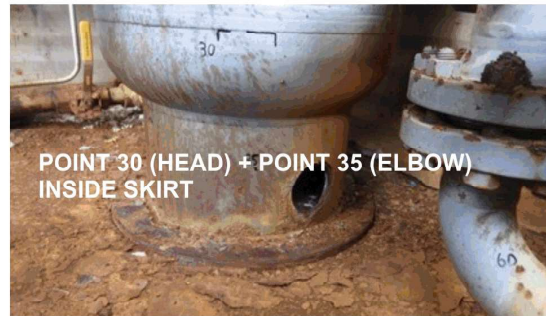
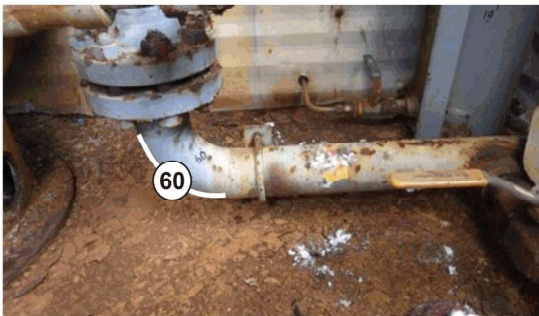
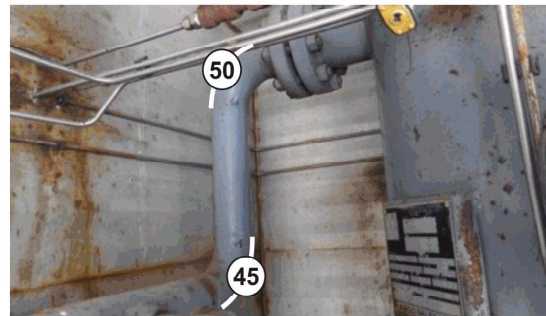
EXAMINATION ILLUSTRATION

DISTRICT:	Fort St John	FACILITY:	Beavertail/Rigel	LOCATION/LSD:	C-084-A/094-A-15
EQUIP NAME:	SEPARATOR			PROV REG No.:	0487741
SERIAL No.:	VS-11687	Equip No.:		National Board No.:	N/A

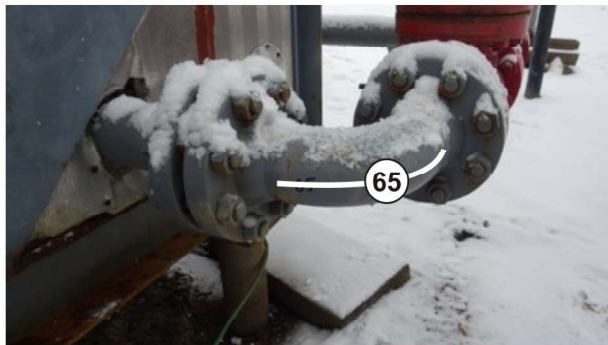
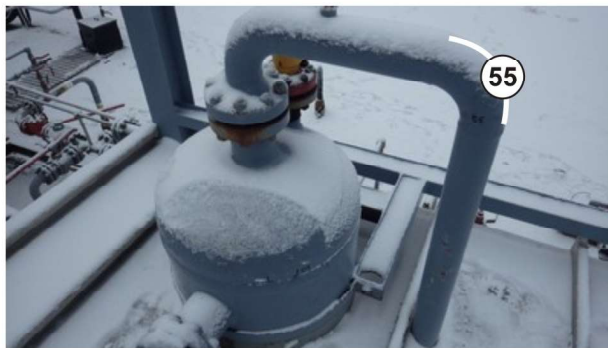
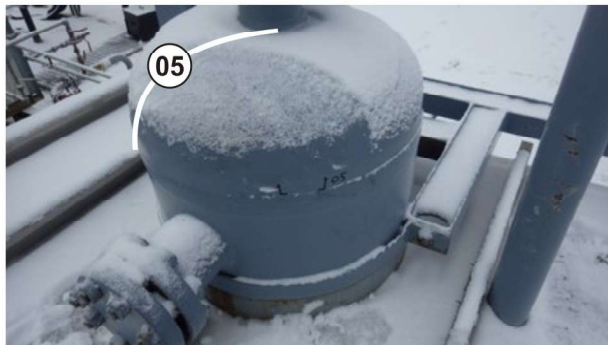
EXAMINATION ILLUSTRATION

DISTRICT:	FORT SAINT JOHN	FACILITY:	BEAVERTAIL/RIGEL	LOCATION/LSD:	C-84-A/094-A-15
EQUIP NAME:	SEPARATOR			PROV REG No.:	0487741
SERIAL No.:	VS-11687	Equip No.:		National Board No.:

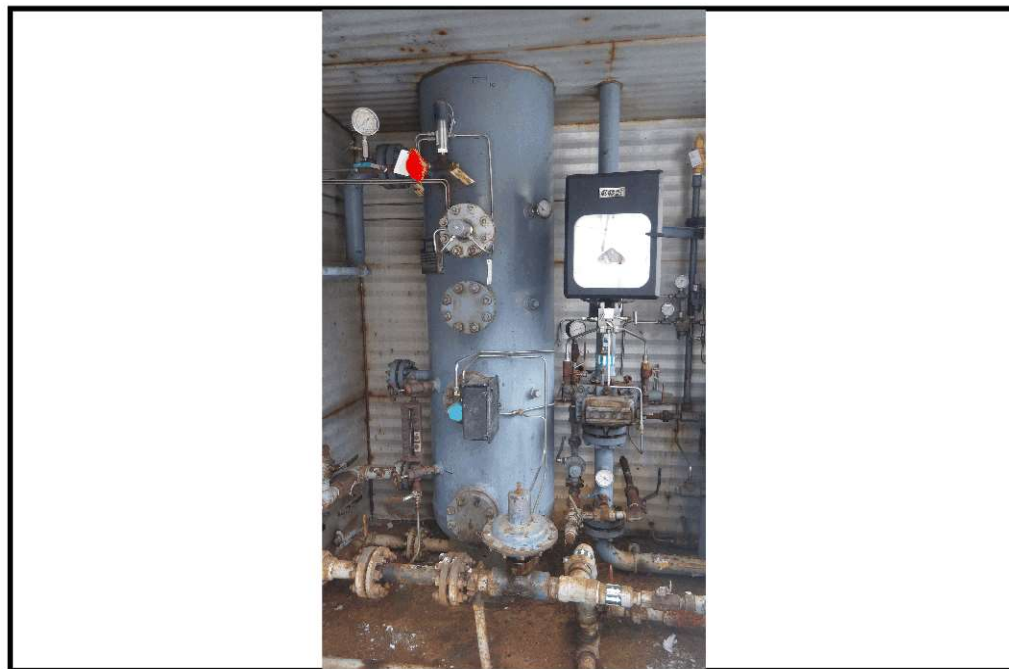
OVERALL

There was no significant external corrosion found on the vessel/piping

Vessel support is Skirt and is acceptable

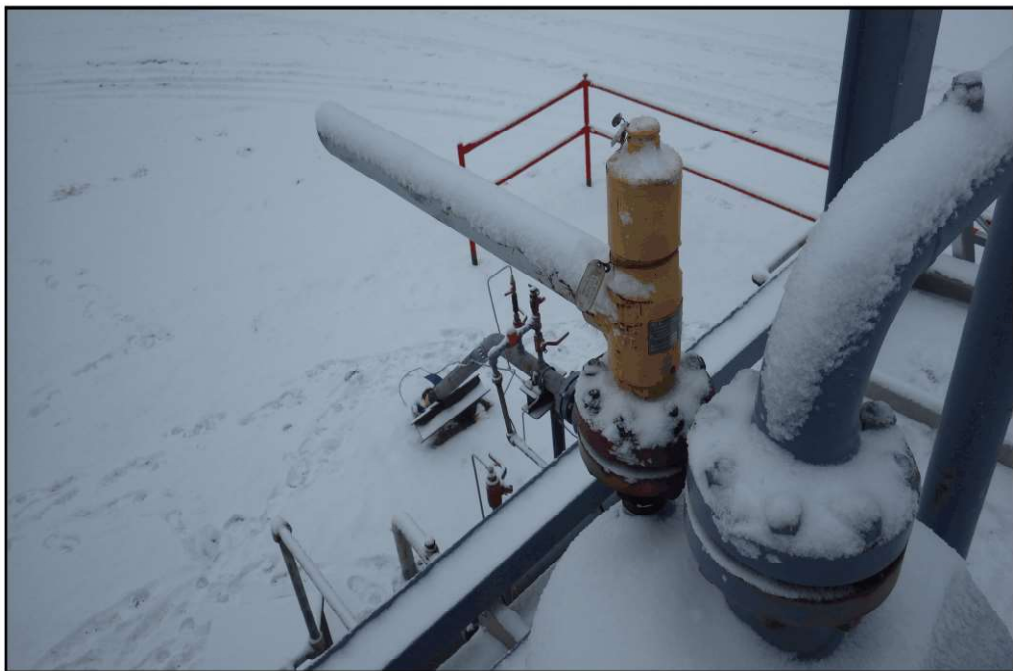
DEFICIENCY	RECOMMENDATION	QUALITY ACTION	RESULT
There is no service tag attached to the psv	OBTAIN THE LATEST PSV SERVICE REPORT AND ENSURE THE PSV IS ACCEPTABLE.	NCR	Concern
PSV service is past due.	SERVICE PSV	NCR	Reject

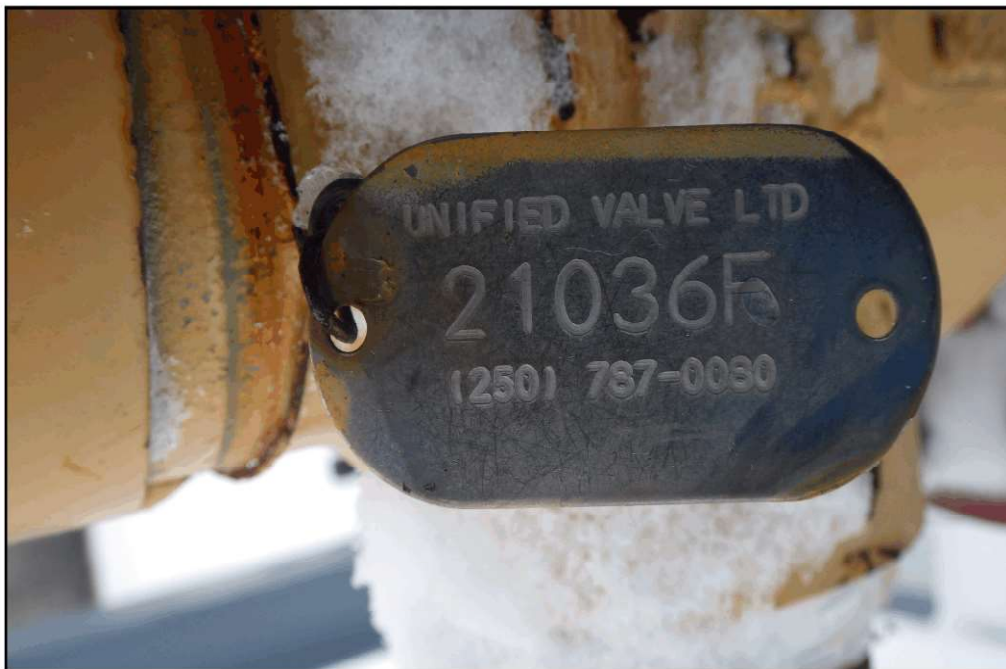
PSV TAG

ASSOCIATED PSV HAS 2 SERVICE DATES. 05/01/2012 AND 08/01/2012
