PRESSURE VESSEL
VISUAL INSPECTION
REPORT

Report #: **FIS009-WF-13**
Inspect Date: 03/03/2011
Page: 1 of 11
Insp. Co. Job #: FIS009

Insp. Comp: Fusion Inspection District: St Albert - North Field: Rush Lake
 Location: 15-11-048-23W4 Unit / Skid #: LSD: 15-11-048-23W4
 Jurisdiction #: A3047046 Equip Tag #: S04395 Serial #: 45919
 CRN #: M5100.231 Nat'l Bd #: Year Built: 1994
 Manufacturer: Bromely Equipment Description: Inlet Separator
 Status: In Service - Equip. Type: Vessel: Separator Service: Sweet
 MAWP Shell: 720 Psi @ 100 °F Volume: Code Stamp: Y N
 MAWP Tube: Psi @ °F Height/Length: Ft. Insulated: Y N
 MDMT: -20 °F RT: RT-1 Size/Diameter.: 36 in. O.D. PWHT: Y N
 Support Skirt Vessel on Original CNRL Inventory List: Y N Manway: Y N
 C.A.: in. Coated: Clad: J.E.: Remote Access: -

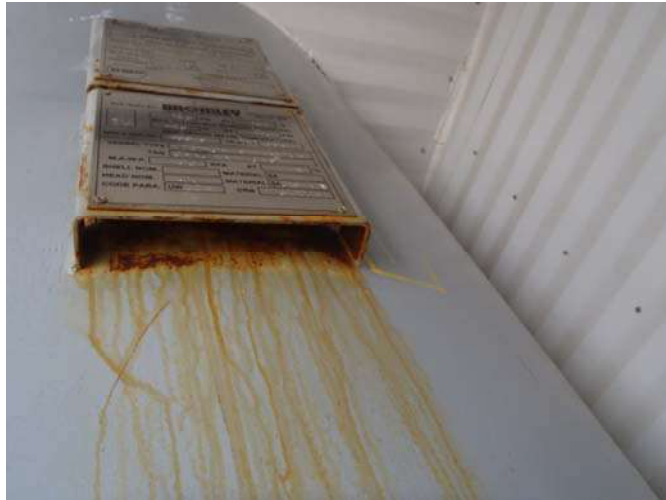
Figure 006_Corrosion behind nameplate

- The vessel was operating at time of inspection. No process leaks or vibrations were noted.
- The PSV carseal is intact. The PSV nameplate is missing and no CRN or stamping is identifiable.
- The vessel is sweating. The paint is intact on the shell and piping with the exception of the flanges and behind the nameplate where light corrosion is present.
- The skirt is secure and level with light corrosion present inside and around the base.
- All visible bolting is intact and fully engaged.
- The vessel is sufficiently grounded.
- The sight glass, temperature and pressure gauges are clear and visible.
- An external UT thickness survey was performed with no significant wall losses noted. UT was carried out with GE DMS 2 SN: 0221JR.
- Refer to the attached photos, UT data and drawing for details.

- Investigate CRN status of the PSV and identify the CRN registration and other applicable static information on the PSV.
- Clean and paint the piping flanges and behind the nameplate to assist surface condition.

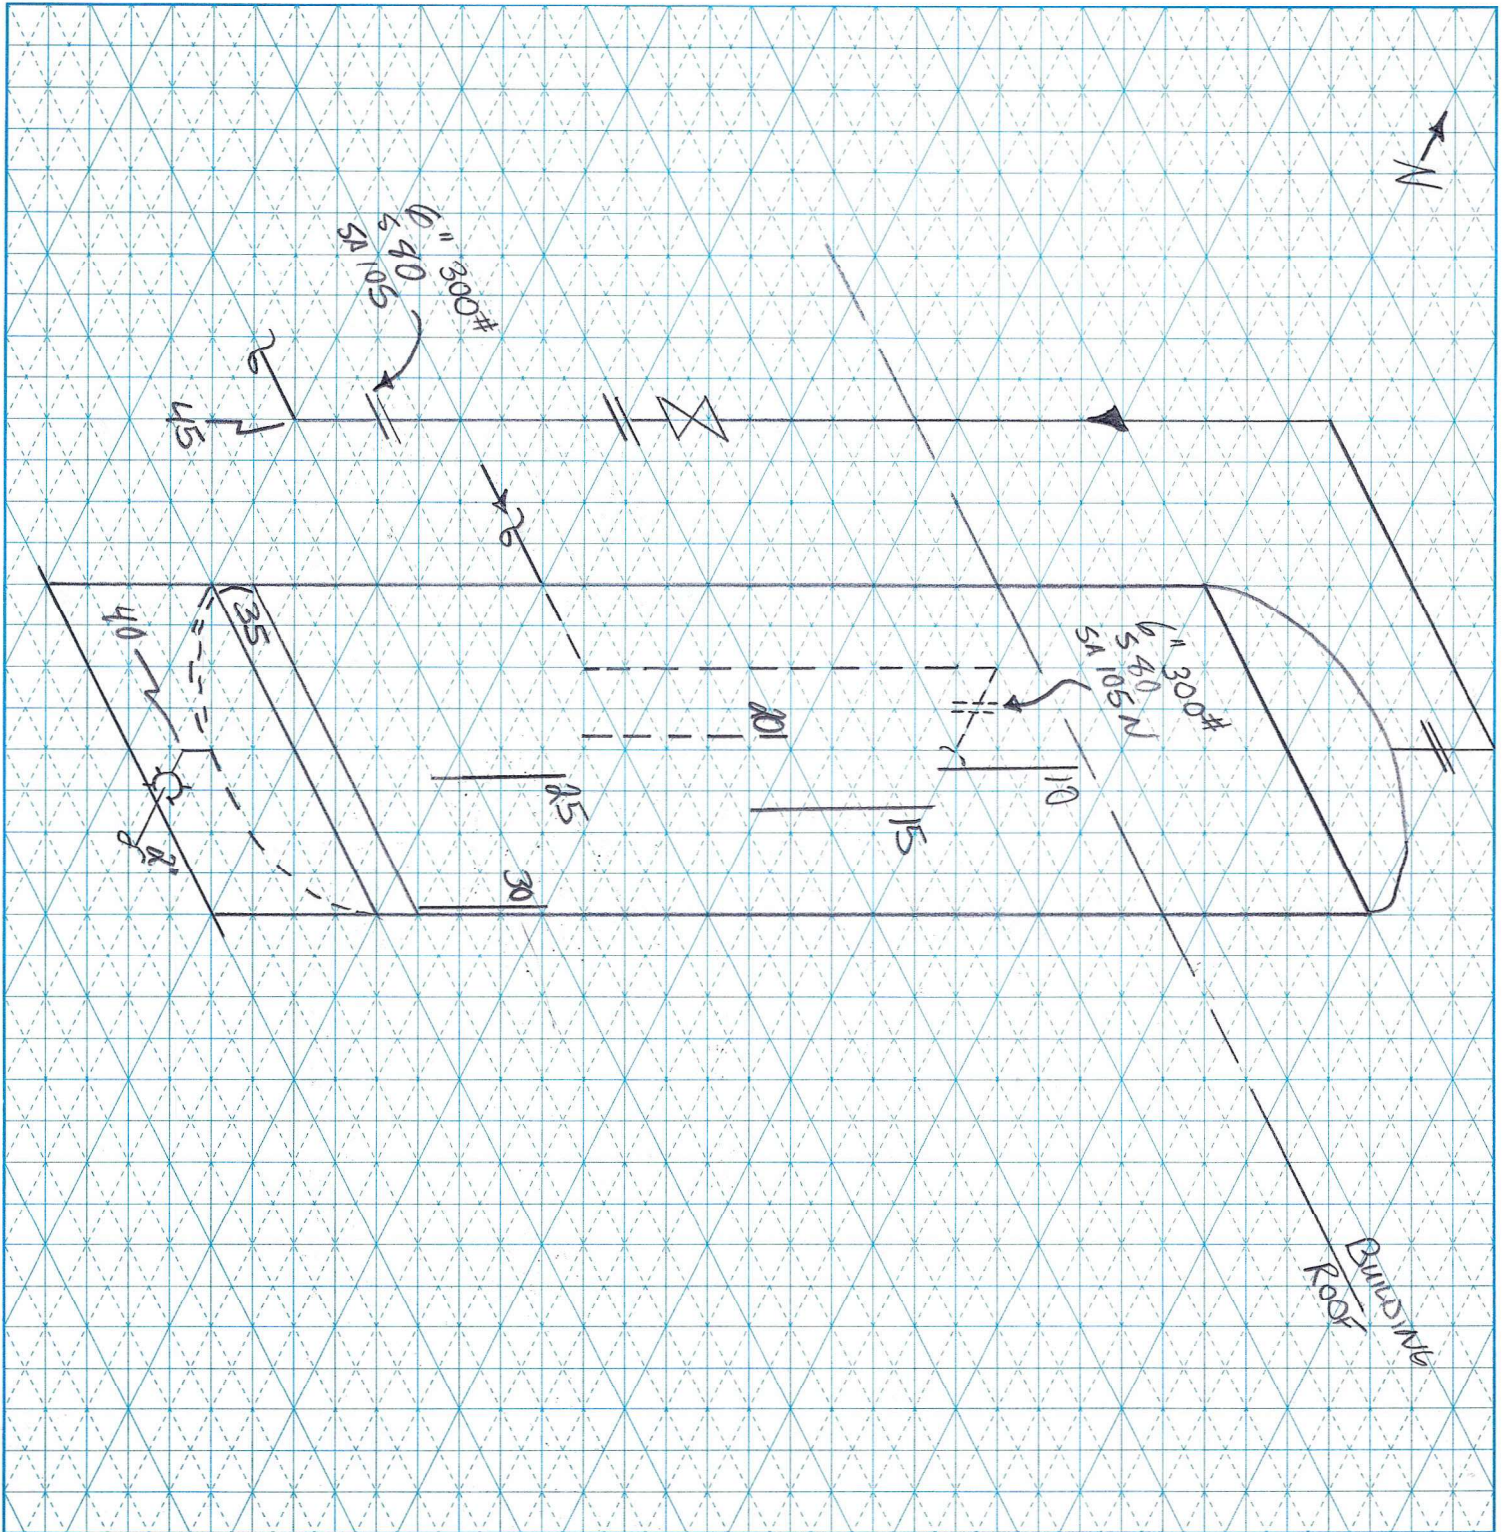
DRAWING NO: WF-13
 DATE: 03-MAR-2011
 DRAWN BY: WES F.

REG. NO. A3047046 EQP. NO. S04395 S/N 45919 EQP. DESC. INLET SEPARATOR
 CODE/STAMP uw 12A CRN M5100.231 DIA. (ID/OD) 36" YEAR BUILT 1994 SERVICE SWEET
 MANUFACTURER Bromely HEIGHT/LENGTH _____ RT RT-1 J.E. _____

HEAD		SHELL		CHANNEL HEAD	
Top/N/S/E/W Mat _____	Nom _____	Mat _____	Nom (top) <u>1.00"</u>	Shell Mat _____	Nom _____
Btm/N/S/E/W Mat _____	Nom _____	Corr. All. _____	Nom (btm) _____	Head Mat _____	Nom _____
MAWP Shell Side <u>720 psi</u>	@ MAWT <u>100°F</u>	PWHT <u>HT</u>	MDMT <u>-20°F</u>	MAWP Tube Side _____	@ MAWT _____
