**PRESSURE VESSEL  
VISUAL INSPECTION  
REPORT**

Report #: **FIS002-WF-37**  
 Inspect Date: 04/11/2010  
 Page: 1 of 9  
 Insp. Co. Job #: FIS002

Insp. Comp: Fusion Inspection District: Lloydminster Heavy Oil Field: Rush Lake  
 Location: 03-30-048-23W3 Unit / Skid #: \_\_\_\_\_ LSD: D03-30-048-23W3  
 Jurisdiction #: A3008898 Equip Tag #: S27227 Serial #: V-2124-1  
 CRN #: M4500-23 Nat'l Bd #: \_\_\_\_\_ Year Built: 1994  
 Manufacturer: OPSCO Equipment Description: Other: VERTICAL SEPARATOR  
 Status: In Service - Equip. Type: Vessel: Separator Service: Sweet  
 MAWP Shell: 1475 Psi @ 100 °F Volume: \_\_\_\_\_ Code Stamp:  Y  N  
 MAWP Tube: \_\_\_\_\_ Psi @ \_\_\_\_\_ °F Height/Length: 5 Ft. Insulated:  Y  N  
 MDMT: -20 °F RT: RT-2 Size/Diameter.: 24.00 in. PWHT:  Y  N  
 Support: Skirt Vessel on Original CNRL Inventory List:  Y  N Manway:  Y  N  
 C.A.: 0.062 in. Coated: \_\_\_\_\_ Clad: \_\_\_\_\_ J.E.: \_\_\_\_\_ Remote Access:  - \_\_\_\_\_

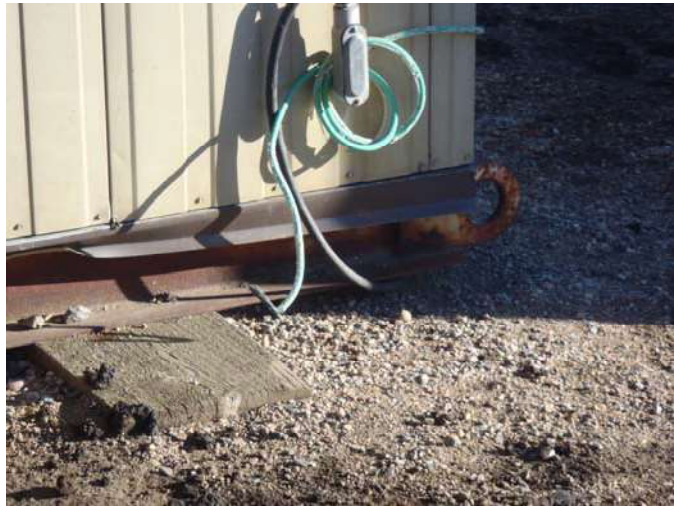
**Figure 004\_Ground Wire Present-Grounding Post Required**

- The vessel was operating at time of inspection. No process leaks or vibrations were noted.
- The ground wire from the skid for the vessel is present; however it has not been installed into the ground.
- The PSV is in good condition with the carseal intact. The PSV is overdue for servicing.
- The paint is deteriorating on isolated areas of the shell and throughout the piping with light corrosion and scale present on the piping and flanges.
- The skirt is secure and level.
- External UT was performed with no significant wall losses noted. UT was carried out with GE DMS 2 SN: 0221JR.
- Refer to the attached photos, UT data and drawing for details.

- Install the ground wire into the ground at the required depth.
- Service the PSV.
- Clean and paint the vessel to assist surface condition.

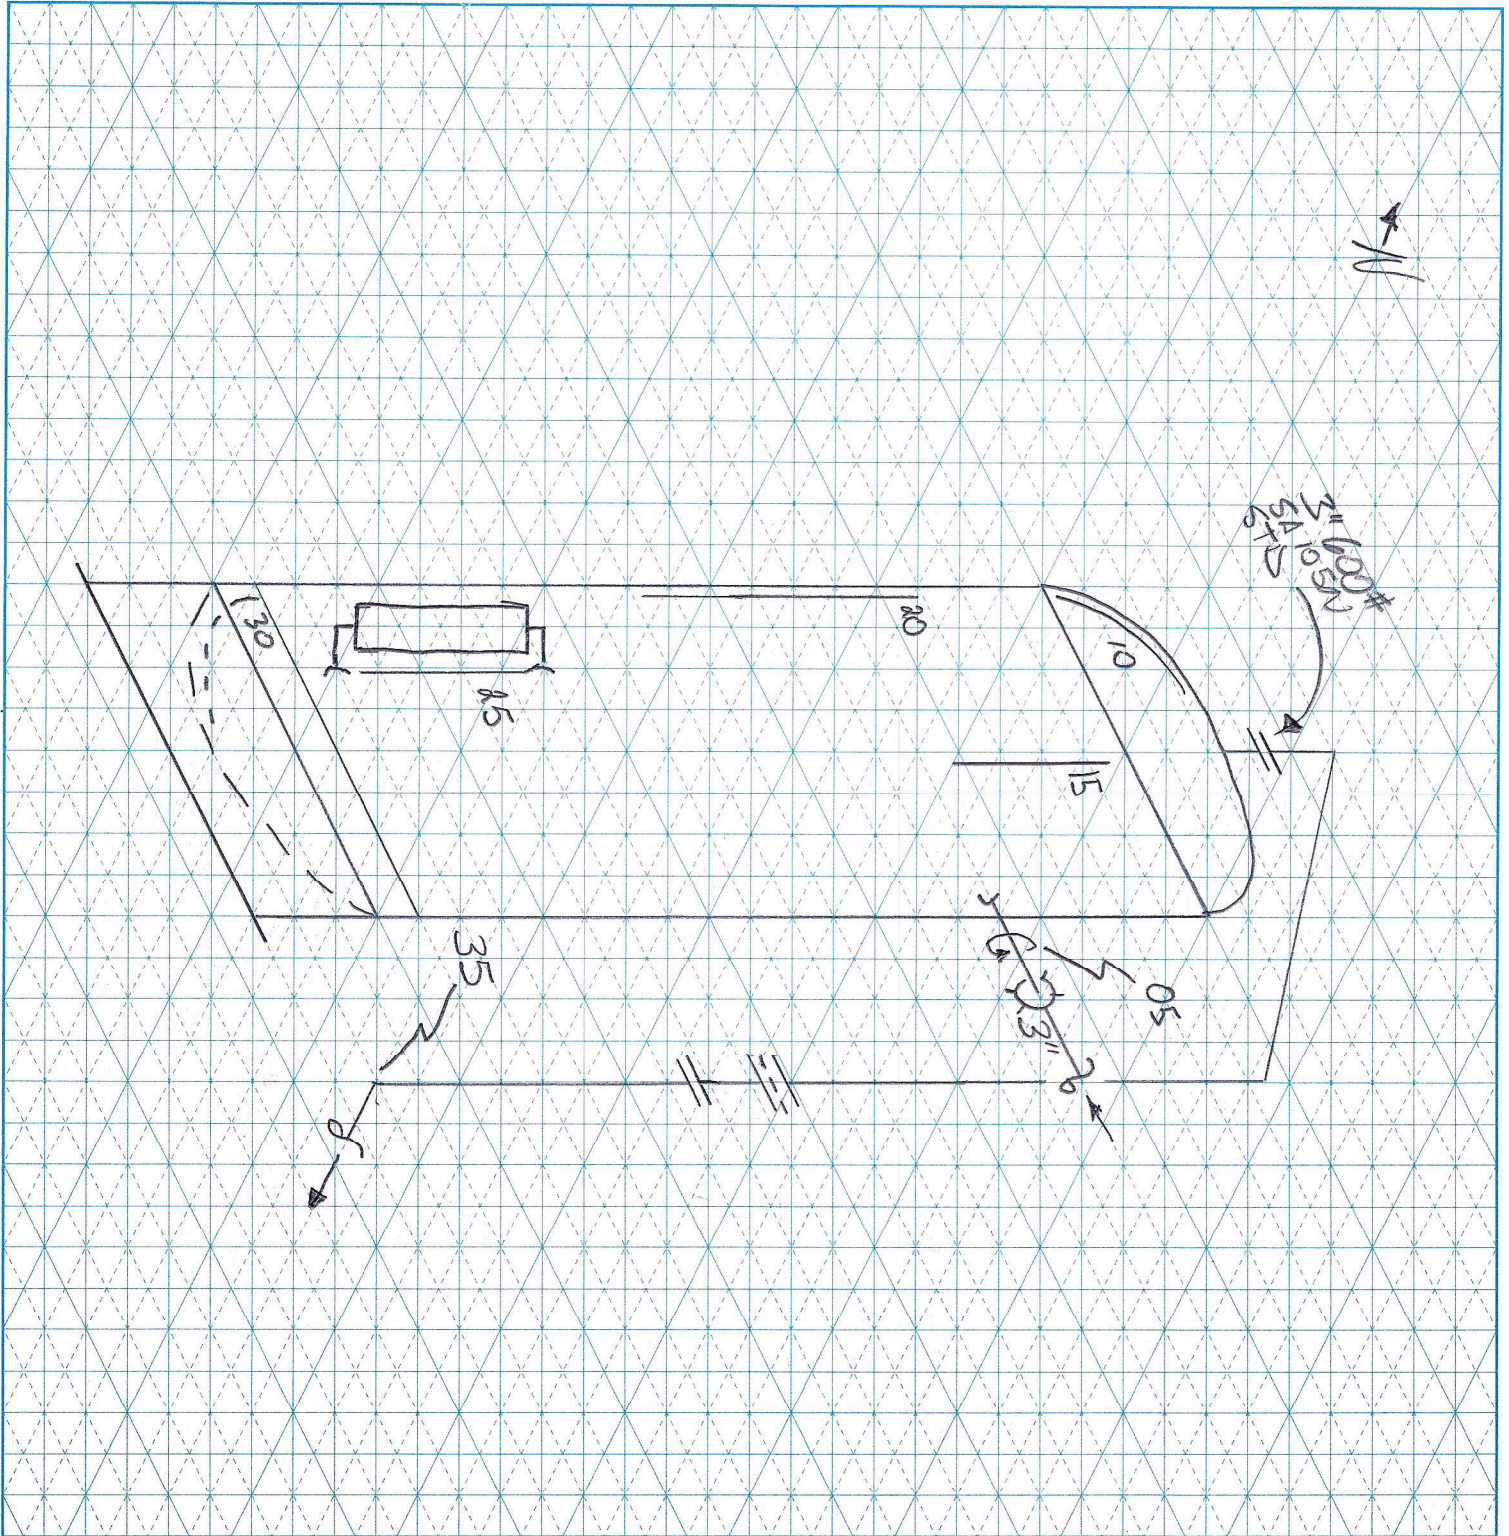
REG. NO. A3009898    EQP. NO. S 27227    S/N V-2124-1    EQP. DESC. VERTICAL SEPARATOR  
 CODE/STAMP U    CRN M4500.23    DIA. (ID/OD) 24"    YEAR BUILT 1994    SERVICE SWEET  
 MANUFACTURER OPSCO    HEIGHT/LENGTH 5'    RT RT-2    J.E. \_\_\_\_\_

HEAD		SHELL		CHANNEL HEAD	
Top/N/S/E/W Mat _____	Nom <u>1.070"</u>	Mat _____	Nom (top) <u>1.125"</u>	Shell Mat _____	Nom _____
Btm/N/S/E/W Mat _____	Nom <u>1.070"</u>	Corr. All. <u>0.0625</u>	Nom (btm) _____	Head Mat _____	Nom _____
MAWP Shell Side <u>1475 PSI</u>	@ MAWT <u>100°F</u>	PWHT <u>U</u>	MDMT <u>-20</u>	MAWP Tube Side _____	@ MAWT _____
