**PRESSURE VESSEL  
VISUAL INSPECTION  
REPORT**

Report #: **156892-MD-25**  
 Inspect Date: 08/07/2012  
 Page: 1 of 12  
 Insp. Co. Job #: 156892

Insp. Comp: Matrix Inspection District: St Albert - North Field: Sedalia  
 Location: 09-16-31-04W4 Unit / Skid #: N/A LSD: 09-16-31-04W4  
 Jurisdiction #: A0583311 Equip Tag #: N/A Serial #: PE 10683  
 CRN #: R4588.213 Nat'l Bd #: N/A Year Built: 2007  
 Manufacturer: Penfabco Ltd Equipment Description: Other: 3 Phase Separator  
 Status: In Service - Equip. Type: Vessel: Separator Service: Sweet  
 MAWP Shell: 1480 Psi @ 100 °F Volume: N/A Code Stamp:  Y  N  
 MAWP Tube: @ Height/Length: 85 in. Insulated:  Y  N  
 MDMT: -20 °F RT: RT-2 Size/Diameter.: 16 in. O.D. PWHT:  Y  N  
 Support: Skirt Vessel on Original CNRL Inventory List:  Y  N Manway:  Y  N  
 C.A.: 0.062 in. Coated: N/A Clad: N/A J.E.: N/A Remote Access:  -

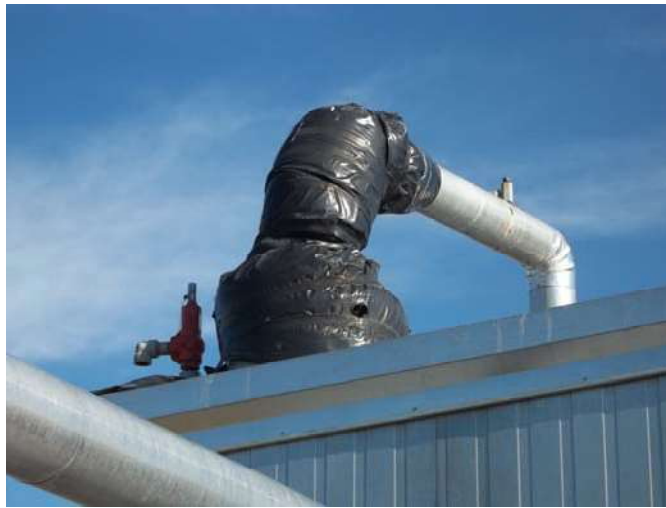
03 overview outdoors

The outdoor section of the separator is wrapped in a black tarp limiting access for inspection and UT

There is no access to the top head and shell outside the building

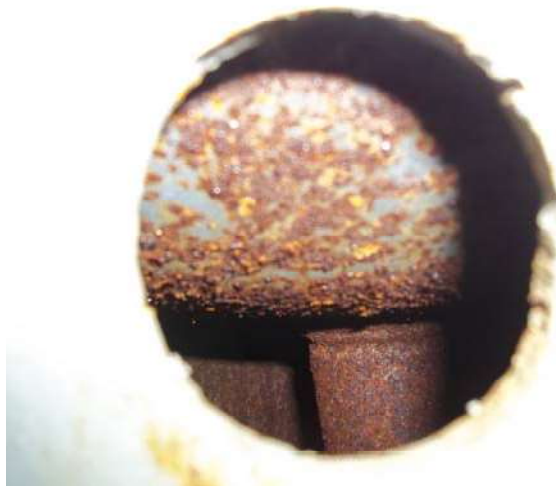
The paint is deteriorated throughout the vessel exposing the base metal to minor surface with no evidence of pitting

04 surface corrosion on bottom head

Service PSV at next turnaround  
 Clean and repaint the areas where the paint is deteriorated  
 Consider cleaning the sight glass

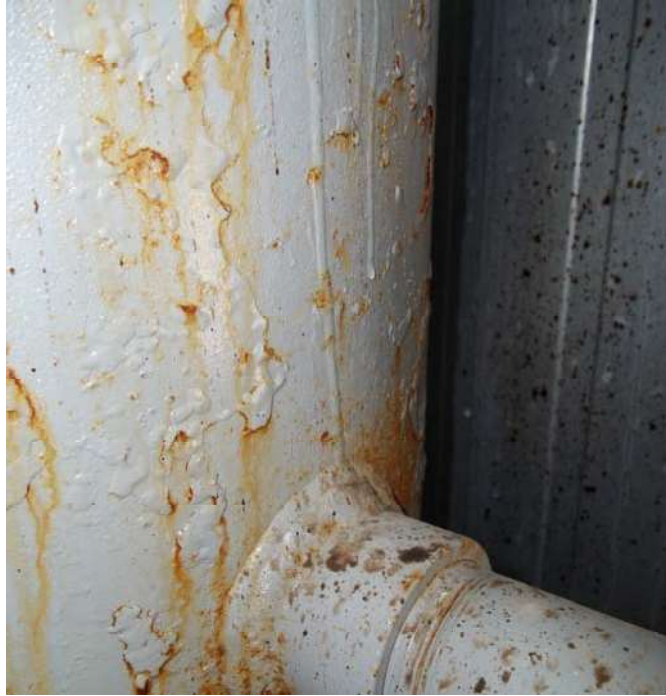
05 paint deterioration

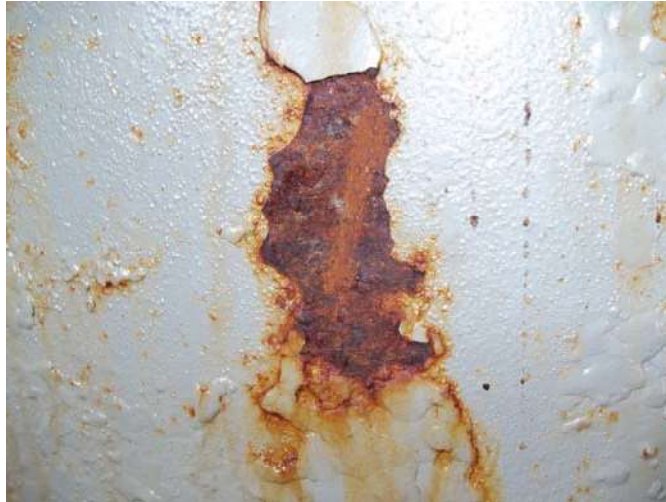
The PSV should be serviced  
Paint deterioration exposing the base metal to minor surface corrosion  
Minor staining in sight glass

06 surface corrosion

Service PSV at next turnaround  
Clean and repaint the areas where the paint is deteriorated  
Consider cleaning the sight glass

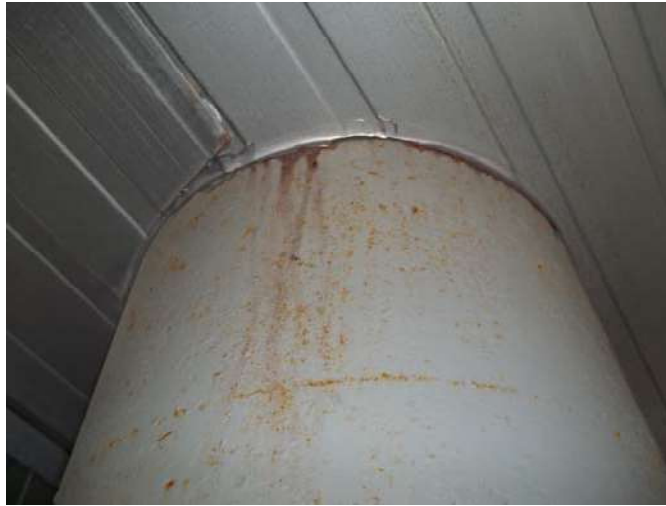
The thru wall caulking seal is deteriorated allowing for moisture ingress

**07 evidence of moisture ingress**
