**PRESSURE VESSEL
VISUAL INSPECTION
REPORT**

Report #: **156892-MD-49**
 Inspect Date: 08/07/2012
 Page: 1 of 12
 Insp. Co. Job #: 156892

Insp. Comp: Matrix Inspection District: St Albert - North Field: Sedalia
 Location: 04-23-30-04W4 Unit / Skid #: N/A LSD: 04-23-30-04W4
 Jurisdiction #: A0541718 Equip Tag #: N/A Serial #: 25519
 CRN #: P7298.21 Nat'l Bd #: N/A Year Built: 2005
 Manufacturer: Panax Oil & Gas Inc. Equipment Description: Other: Vertical Separator
 Status: Out of Service - 888 - Equip. Type: Vessel: Separator Service: Sweet
 MAWP Shell: 1480 Psi @ 100 °F Volume: N/A Code Stamp: Y N
 MAWP Tube: @ Height/Length: 78 in. Insulated: Y N
 MDMT: -20 °F RT: RT-2 Size/Diameter.: 16.00 in. O.D. PWHT: Y N
 Support: Skirt Vessel on Original CNRL Inventory List: Y N Manway: Y N
 C.A.: 0 in. Coated: N/A Clad: N/A J.E.: N/A Remote Access: -

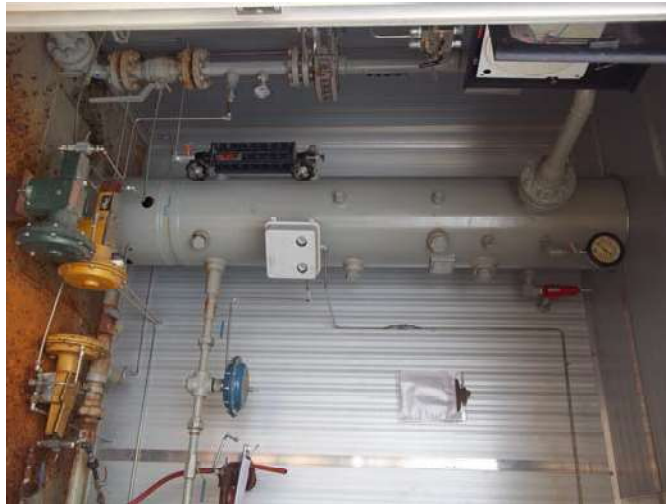
02 overview

At the time of inspection the separator was not in operation, various threaded and flanged piping was disconnected. Some of the threaded and flanged piping connections were left open to environmental conditions (weather/ animals)

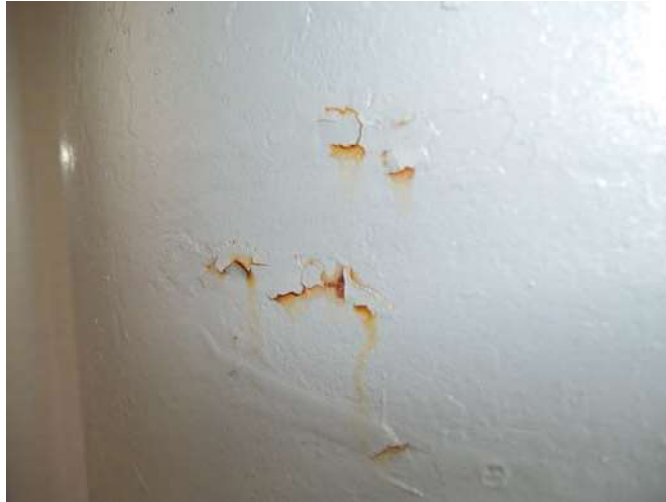
The paint is chipping and flaking exposing the base metal to minor surface corrosion with no evidence of pitting

04 flaking paint

- Service the PSV during the 2012 TA
- Clean and touch up the paint to aid in corrosion protection
- Consider blinding and covering the open threaded connections to reduce environmental type corrosion
- Consider cleaning the sight glass
- Update Maxi-trac to reflect field status

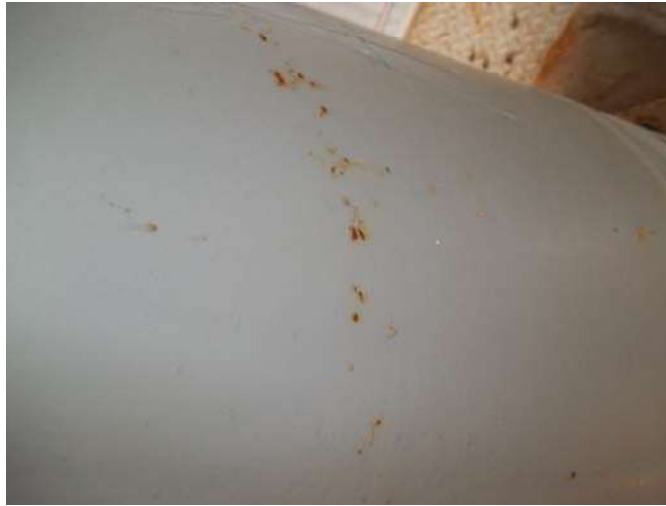
05 surface corrosion

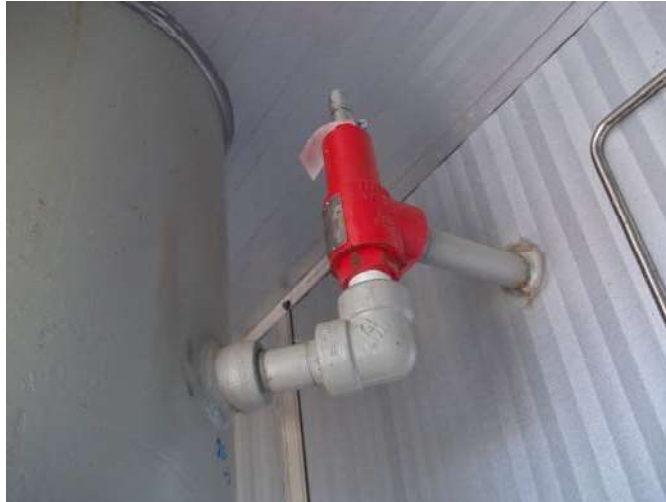
06 PSV overview

To be removed for service during 2012 TA

The PSV will be removed for service as discussed with the CNRL integrity representative

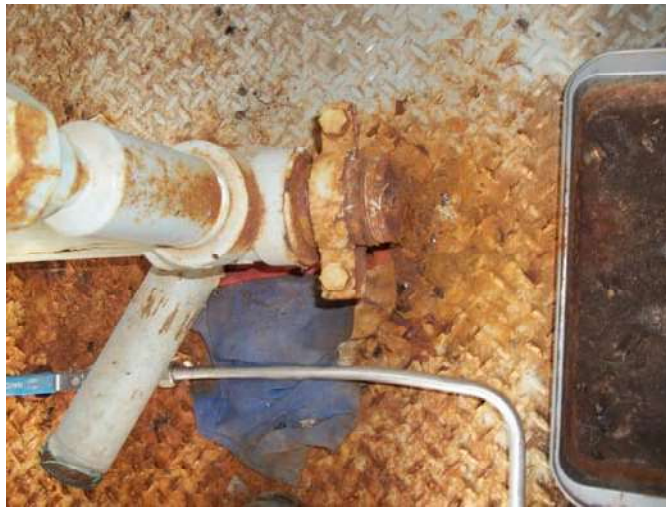
07 disconnected piping

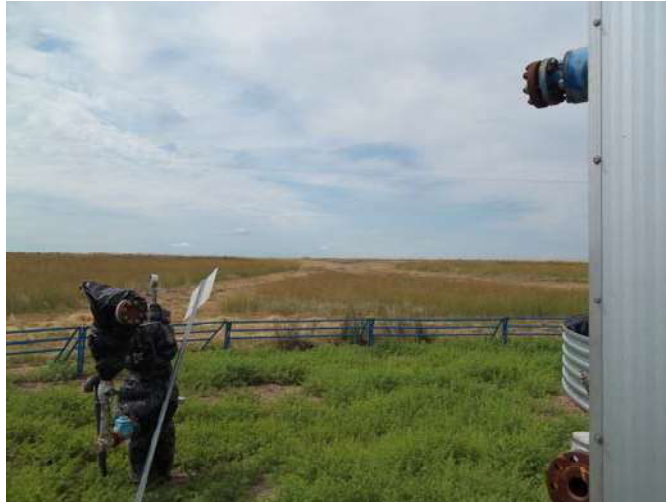
Not in operation during inspection, wellhead is isolated
PSV due for service
Chipped/ flaked paint
Very minor staining in sight glass

08 isolated well
