Client: CNRL District: St. Albert Field: Endiang  
 Facility: 06-28-034-15W4 Unit / Skid #: \_\_\_\_\_ LSD: 06-28-034-15W4  
 Jurisdiction #: A0405032 Equip Tag #: \_\_\_\_\_ Serial #: 115-90-96  
 CRN #: H5173.2 Nat'l Bd #: \_\_\_\_\_ Year Built: 1996  
 Manufacturer: Mar-quinn Industries Ltd. Equipment Description: 3 Phase Vertical Separator  
 Status: In Service - Date Removed From Service: \_\_\_\_\_ Service: Sweet  
 MAWP Shell: 1440 Psi @ 100 °F Height/Length: 114 in. Code Stamp:  Y  N  
 MAWP Tube: \_\_\_\_\_ @ \_\_\_\_\_ Size/Diameter.: 16 in. O.D. Insulated:  Y  N  
 MDMT: -20 °F RT: RT-2 Volume: 0.37 m³ PWHT:  Y  N  
 Support Type: Skirt Manway:  Y  N  
 C.A.: 1.6000 mm Coated:  Y  N Clad:  Y  N J.E.: \_\_\_\_\_ Remote Access:  - \_\_\_\_\_

**VESSEL INSPECTION  
SUMMARY**

Report #: **141148-PM-22**  
 Inspect Date: 02/03/2010  
 Page: 2 of 4  
 IRISNDT #: 141148

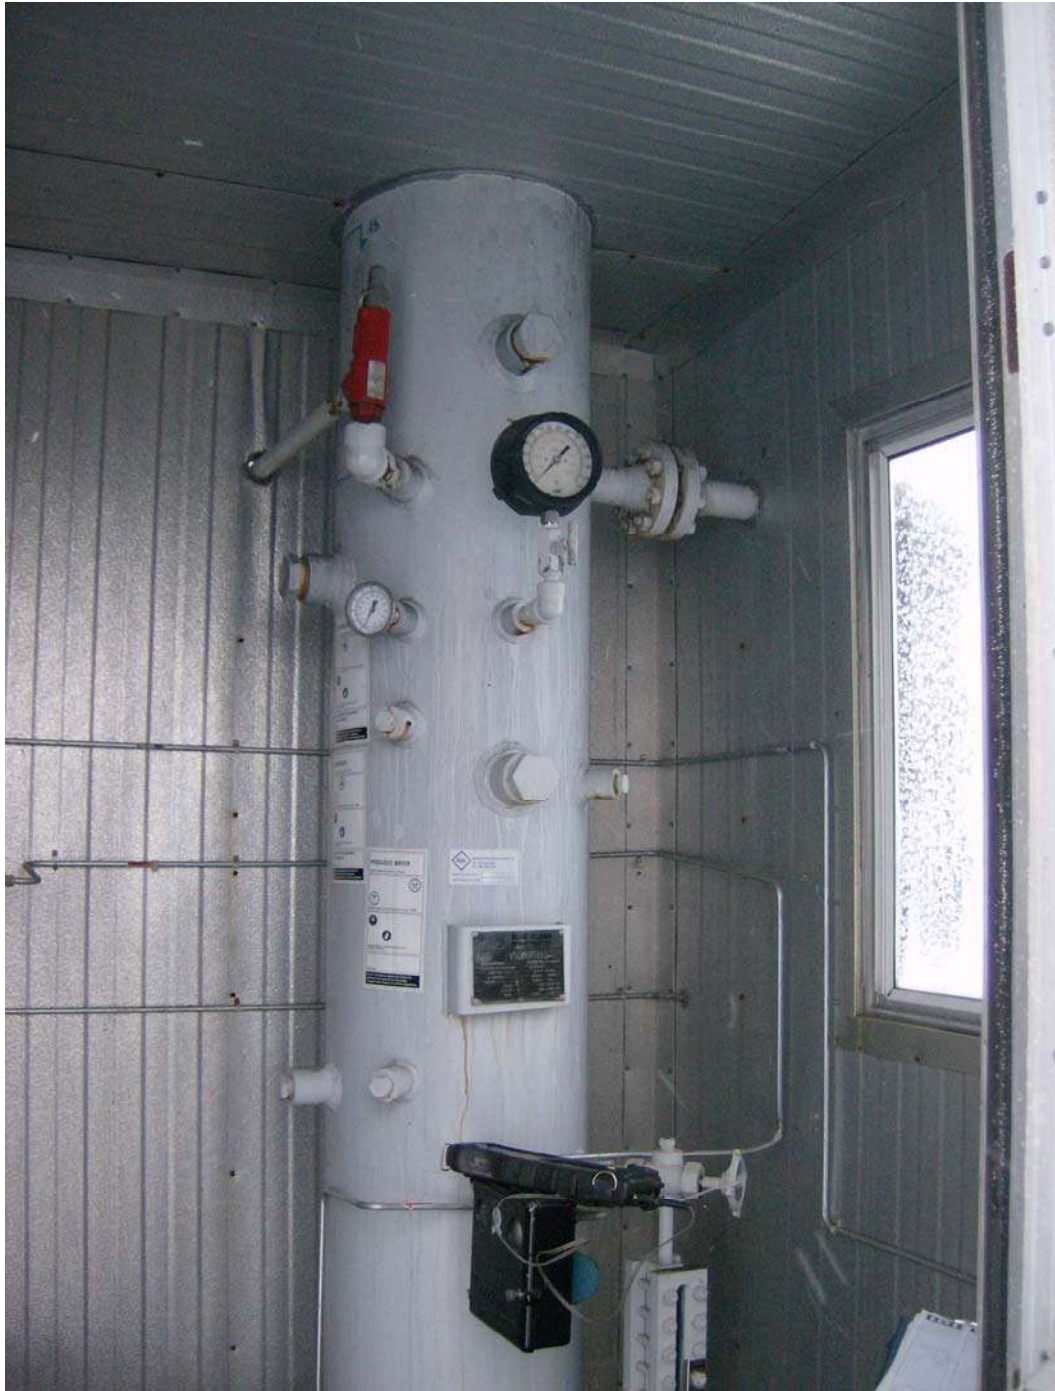
A0405032\_Overview\_03Feb10

- The vessel was not operating at time of inspection but is connected and on standby. No process leaks or vibrations were noted.
- The paint on the shell is in good condition with very minor areas of paint flaking with mild general corrosion where metal is exposed fair condition. Inlet and outlet piping is in good condition with minor areas of paint flaking with mild general corrosion where metal is exposed concentrating around the threaded fittings.

- The skirt is secure and level.
- Under skirt bottom head and drain nozzle is 100% rust covered.
- The Pressure and Temperature gauge are clear and visible. Sight glass is clear and in good condition.

- The vessel appears to be in good operating condition for continued service based on the external visual observations and UT thicknesses recorded.
