**PRESSURE VESSEL
VISUAL INSPECTION
REPORT**

Report #: **123938-DB-34**
 Inspect Date: 09/17/2010
 Page: 1 of 10
 Insp. Co. Job #: 123938

Insp. Comp: Matrix Inspection District: St Albert Field: Joffre
 Location: 04-10-039-26W4 Unit / Skid #: N/A LSD: 04-10-039-26W4
 Jurisdiction #: A3027808 Equip Tag #: N/A Serial #: 94C-5260-01
 CRN #: H6599.12 Nat'l Bd #: N/A Year Built: 1995
 Manufacturer: ALCO GAS & OIL PRODUCTION Equipment Description: Other: GLYCOL CONTACTOR
 Status: In Service - Equip. Type: Vessel: Service: Sweet
 MAWP Shell: 1650 Psi @ 150 °F Volume: N/A Code Stamp: Y N
 MAWP Tube: @ Height/Length: 336.00 in. Insulated: Y N
 MDMT: -20 °F RT: RT-1 Size/Diameter.: 28.00 in. O.D. PWHT: Y N
 Support: Skirt Vessel on Original CNRL Inventory List: Y N Manway: Y N
 C.A.: N/A in. Coated: N/A Clad: N/A J.E.: N/A Remote Access: -

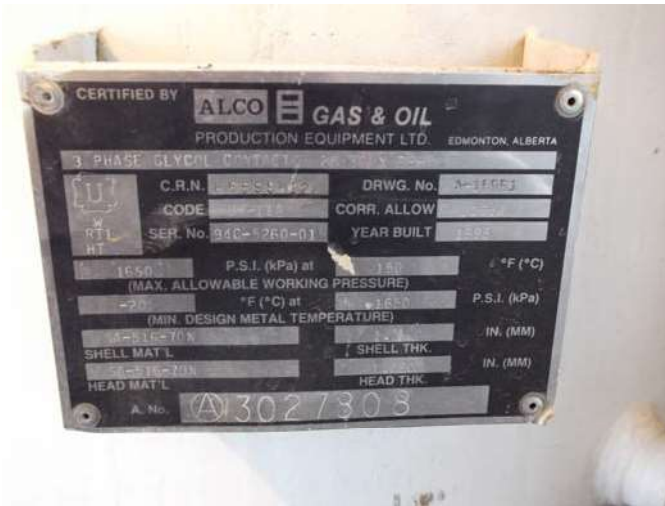
Figure_001_Nameplate

Nameplate secure and legible.
 Adequate information stated.
 Date of construction changed to tag information.

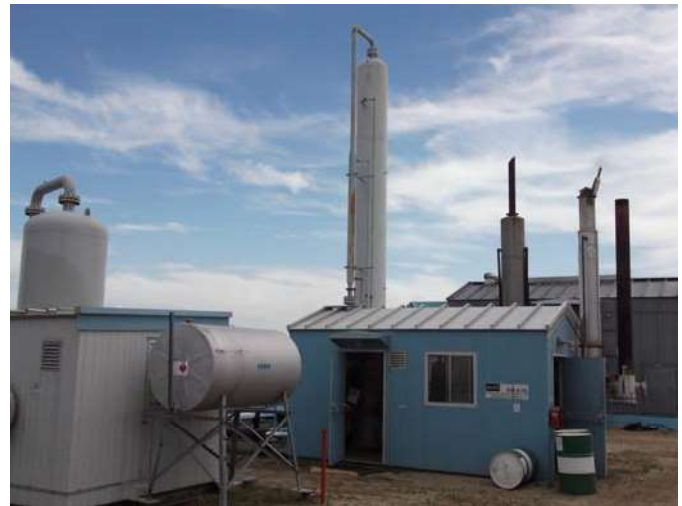
Figure_002_Overview

Vessel and associated components in good external condition.
 * PSV is overdue for service.
 Nameplate is secure and legible.
 Foundation and supports in good condition.
 Anchor bolts in place and secure.
 Ground is secure to skid. Clean and tight.
 Shell, Heads and Nozzles in good condition.
 Metal surfaces and paint good condition.,
 Vessel alignment is good.
 Flange connections proper, in good condition.
 Temperature gauge appears functional.
 Pressure gauge appears functional.
 Sight glass clean and in good condition.
 No leaks noted at time of inspection.
 Piping is well supported and in good condition.

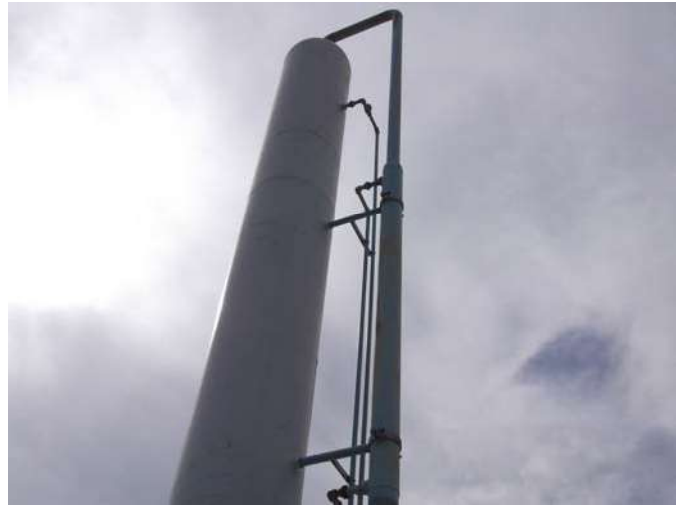
Figure_006_Top Shell Section No Access
