Client: Cnrl District: St. Albert Field: Byemoor
 Facility: 08-32-034-17W4 Unit / Skid #: N/A LSD: 08-32-034-17W4
 Jurisdiction #: A0277029 Equip Tag #: N/A Serial #: 27344A
 CRN #: C4936.231 Nat'l Bd #: N/A Year Built: 1985
 Manufacturer: Western Rock Bit Equipment Description: Propane Bullet
 Status: In - Date Removed From Service: _____ Service: Sweet
 MAWP Shell: 250 Psi @ 100 °F Height/Length: 480 in. Code Stamp: Y N
 MAWP Tube: _____ @ _____ Size/Diameter.: 108 in. O.D. Insulated: Y N
 MDMT: _____ °F RT: RT-2 Volume: _____ PWHT: Y N
 Support Type: Saddle Manway: Y N
 C.A.: _____ mm Coated Y N Clad: Y N J.E.: _____

VESSEL INSPECTION SUMMARY

Report #: **141136-PM-17**
Report Date: 01/26/2010
Page: 4 of 4
IRISNDT #: 141136

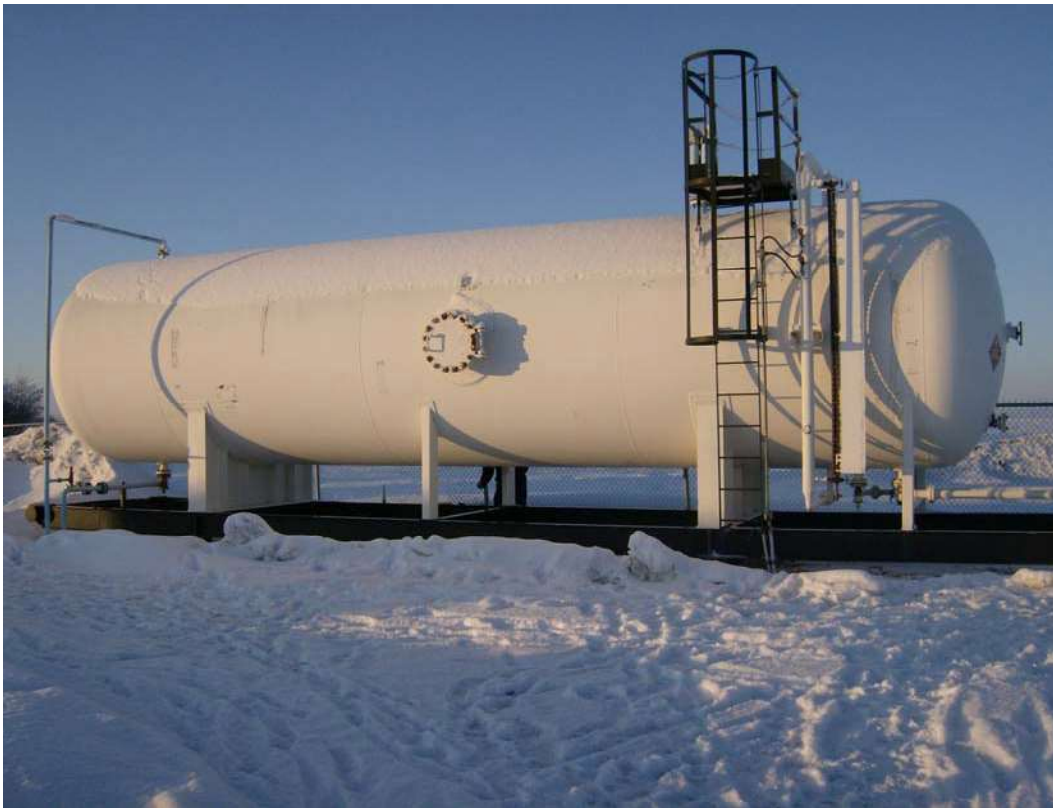
A0277029_Overview_26Jan2010

- The vessel was operating at time of inspection. No process leaks or vibrations were noted..
- The paint is on shell and piping in very good condition with very isolated areas of paint flaking down to clean bare metal.

- The vessel appears to be in good operating condition for continued service based on the external visual observations and UT thicknesses recorded.

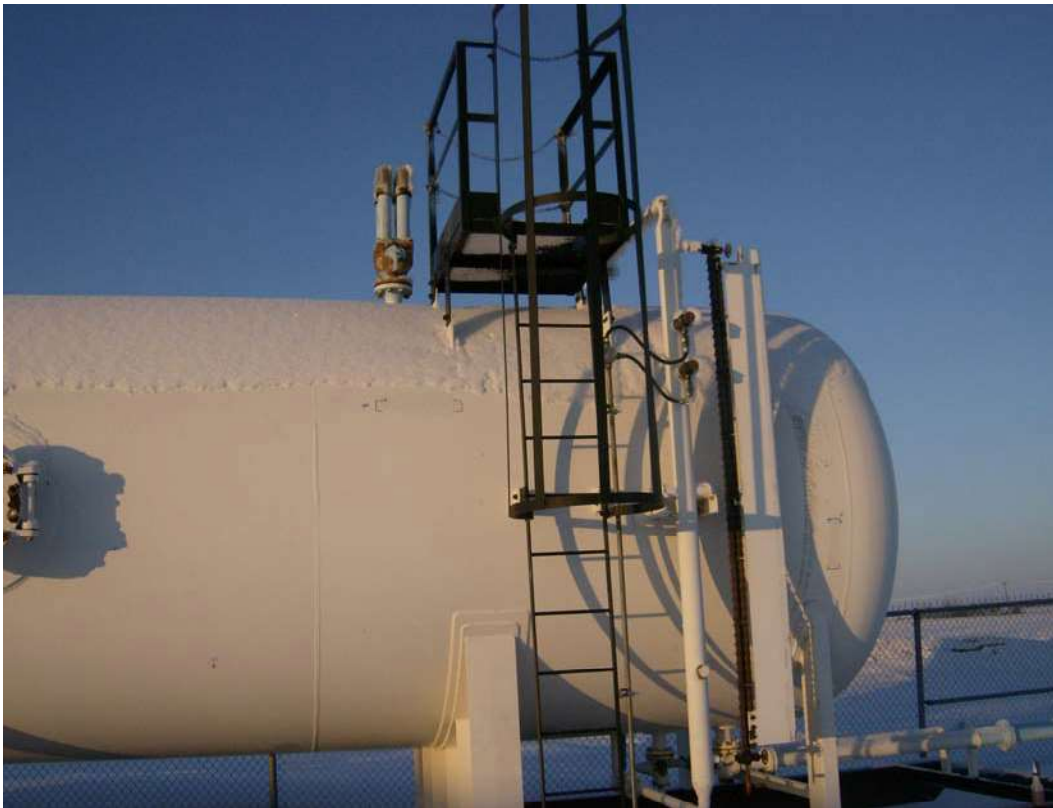
A0277029_Ladder and platform_26Jan2010

- Ladder and platform is in good condition and secure
- The vessel is supported by saddles welded to shell and welded to metal skid. Vessel is secure and level.
