CLIENT	CANADIAN NATURAL RESOURCES LTD	
FACILITY	PEE JAY SOLUTION	
	LSD d-39-E/94-A-16	
ITEM	GLYCOL CONTACTOR	
BY: KB/AN	DATE: 01/2015	DWG.# 12A

CLIENT: CANADIAN NATURAL RESOURCES LTD
EQUIPMENT: GLYCOL CONTACTOR
CRN#: P-0620.21
PROV REG: C 35011
TESTED ON STREAM

**Canadian Natural Resources Limited
GENERAL PRESSURE VESSEL INFORMATION**

District: Fort Saint John, BC		Skid No.					
Facility: Pee Jay Solution Gas		Location (LSD): d-39-E / 94-A-16					
Vessel Name Equipment Number: Glycol Contactor							
Orientation: Vertical							
Status: In Service		Regulatory Inspection					
PRESSURE VESSEL NAMEPLATE DATA							
"A" or "G" or "S" (Sask.) or BC Registration Number. C35011		CRN Number: P 6020.21					
Vessel serial number: 032157-101		Size: 24 in x 24 ft.					
Shell thickness: 25.4 mm		Shell material: SA 516 70N					
Head thickness: 24.3 mm		Head material: SA 516 70N					
Tube wall thickness:		Tube material:					
Tube diameter:		Tube length:					
Channel thickness:		Channel material:					
Design pressure	Shell: 1480 PSI	Design pressure	Shell:				
	Tubes:		Tubes:				
Design Temp.	Shell: 100°F	Design Temp.	Shell:				
	Tubes:		Tubes:				
X-ray: RT 1		Heat treatment: Yes					
Code para

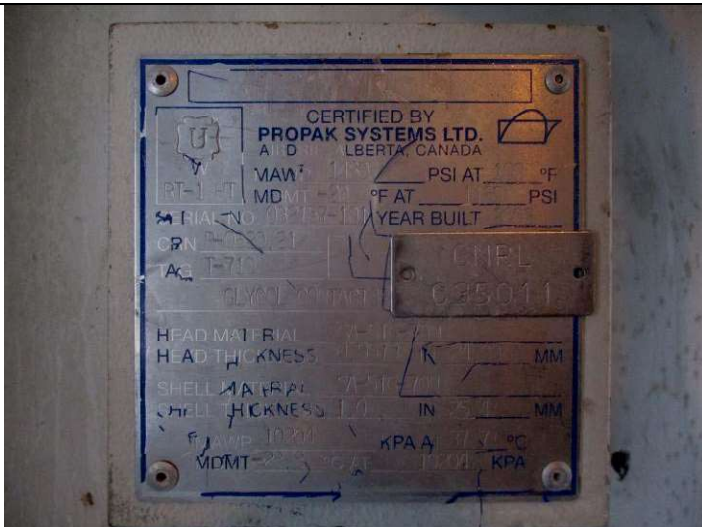
<p>LSD</p>	<p>Data Plate</p>

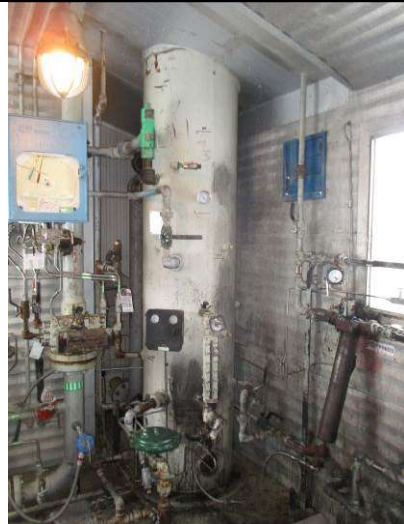
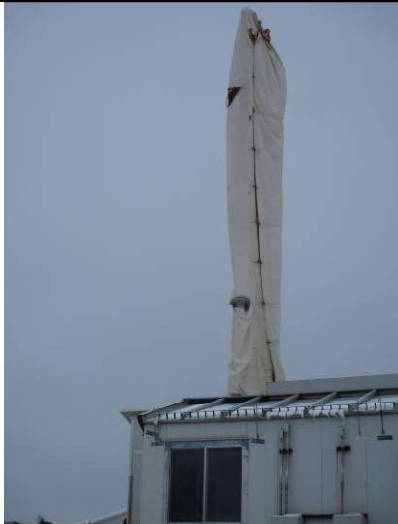
External Inspection Items	G	F	P	N/A	Comments
Insulation Verify sealed around manways, nozzles, no damage present, and there is no egress of moisture.	X				Vessel is insulated outside skid – insulation wrap – no exposed areas.
External Condition Assess paint condition, areas peeling, record any corrosion, damage, etc (record location, size and depth of corrosion or damage)	X				Paint in good general condition – no exposed metal.
Leakage Record any leakage at flanges, threaded joints, weep holes on repads, etc.	X				No leaks.
Saddle/skirt Assess condition of paint, fire protection, and concrete. Look for corrosion, buckling, dents, etc. Look at vessel surface area near supports. Verify no signs of leakage at attachment to vessel and attachment welds are acceptable. Ground wire attached?	X				Skirt is in good condition – no buckles or distortion. No corrosion at skirt to head area – no leaks. Ground attached to skid.

<p>Overview</p>	<p>Overview</p>

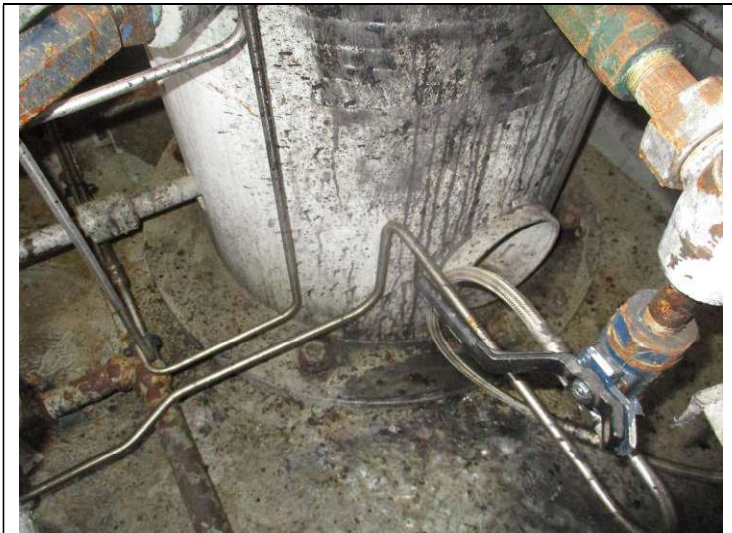
Anchor Bolts Hammer tap to ensure secure. Look for cracking in treads or signs of deformation.	X				Firmly bolted to skid deck.
Concrete foundation Check for cracks, spalling, etc.				X	None.
Ladder / Platform Describe general condition, ensure support is secure to vessel, and describe any hazards.				X	None.
Nozzle Assess paint, look for leakage, and ensure stud threads are fully engaged. Record any damage, deflection, etc. Are nozzles gusseted?	X				All flanged and threaded fittings are fully engaged – No short studs. No deflection – no leaks. Paint is in good condition – no corrosion.
Gauges Ensure gauges are visible, working, no leakage, and suitable for range of MAWP/ Temp.	X				Pressure gauge: No pressure gauge. Temperature gauge: 0 to 250 deg F.
External Piping Ensure pipe is well supported. All clamps, supports, shoes, etc. in place. Look for evidence of structural overload, deflection, etc. Paint condition, external corrosion?	X				Piping is well supported; no deflection, all clamps and supports are in place. Paint is in good condition – no corroded areas.

Anchor bolts

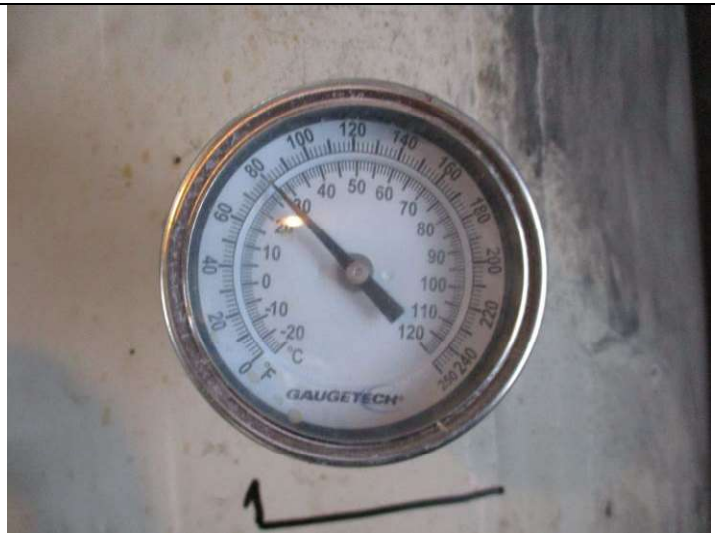
Temperature gauge

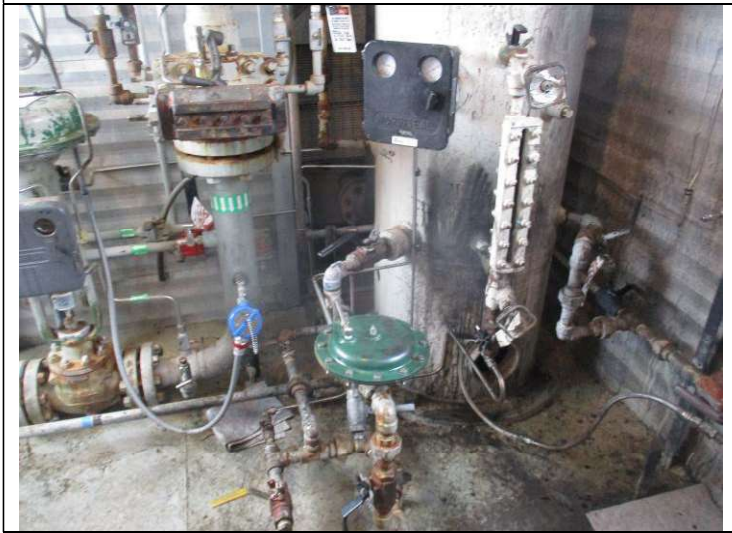
Glycol piping

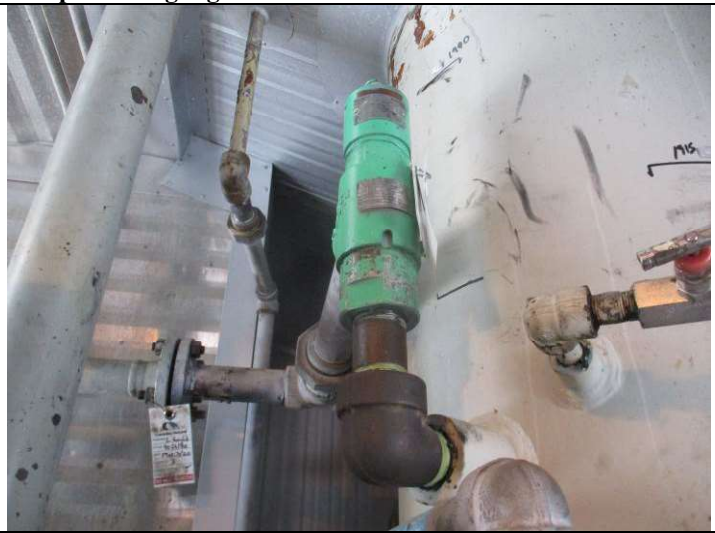
Valving Ensure no leaks are visible. Valves are properly supported and chained if necessary.	X				Well supported – no leaks.
PSV Ensure PSV is set at pressure at or below that of vessel.	X				Located on lower shell – set below MAWP of vessel. Discharge piping is the same size as the outlet to PSV. No block valve present. Seal is intact. PSV vents to closed header.

PSV

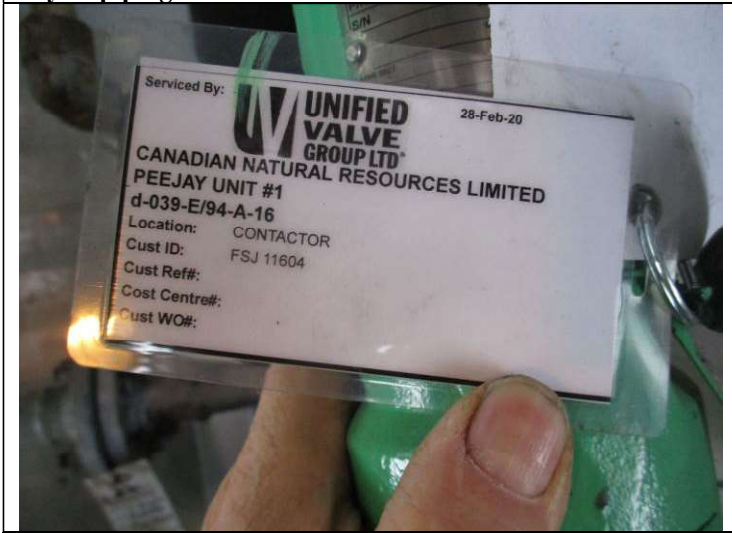
PSV Service Tag

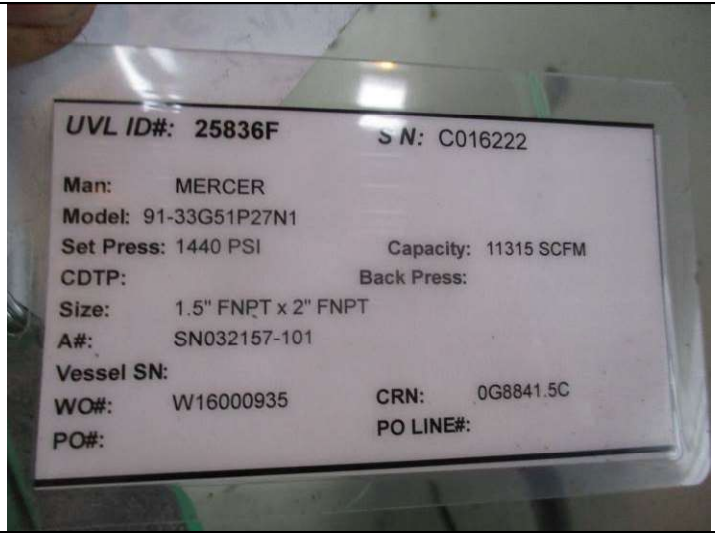
PSV Service Tag

Serviced By: **UNIFIED VALVE GROUP LTD.** 28-Feb-20
CANADIAN NATURAL RESOURCES LIMITED
 PEEJAY UNIT #1
 d-039-E/94-A-16
 Location: CONTACTOR
 Cust ID: FSJ 11604
 Cust Ref#:
 Cost Centre#:
 Cust WO#:

UVL ID#: 25836F S N: C016222
 Man: MERCER
 Model: 91-33G51P27N1
 Set Press: 1440 PSI Capacity: 11315 SCFM
 CDTP: Back Press:
 Size: 1.5" FNPT x 2" FNPT
 A#: SN032157-101
 Vessel SN:
 WO#: W16000935 CRN: 0G8841.5C
 PO#: PO LINE#:
