CLIENT	CANADIAN NATURAL RESOURCES LTD	
FACILITY	PEE JAY SOLUTION LSD d-39-E/94-A-16	
ITEM	GLYCOL CONTACTOR	
BY: KB/AN	DATE: 01/2015	DWG.# 12A

**Canadian Natural Resources Limited  
GENERAL PRESSURE VESSEL INFORMATION**

**Job 4025400**

District: <b>Fort Saint John, BC</b>	Skid No.
Facility: <b>Pee Jay Solution Gas</b>	Location (LSD): <b>d-39-E / 94-A-16</b>
Vessel Name Equipment Number: <b>Glycol Contactor</b>	
Orientation: <b>Vertical</b>	
Status: <b>In Service</b>	<b>Regulatory Inspection</b>

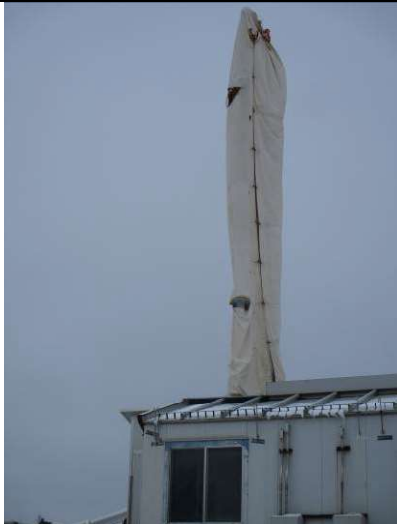
<p><b>Overview</b></p>	<p><b>Overview</b></p>

External Inspection Items	G	F	P	N/A	Comments
<b>Insulation</b> Verify sealed around manways, nozzles, no damage present, and there is no egress of moisture.	X				<b>Vessel is insulated outside skid – insulation wrap – no exposed areas.</b>
<b>External Condition</b> Assess paint condition, areas peeling, record any corrosion, damage, etc (record location, size and depth of corrosion or damage)	X				<b>Paint in good general condition – no exposed metal.</b>
<b>Leakage</b> Record any leakage at flanges, threaded joints, weep holes on repads, etc.	X				<b>No leaks.</b>
<b>Saddle/skirt</b> Assess condition of paint, fire protection, and concrete. Look for corrosion, buckling, dents, etc. Look at vessel surface area near supports. Verify no signs of leakage at attachment to vessel and attachment welds are acceptable. Ground wire attached?	X				<b>Skirt is in good condition – no buckles or distortion. No corrosion at skirt to head area – no leaks.  Ground attached to skid.</b>

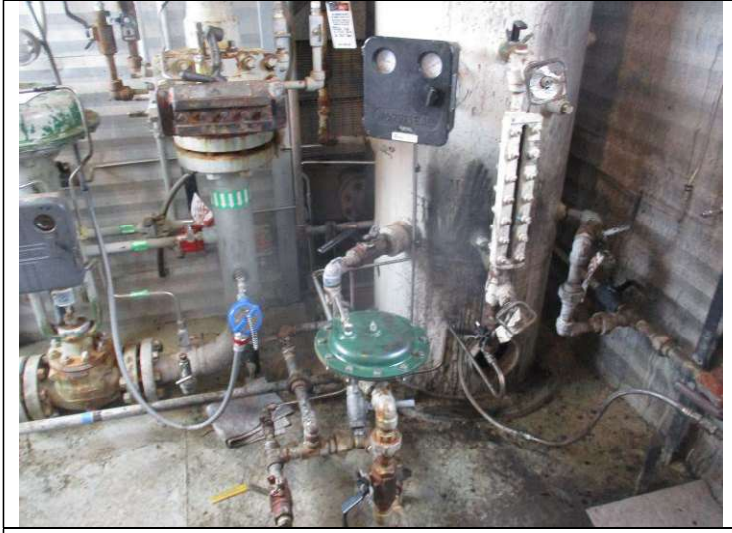
Glycol piping

<b>Valving</b> Ensure no leaks are visible. Valves are properly supported and chained if necessary.	X				<b>Well supported – no leaks.</b>
<b>PSV</b> Ensure PSV is set at pressure at or below that of vessel.	X				<b>Located on lower shell – set below MAWP of vessel. Discharge piping is the same size as the outlet to PSV. No block valve present. Seal is intact. PSV vents to closed header.</b>

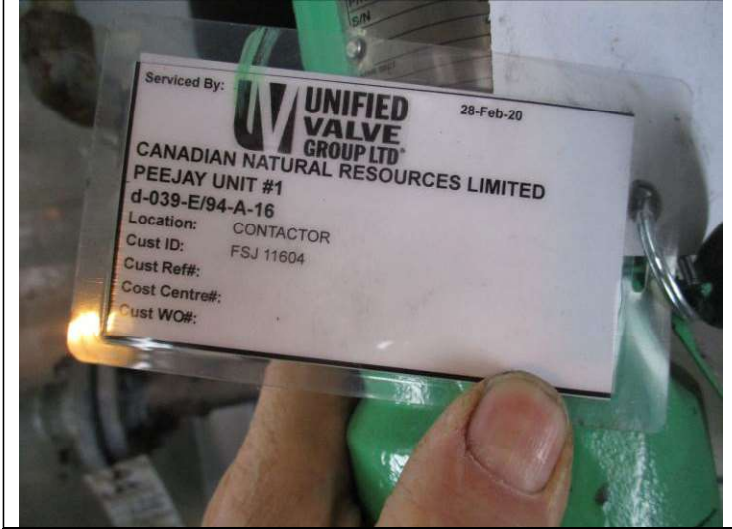
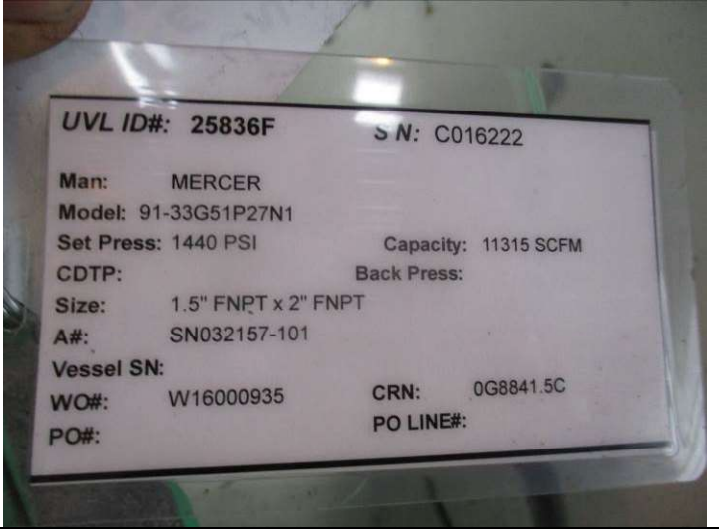
PSV Service Tag

Serviced By: **UNIFIED VALVE GROUP LTD.** 28-Feb-20  
**CANADIAN NATURAL RESOURCES LIMITED**  
 PEEJAY UNIT #1  
 d-039-E/94-A-16  
 Location: CONTACTOR  
 Cust ID: FSJ 11604  
 Cust Ref#:   
 Cost Centre#:   
 Cust WO#:

**UVL ID#: 25836F**      **S N: C016222**  
 Man: MERCER  
 Model: 91-33G51P27N1  
 Set Press: 1440 PSI      Capacity: 11315 SCFM  
 CDTP:      Back Press:  
 Size: 1.5" FNPT x 2" FNPT  
 A#: SN032157-101  
 Vessel SN:  
 WO#: W16000935      CRN: 0G8841.5C  
 PO#:      PO LINE#:
