## Field Inspection Report

Client	CNRL		Date of Inspection	April 17, 2013			
Prov. Reg.#	A0490198		Inspection Type	VE, UT			
Equipment	Vertical Separator		Location	Badger Compressor Station			
Tag/Equip. #			LSD	01-31-015-16W4M			
Vessel Status	In Service		Comp./Unit #				
Manufacturer	Rushton Gas & Oil Equipment Ltd.		MAWP / Temp	9928 KPA @ 54 C			
Serial #	C1496B.C	CRN #	L 8949.2	MDMT@ Pressure	-29 C @ 9928 KPA		
Corrosion Allowance		Shell Material		Shell Thickness			
Year Built	2002	Head Material		Head Thickness			
Diameter	30" OD	Length		Height	RT	RT-2	HT
Service		Next Inspection		Next Insp. Type			
ASME Stamp	No	Next Inspection		Next Insp. Type			
PSV Tag #		CRN#	OG 1316.2C	Set Pressure			
Manufacturer	Taylor Valve			NB#		ASME Stamp	
Type/Model		Serial	41924-35	Inlet Size	2"		
Capacity	10871 SCFM	Service Company		Outlet Size	2"		
Service Date		Next Service Date					
Valve Location	<input type="checkbox"/> On Vessel <input type="checkbox"/> On Piping <input type="checkbox"/> Vents to Flare <input type="checkbox"/> Vents to Atmosphere	Valve Connection	<input type="checkbox"/> Threaded <input type="checkbox"/> Flanged <input type="checkbox"/> Welded	ABSA CODE TYPE

**General Com

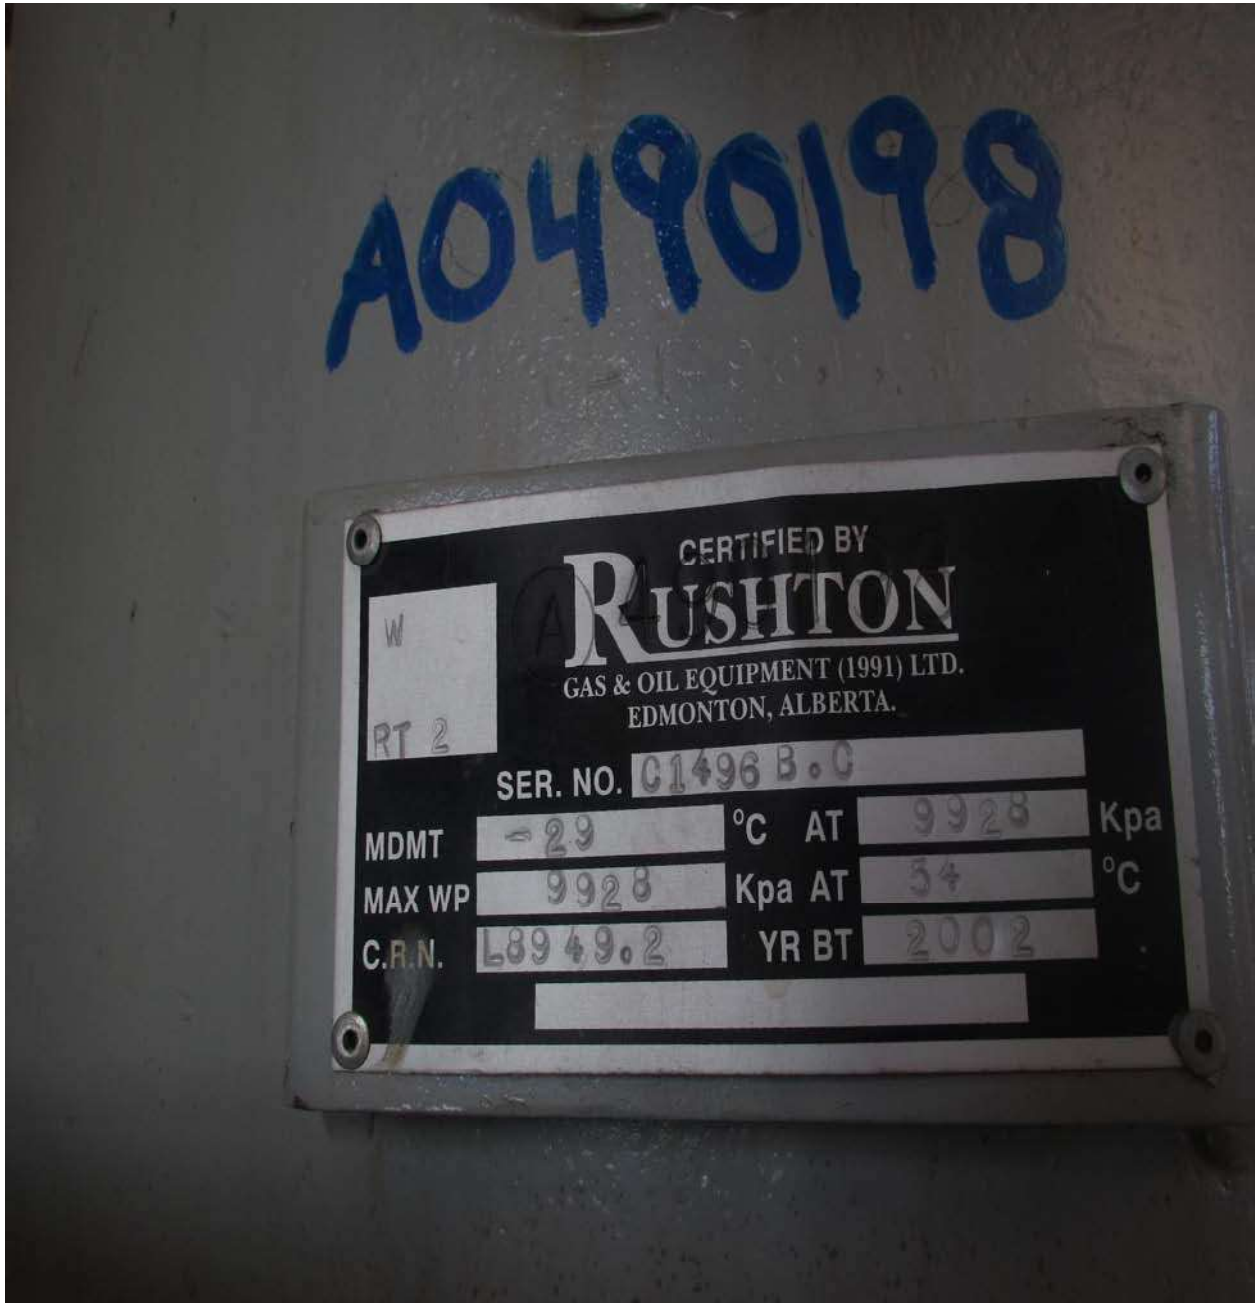
A0490198\_Name plate\_17April2013

- Name plate was attached and readable.
- External paint was in good condition with no signs of external corrosion noted.
- Vessel is supported on a skirt, bottom head to skirt weld was in good shape.
