Pressure Equipment Integrity Management System Installation Inspection Form

Owner: Arsenal Energy Inc District/Area: British Columbia
 Facility: Osborn Location (LSD) ♦: B-33-J/94-a-9

A Number ♦: 536143 Serial Number ♦: S-1664
 CRN ♦: T0849.23 Vessel Type: Separator
 Description ♦: Sweet Gas After Scrubber Process: Sweetening
 Tag No: _____ Current Status: Out of Service

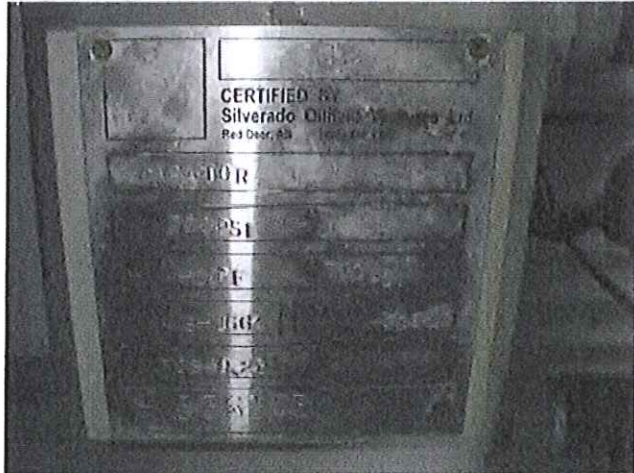
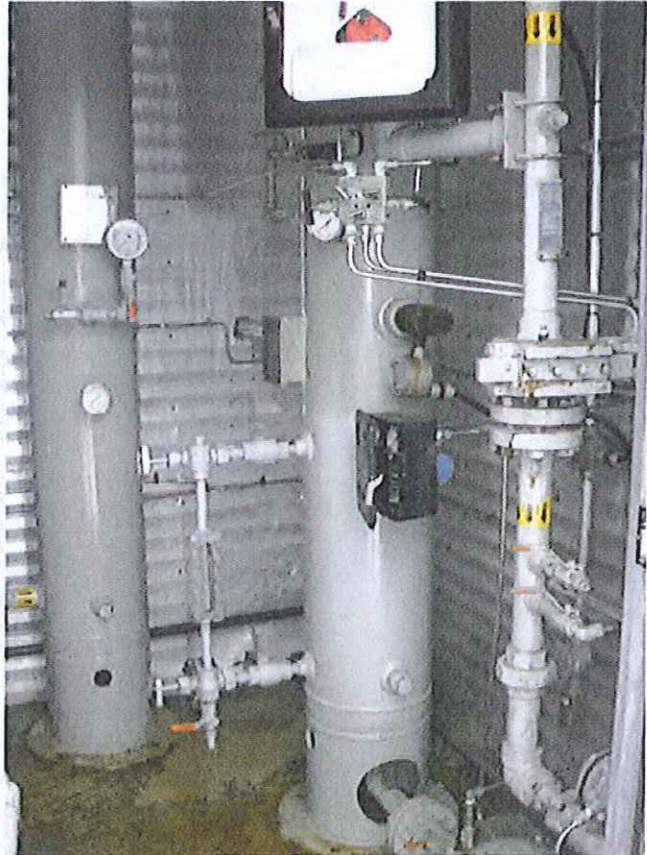
Sketch / Image Area

External Inspection	O.K.	<u>Comments</u>
Paint/Coating Condition	<input checked="" type="checkbox"/>	Blisters noted
Insulation Condition:	<input type="checkbox"/>	N/A
External Condition:	<input checked="" type="checkbox"/>	Minor surface corrosion at blisters
Foundation:	<input checked="" type="checkbox"/>	Welded
Leaks/Drips/Seeping:	<input type="checkbox"/>	N/A
Bending/Warping/Distortion:	<input checked="" type="checkbox"/>	
Dents/Cuts/Gouges:	<input checked="" type="checkbox"/>	
Condition of Gauges:	<input checked="" type="checkbox"/>	No pressure gauge.

CRN not registered in BC. No BC#.

PRV Check: OK- PRV Set pressure is not greater than vessel MAWP PRV is set too high. Reset PRV to vessel MAWP.
