Canadian Natural Resources Limited GENERAL PRESSURE VESSEL INFORMATION							Job # 05.002851
District: Ft St John, B.C.				Skid No.			
Facility: Ladyfern Compressor Station				Location (LSD): 10 – 19 – 94 – 12 – W6M			
Vessel Name & Equipment Number: Inlet Separator							
Orientation: Vertical							
Status: Operating				Regulatory Inspection			
PRESSURE VESSEL NAMEPLATE DATA							
Registration Number A 491455				CRN Number R 1702.2			
Vessel serial number: 215508				Size: 36 in. OD x 8 ft			
Shell thickness: 19.1 mm				Shell material: SA 516 70			
Head thickness: 19.1 mm				Head material: SA 516 70			
Tube wall thickness:				Tube material:			
Tube diameter:				Tube length:			
Channel thickness:				Channel material:			
Design pressure	Shell: 670 PSI			Operating pressure	Shell:		
	Tube:				Tubes:		
Design Temp.	Shell: 200 deg F			Operating temperature	Shell:		
	Tube:				Tubes:		
X-ray: RT 2				Heat treatment: Nil

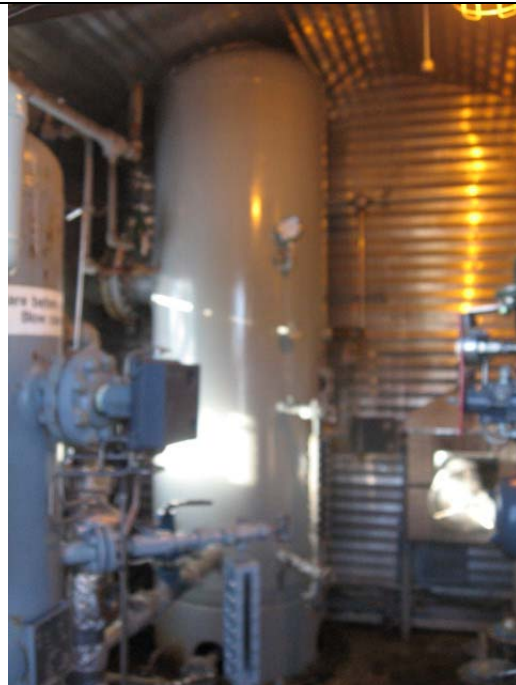
Over view

External Inspection Items	G	F	P	N/A	Comments
Insulation: Verify sealed around man ways, nozzles, no damage present, and there is no egress of moisture.				X	This vessel is not insulated.
External Condition: Assess paint condition, areas peeling, record any corrosion, damage, etc (record location, size and depth of corrosion or damage)	X				Paint in good condition - no loose or flaking paint.
Leakage: Record any leakage at flanges, threaded joints, weep holes on repads, etc.	X				No leaks detected.
Skirt: Assess condition of paint, fire protection, concrete. Look for corrosion, buckling, dents, etc. Look at vessel surface area near supports. Verify no signs of leakage at attachment to vessel and attachment welds are acceptable. Ground wire attached?	X				Skirt – good condition, no distortion or buckles – no leaks at skirt to shell weld. Paint is in good condition – no exposed metal. Skid Package is grounded.

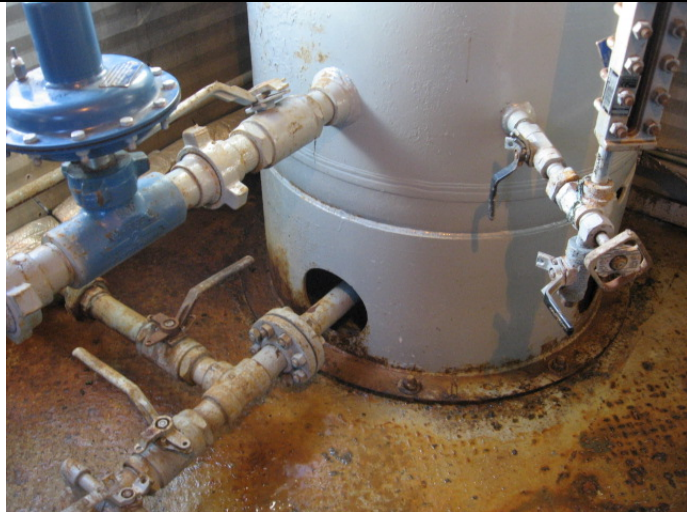
Skirt bolting

Anchor Bolts: Hammer tap to ensure secure. Look for cracking in treads or signs of deformation.	X				Firmly bolted to skid deck.
Concrete foundation: Check for cracks, spalling, etc.				X	
Ladder / Platform: Describe general condition, ensure support is secure to vessel, describe any hazards.				X	
Nozzle: Assess paint, look for leakage, and ensure stud threads are fully engaged. Record any damage, deflection, etc. Are nozzles gusseted?	X				All studs fully engaged to nuts on bolted fittings. Threaded fittings – fully engaged. No deflection of nozzles. No gussets.
Gauges: Ensure gauges are visible, working, no leakage, and suitable for range of MAWP/ Temp.	X				Pressure gauge: 0 to 1000 psi. Temperature gauge: 0 to 250 deg F. Gauges cover range listed on data plate.
External Piping: Ensure pipe is well supported. All clamps, supports, shoes, etc. in place. Look for evidence of structural overload, deflection, etc. Paint condition, external corrosion?	X				Firmly supported, no deflection, no loose or missing clamps. Paint is in good condition – no exposed metal.

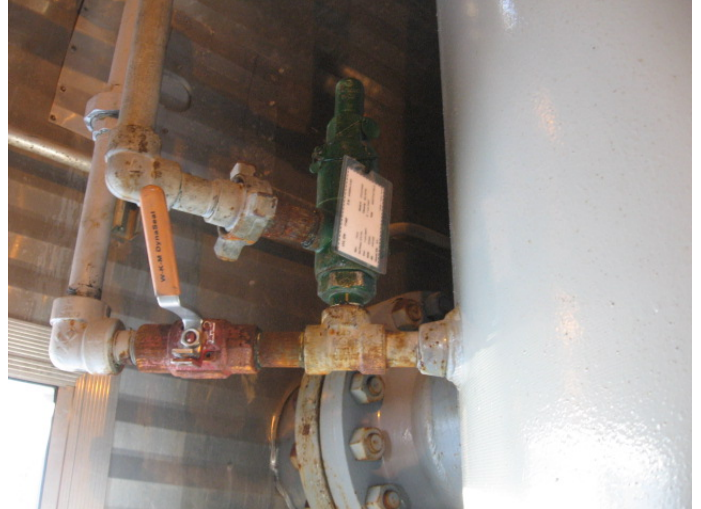
PSV location

Valving: Ensure no leaks are visible. Valves are properly supported and chained if necessary.	X				Well supported, no leaks.
PSV: Ensure PSV is set at pressure at or below that of vessel.	X				Located on upper shell – set at MAWP of vessel. Seal intact. No block valve. Inlet and discharge piping is same size as orifice.
NDE methods: Was UT/ MPI done on vessel (MI coordinator to review results)	X				Ultrasonic thickness survey carried out – no metal thickness detected below nominal minus corrosion allowance.
Recommendations or corrective actions : Vessel is Fit for Service or describe corrective actions required) (MIC to review corrective actions with Operations, discuss with Chief Inspector where necessary, and get remedial action implemented) Recommendations: 1. No recommendations at this time. Summary: This vessel is in good condition, visual external and ultrasonic corrosion survey carried out – no metal thickness detected below nominal minus corrosion allowance. Vessel is fit for service.
