**PRESSURE VESSEL  
VISUAL INSPECTION  
REPORT**

Report #: **156816-KK-20**  
Inspect Date: 05/09/2012  
Page: 1 of 11  
Insp. Co. Job #: 156816

Insp. Comp: Matrix Inspection District: St Albert - South Field: Hobbema-1775  
Location: Hobbema Field Unit / Skid #: N/A LSD: 05-16-044-24W4M  
Jurisdiction #: A0441749 Equip Tag #: N/A Serial #: V98309  
CRN #: N0684.21 Nat'l Bd #: N/A Year Built: 1998  
Manufacturer: Chadco Equipment Description: Other: Separator  
Status: In Service - Equip. Type: Vessel: Separator Service: Sweet  
MAWP Shell: 1480 Psi @ 100 °F Volume: N/A Code Stamp: ☒ Y ☐ N  
MAWP Tube: N/A @ N/A Height/Length: 8 Ft. Insulated: ☐ Y ☒ N  
MDMT: -20 °F RT: RT-2 Size/Diameter.: 24 in. O.D. PWHT: ☐ Y ☒ N  
Support: Skirt Vessel on Original CNRL Inventory List: ☒ Y ☐ N Manway: ☐ Y ☒ N  
C.A.: 0.125 in. Coated: No Clad: No J.E.: N/A Remote Access: ☐ -

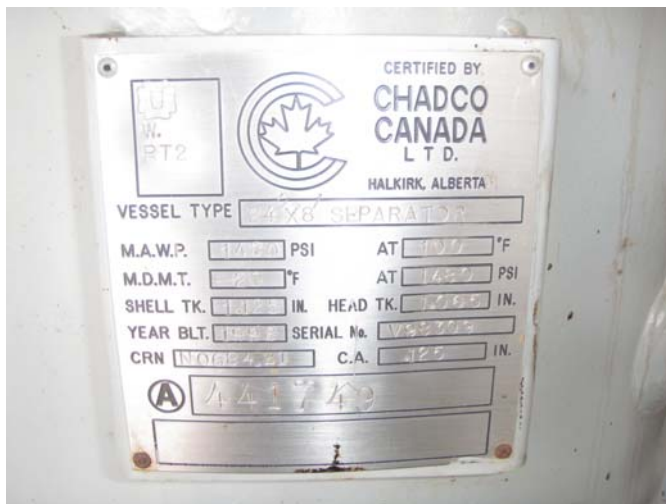
Nameplate is secure and easy to read, but contains little information.  
The vessel is secure and level, with properly aligned piping and external attachments.  
The paint is in fair condition, with isolated flaking paint noted.  
The paint is thick and rough in some locations.  
The attached piping is in good condition with isolated areas of surface corrosion.  
The vessel piping to wall and vessel to roof interface is in good condition.

01-A0441749 Data Plate

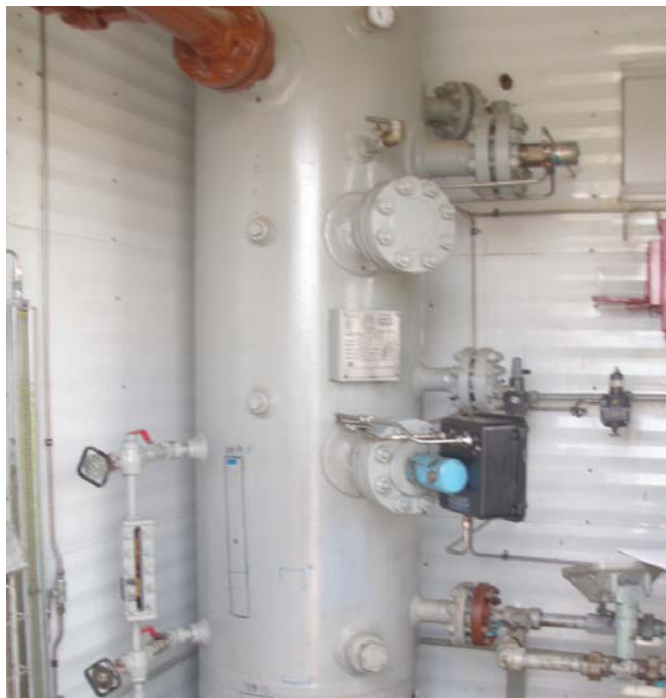
02-A0441749 Overview Inside

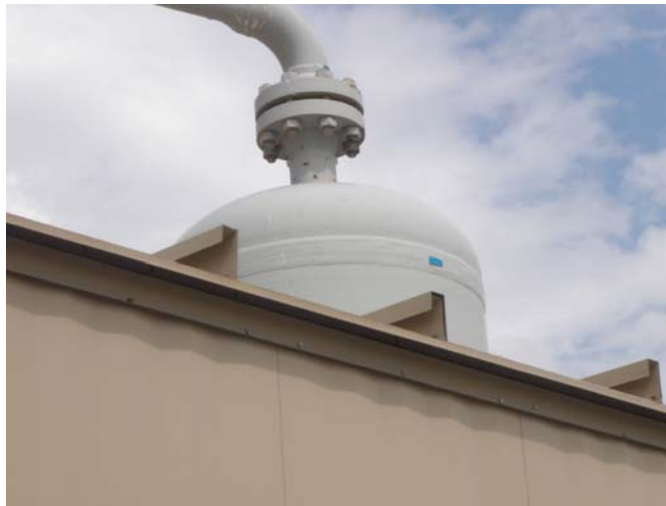
03-A0441749 Overview Outside

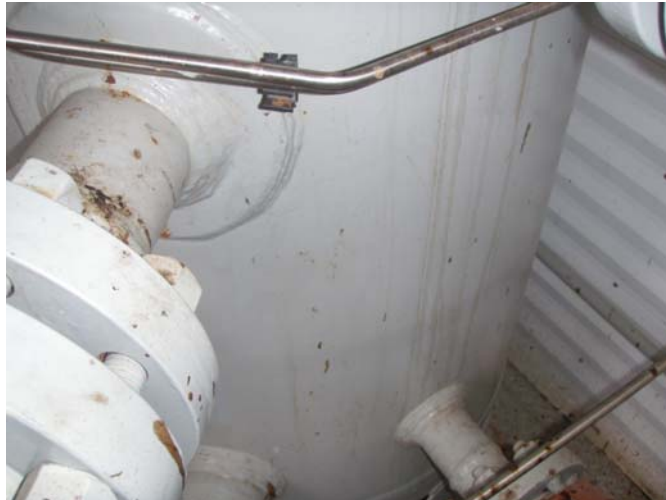
Isolated minor flaking paint noted. Mild product staining on shell. Overall good condition.

04-A0441749 Minor Product Staining

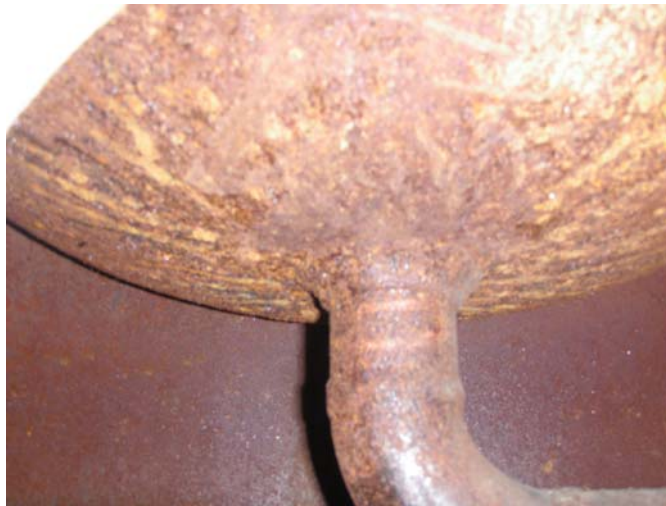
05-A0441749 Bottom Head Under Skirt

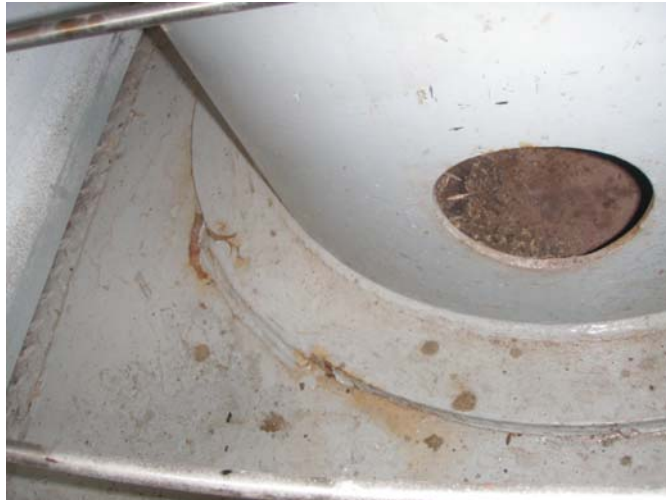
06-A0441749 Flaking Paint at Base

Continue to perform regular maintenance and regulatory inspections to maintain equipment integrity and continued safe operation.  
Ensure PSV's are serviced, installed, and rated correctly before putting this equipment back into service post TAR.
