**PRESSURE VESSEL  
VISUAL INSPECTION  
REPORT**

Report #: **123844-DB-09**  
Inspect Date: 07/16/2010  
Page: 1 of 10  
Insp. Co. Job #: 123844

Insp. Comp: Matrix Inspection District: Slave Lake Field: North Britnell  
Location: 06-26-082-20 W4 Unit / Skid #: Pad # 24 POLYMER LSD: 06-26-082-20 W4  
Jurisdiction #: C43478 Equip Tag #: #B-176 Serial #: FK0D-JH-T75-13446  
CRN #: N/A Nat'l Bd #: N/A Year Built: 2004  
Manufacturer: Bilton Welding and Manufacturing Equipment Description: Other: Flare knock out drum. (Facility)  
Status: In Service - Equip. Type: Vessel: Flare K.O. Drum Service: Sweet  
MAWP Shell: 14.9 Psi @  Volume:  Code Stamp: ☒ Y ☐ N  
MAWP Tube:  @  Height/Length: 120 in. Insulated: ☒ Y ☐ N  
MDMT: -20 °F RT: N/A Size/Diameter.: 72 in. O.D. PWHT: ☐ Y ☒ N  
Support Legs Vessel on Original CNRL Inventory List: ☐ Y ☒ N Manway: ☒ Y ☐ N  
C.A.: N/A Coated: N/A Clad: No J.E.: N/A Remote Access: ☐ -

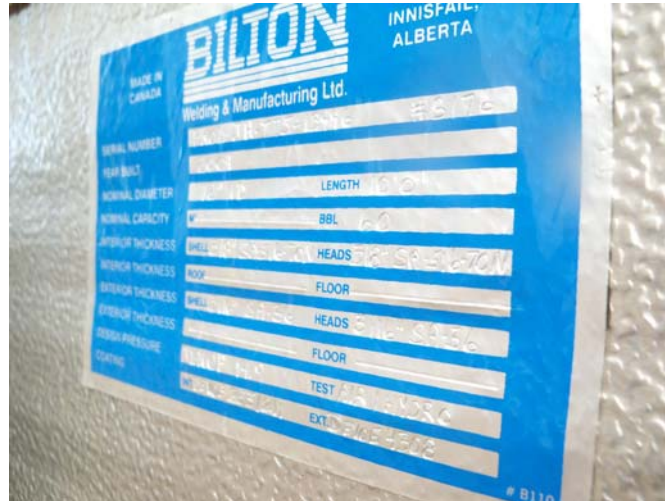
FIGURE\_001\_NAMEPLATE

Nameplate secure and legible.  
Contains adequate information.

| Item | N/A | Condition | Comment<br>(Check Status Bar or Press F1 for Help) | NCR | Action Item<br>Integrity | Action Item<br>Maintenance |
|---|---|---|---|---|---|---|
| Nameplate | <input type="checkbox"/> | Accept | Name plate attached and legible | <input type="checkbox"/> | <input type="checkbox"/> | <input type="checkbox"/> |

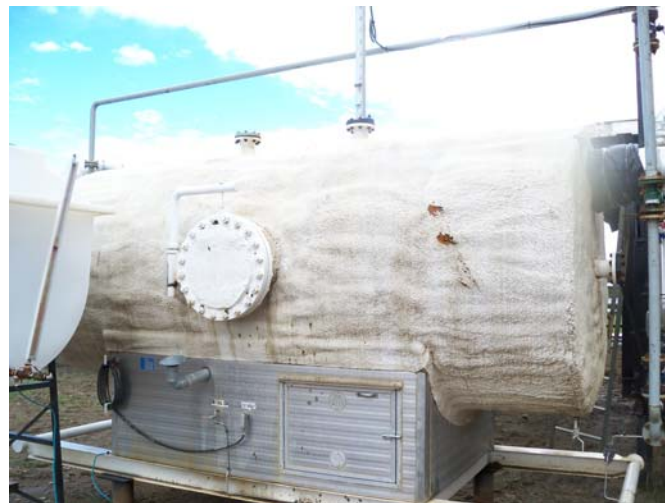
FIGURE\_002\_OVERVIEW

Vessel is in good external condition.  
Insulation in good condition, as well as vessel components

Vessel is in good condition externally.

This vessel and the components associated with it are in good external condition.  
Continue to reinspect at regular intervals.

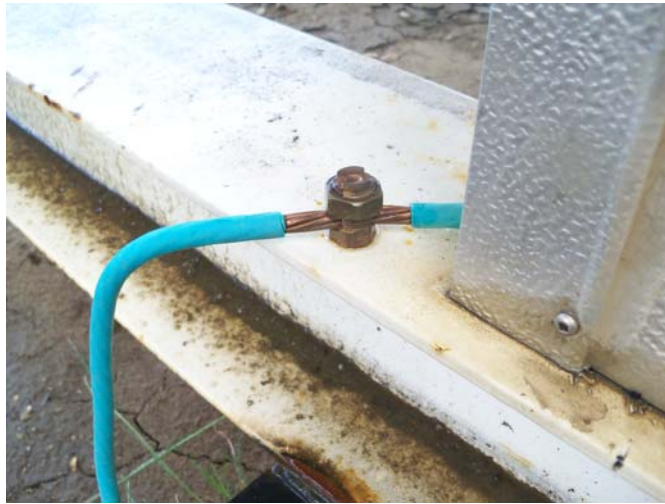
FIGURE\_003\_GROUND

| Item | N/A | Condition | Comment<br>(Check Status Bar or Press F1 for Help) | NCR | Action Item<br>Integrity | Action Item<br>Maintenance |
|---|---|---|---|---|---|---|
| Grounding | <input type="checkbox"/> | Accept | Ground wire clean and tightly attached to skid | <input type="checkbox"/> | <input type="checkbox"/> | <input type="checkbox"/> |

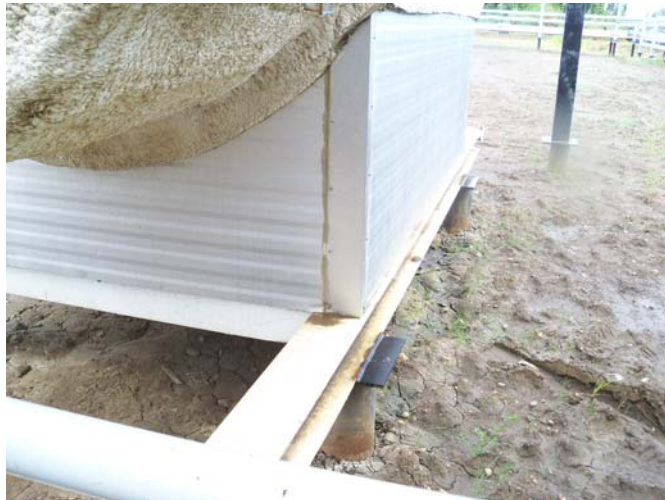
FIGURE\_004\_SUPPORTS

| Item | N/A | Condition | Comment<br>(Check Status Bar or Press F1 for Help) | NCR | Action Item<br>Integrity | Action Item<br>Maintenance |
|---|---|---|---|---|---|---|
| Foundation and Supports | <input type="checkbox"/> | Accept | Ground wire clean and tightly attached to skid | <input type="checkbox"/> | <input type="checkbox"/> | <input type="checkbox"/> |
| Anchor Bolts | <input type="checkbox"/> | Accept | Anchor bolts in good condition, and tight | <input type="checkbox"/> | <input type="checkbox"/> | <input type="checkbox"/> |
