**Canadian Natural Resources Limited
GENERAL PRESSURE VESSEL INFORMATION**

Job # 105.00157

District: Grand Prairie		Skid No. Nil				
Facility: Saddle Hills Gas Plant		Location (LSD): 10-11-75-07 W6M				
Vessel Name Equipment Number: High Pressure Inlet Separator V-400						
Orientation: Vertical						
Status: In service		Regulatory Inspection				
PRESSURE VESSEL NAMEPLATE DATA						
“A” or “G” or “S” (Sask.) or BC Registration Number. A245726		CRN Number: H-4989.2				
Vessel serial number: 88-4283-0		Size: 42” x 120”				
Shell thickness: 25.4mm		Shell material: SA 516 70N				
Head thickness: 24.6mm		Head material: SA 516 70N				
Tube wall thickness:		Tube material:				
Tube diameter:		Tube length:				
Channel thickness:		Channel material:				
Design pressure	Shell: 5102 kPa	Operating pressure	Shell: 900 kPa			
	Tubes:		Tubes:			
Design Temp.	Shell: 38°C	Operating temperature	Shell: 10 °C			
	Tubes:		Tubes:			
X-ray: RT -1		Heat treatment: Nil				
Code parameters: ASME VIII, Div 1		Coated: Nil

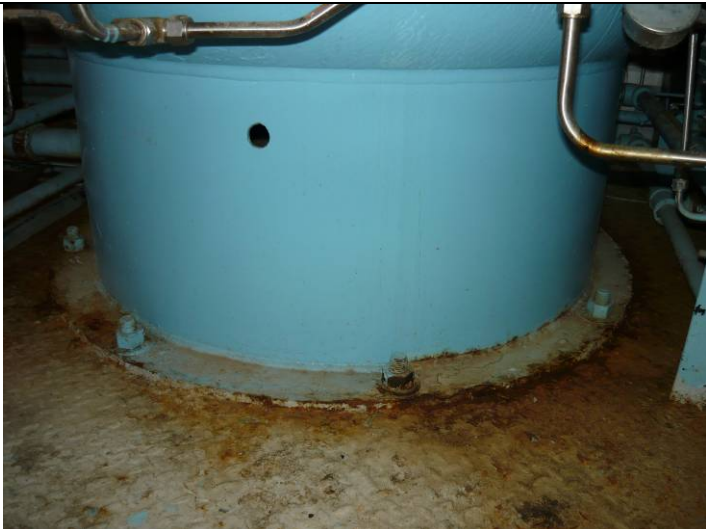
Skirt Overview

Anchor Bolts Hammer tap to ensure secure. Look for cracking in treads or signs of deformation.	X				Skirt is bolted to skid floor, No deformation or cracking present.
Concrete foundation Check for cracks, spalling, etc.				X	
Ladder / Platform Describe general condition, ensure support is secure to vessel, describe any hazards.				X	
Nozzle Assess paint, look for leakage, and ensure stud threads are fully engaged. Record any damage, deflection, etc. Are nozzles gusseted?	X				Nozzle paint is in good condition no leaks present. Stud threads present fully engaged, no damage or deflection present. No gussets present.
Gauges Ensure gauges are visible, working, no leakage, and suitable for range of MAWP/ Temp.	X				Pressure gauge (0-3440 kPa) Not suitable for MAWP of Vessel Temperature gauge (-40-50 °C) Suitable for allowable range. Gauges are clear and visible.
External Piping Ensure pipe is well supported. All clamps, supports, shoes, etc. in place. Look for evidence of structural overload, deflection, etc. Paint condition, external corrosion?	X				Piping is well supported and in place. No loose clamps or supports. No evidence of structural overload or deflection. Paint is in good condition no significant corrosion present.
