## VESSEL INSPECTION SUMMARY

Report #: **141136-PM-09**  
Inspect Date: 01/26/2010  
Page: 1 of 4  
IRISNDT #: 141136

Client: CNRL District: St. Albert Field: Byemoor  
Facility: 08-32-034-17W4 Unit / Skid #: N/A LSD: 08-32-034-17W4  
Jurisdiction #: A0225171 Equip Tag #: N/A Serial #: 85C339004  
CRN #: F1879.2 Nat'l Bd #: N/A Year Built: 1985  
Manufacturer: Alco Gas & Oil LTD. Equipment Description: De-Ethanizer Column  
Status: In - Date Removed From Service: \_\_\_\_\_ Service: Sweet  
MAWP Shell: 400 Psi @ 250 °F Height/Length: 14325 mm Code Stamp: ☒ Y ☐ N  
MAWP Tube: \_\_\_\_\_ @ \_\_\_\_\_ Size/Diameter.: 219 mm I.D. Insulated: ☒ Y ☐ N  
MDMT: \_\_\_\_\_ RT: RT-3 Volume: \_\_\_\_\_ PWHT: ☐ Y ☒ N  
Support Type: Skirt Manway: ☐ Y ☒ N  
C.A.: 1.6000 mm Coated ☐ Y ☐ N Clad: ☒ Y ☐ N J.E.: \_\_\_\_\_

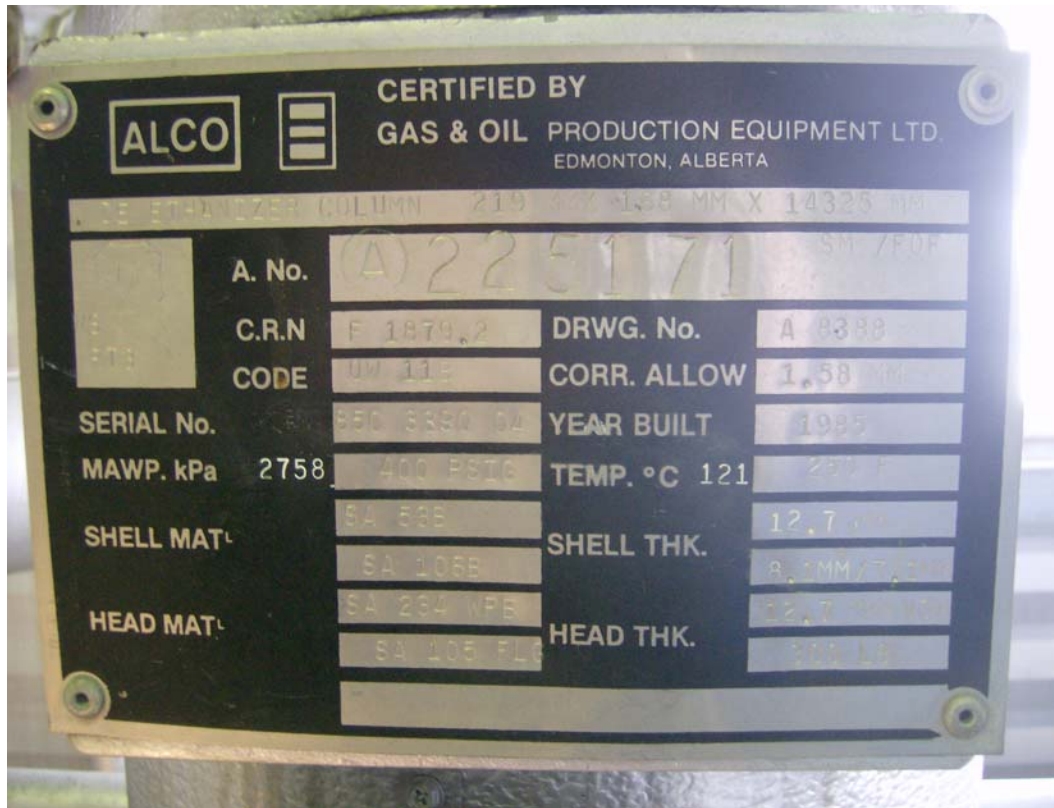
A0225171\_Nameplate\_26Jan2010

Could not read CRN number off of nameplate.

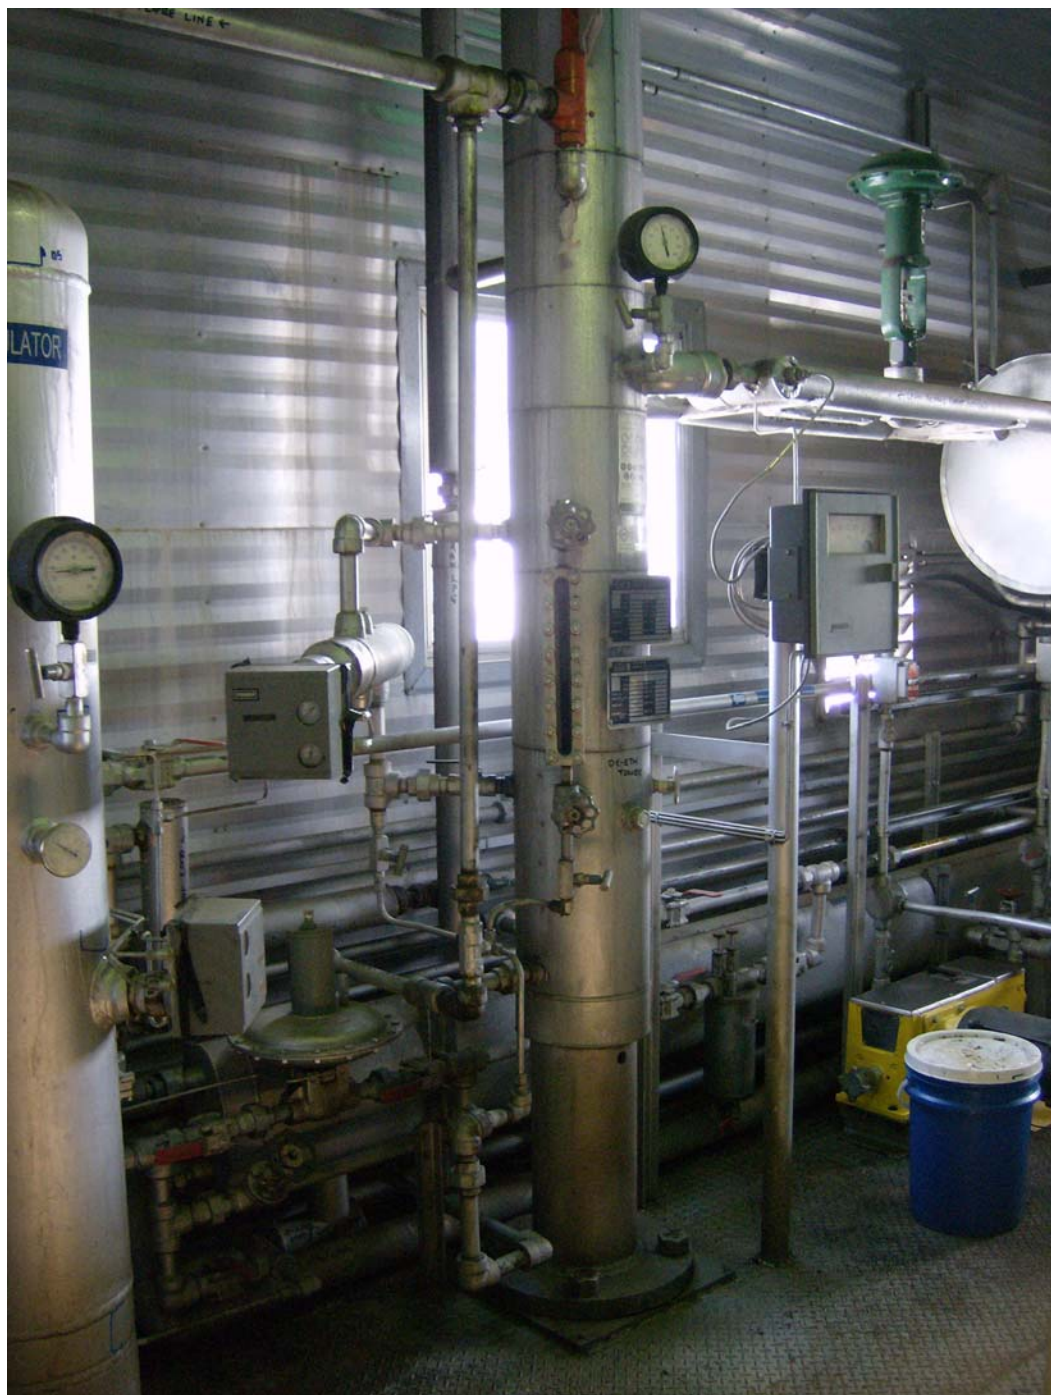
A0225171\_Overview inside building\_26Jan2010

- The vessel was operating at time of inspection and located inside and outside of building. No process leaks or vibrations were noted. Due to the vessel being insulated a limited visual inspection was performed.
- The insulation on the shell and piping is intact and in good condition.
- Where exposed all piping, flanges and bolting were in good condition. All exposed piping had threaded fittings but in good condition.
- The vessel is supported by skirt bolted to floor. Vessel is secure and level.
- External UT was not performed as the vessel was fully insulated with no inspection ports available.
- The PSV is in good condition with the carseal intact.
- Refer to the attached photos and drawing for inspection findings.
- The vessel appears to be in good operating condition for continued service based on the external visual observations.
