### Pressure Equipment Static Data

## Pressure Vessel External Inspection

# AUT CORROSION MAPPING EXAMINATION REPORT

# NON-DESTRUCTIVE EXAMINATION REPORT

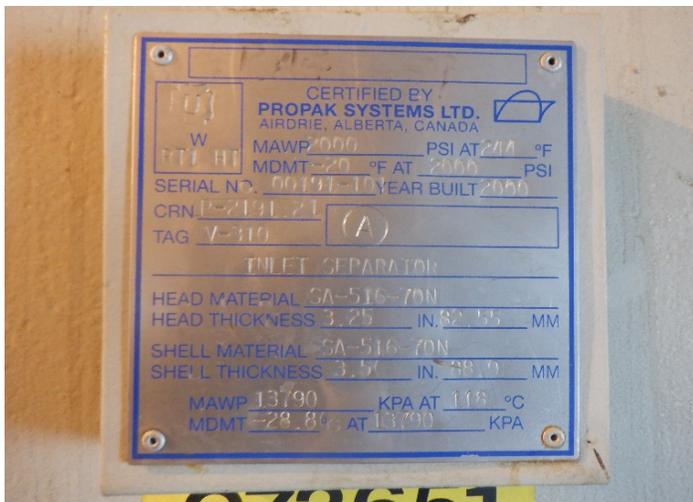
Nameplate

| <b>Date:</b> July 11, 2021 | | <b>Equip Name:</b> Inlet Separator | |
|--|--|--|---|
| <b>Nameplate</b> | Concern | NCR - Admin / Regulatory: No A# found.<br>Good condition. Securely attached and legible. | |

| <b>Date:</b> July 11, 2021 | | <b>Equip Name:</b> Inlet Separator | |
|--|--|--|---|
| Review MDR to confirm if vessel has an A# and stamp A# in nameplate. | | | |

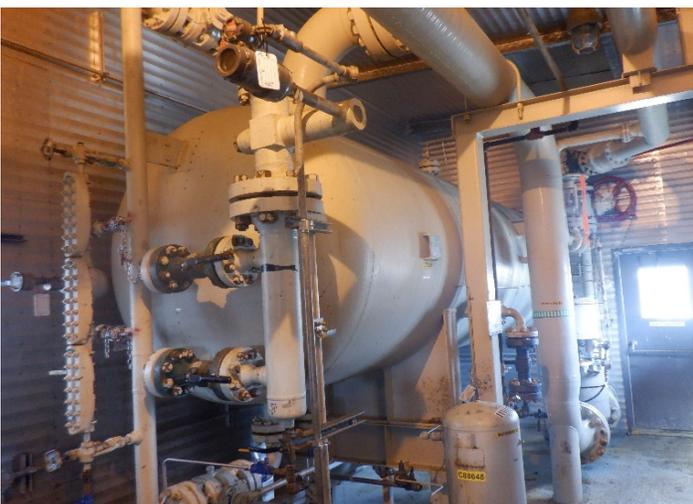
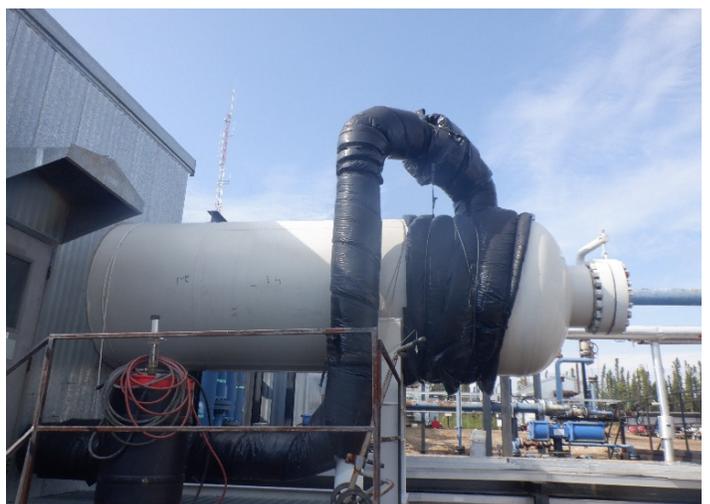
Overview

| <b>Date:</b> July 11, 2021 | | <b>Equip Name:</b> Inlet Separator | |
|--|--|--|---|
| <b>Foundation/Supports</b> | Acceptable | Vessel is well supported on saddles, no concerns noted. | |
| <b>Shell</b> | Acceptable | Shell is in good condition, no concerns noted. | |
| <b>Heads</b> | Acceptable | Heads are in good condition, no concerns noted. | |

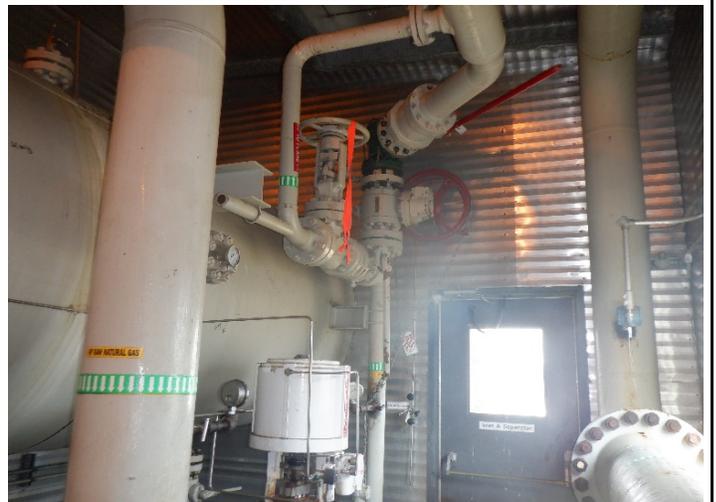
PSV Overview

| <b>Date:</b> July 11, 2021 | | <b>Equip Name:</b> Inlet Separator | |
|--|--|--|---|
| <b>PSV</b> | Acceptable | PSV is in good condition. Service seal is intact, no piping restrictions or other concerns noted.<br>PSV has CRN and applicable code stamping present. | |

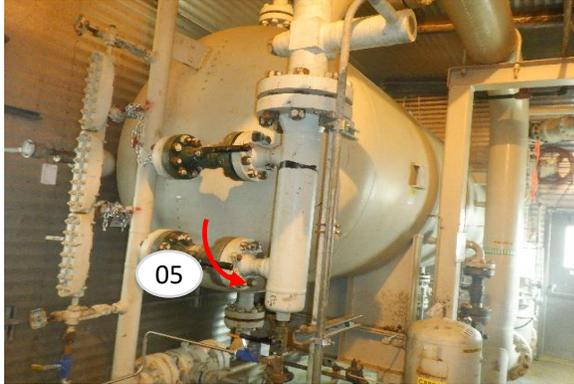
EAST HEAD

| GENERAL INFORMATION | | | | | | | | | |
|--|---|---|---|---|---|---|---|---|---|
| <p>NO INTERNAL CORROSION LOCATED IN THE AUT SCANNED AREAS.</p> <p>NO INTERNAL CORROSION LOCATED IN THE WEST &amp; EAST HEADS. SEE PG-2 FOR HEAD READINGS AND DESCRIPTIONS.</p> <p>SEE PAGE 3 FOR SCAN TEST RESULTS</p> <p>SEE PAGES 5 THROUGH TO 9 FOR C-SCANS, SCAN LOCATIONS AND DESCRIPTIONS.</p> | | | | | | | | | |

| TML | NOM | LOW | AVG | COMMENT |
|---|---|---|---|---|
| 05 | 3.25" (Min) | 3.457" | 3.515" | NO CONCERNS LOCATED |

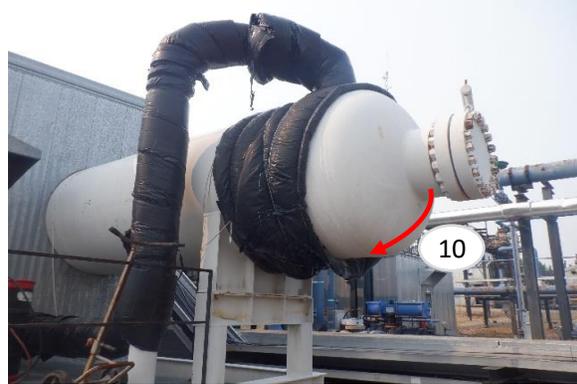
WEST HEAD

| TML | NOM | LOW | AVG | COMMENT |
|---|---|---|---|---|
| 10 | 3.25" (Min) | 3.465" | 3.512" | NO CONCERNS LOCATED |

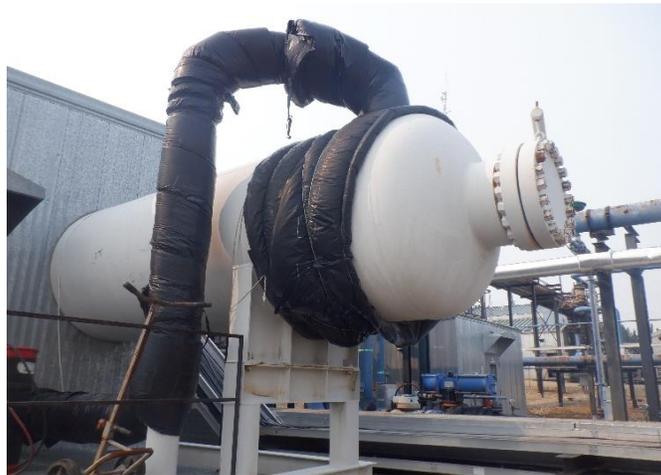
**OVERVIEW**

| GENERAL INFORMATION | | | | | | | | | |
|--|---|---|---|---|---|---|---|---|---|
| <p>A ZERO DEGREE AUT MAP SCAN WAS CONDUCTED ON AREAS OF THE 66" O.D. INLET SEPARATOR SHELL. INSPECTION WAS DONE ON 35% OF THE SHELL AREA AS REQUESTED BY THE CLIENT. ALL ACCESSIBLE SECTIONS WERE INSPECTED FROM THE EXTERNAL SURFACE TO MAP OUT POSSIBLE WALL LOSS AND CORRODED AREAS OF THE SCANNED LOCATIONS. ALL AREAS IDENTIFIED WITH CORROSION ARE TO BE VERIFIED WITH MANUAL ZERO DEGREE UT.</p> <p>5 SCANS WERE UTILIZED TO OBTAIN COVERAGE OF THE SHELL AREAS.</p> <p>A ZERO DEGREE UT INSPECTION OF THE WEST AND EAST HEADS WERE ALSO DONE AS REQUESTED BY THE CLIENT.</p> | | | | | | | | | |

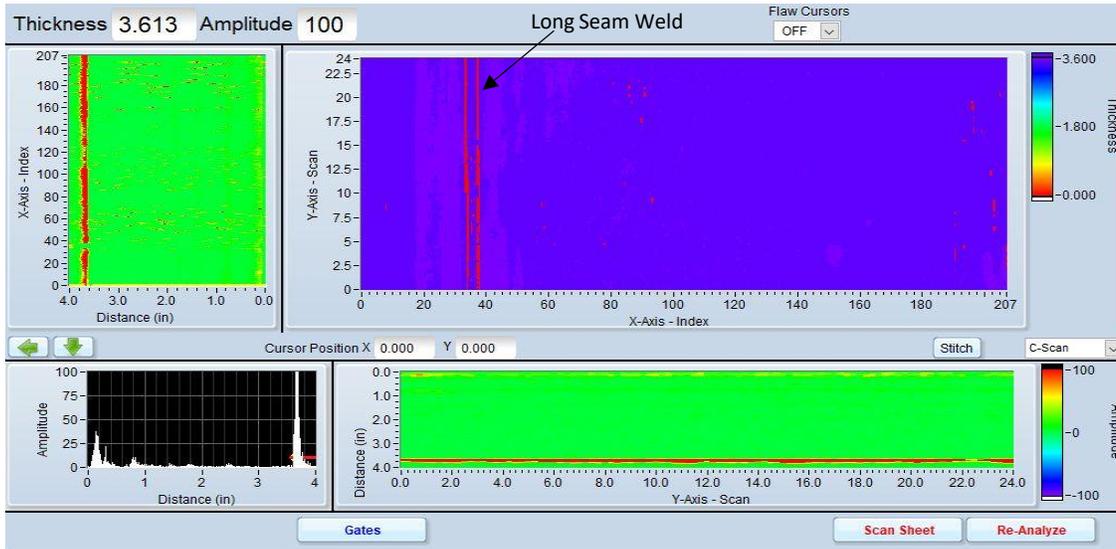
SCAN 1 (C SCAN)

| SCAN # | X START | X STOP | Y START | Y STOP | X-Incr. | Y-Incr | Readings | AVERAGE READING | MINIMUM THICKNESS | NOMINAL | % Wall Loss | Comments / Corrosion Mechanism |
|---|---|---|---|---|---|---|---|---|---|---|---|---|
| 1 | 0 | 207 | 0 | 24 | 0.5 | 0.25 | 40255 | 3.612 | 3.557 | 3.500 | 0.0% | No concerns |

NOTE: RED SECTIONS ARE DUE TO PROBE LIFTOFF (NRI'S).

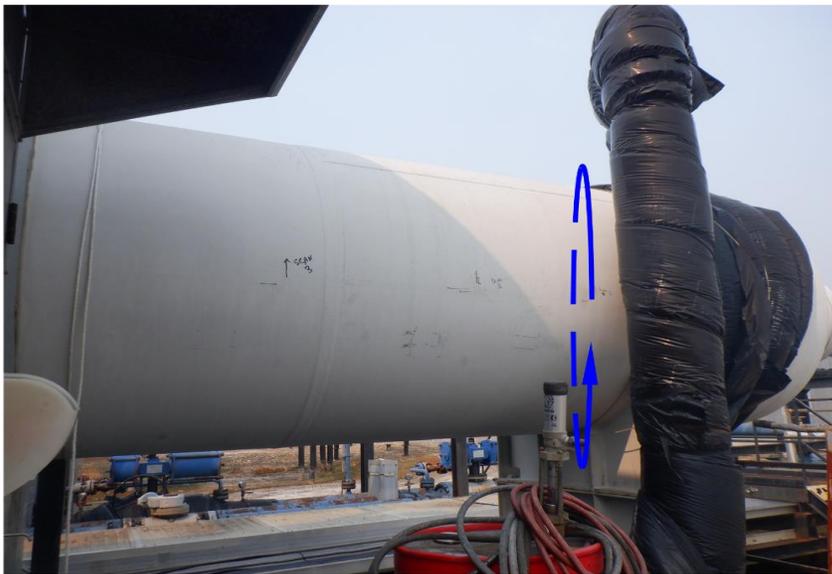
SCAN 1 LOCATION

SCAN 1 START LOCATION: 52" EAST FROM 2ND CIRC WELD (FROM EAST END), AND 29" DOWN FROM SOUTH LONG SEAM WELD.

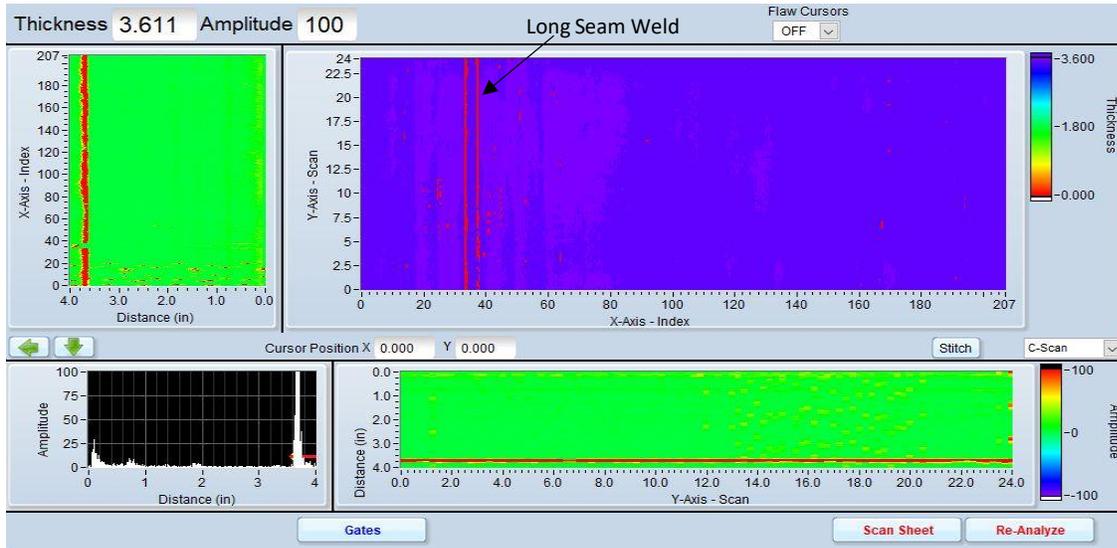
SCAN 2 (C SCAN)

| SCAN # | X START | X STOP | Y START | Y STOP | X-Incr. | Y-Incr | Readings | AVERAGE READING | MINIMUM THICKNESS | NOMINAL | % Wall Loss | Comments / Corrosion Mechanism |
|---|---|---|---|---|---|---|---|---|---|---|---|---|
| 2 | 0 | 207 | 0 | 24 | 0.5 | 0.25 | 40255 | 3.610 | 3.557 | 3.500 | 0.0% | No concerns |

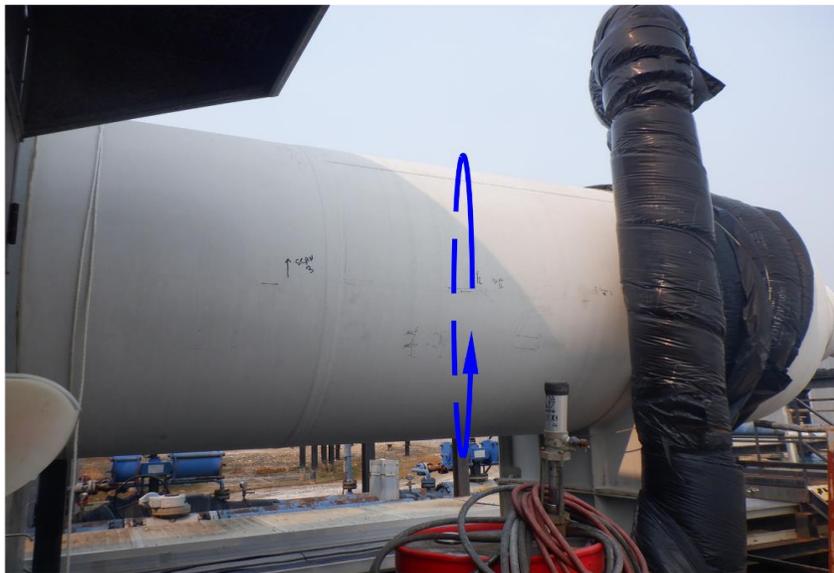
SCAN 2 LOCATION

SCAN 2 START LOCATION: 25" EAST FROM 2ND CIRC WELD (FROM EAST END), AND 28" DOWN FROM SOUTH LONG SEAM WELD.

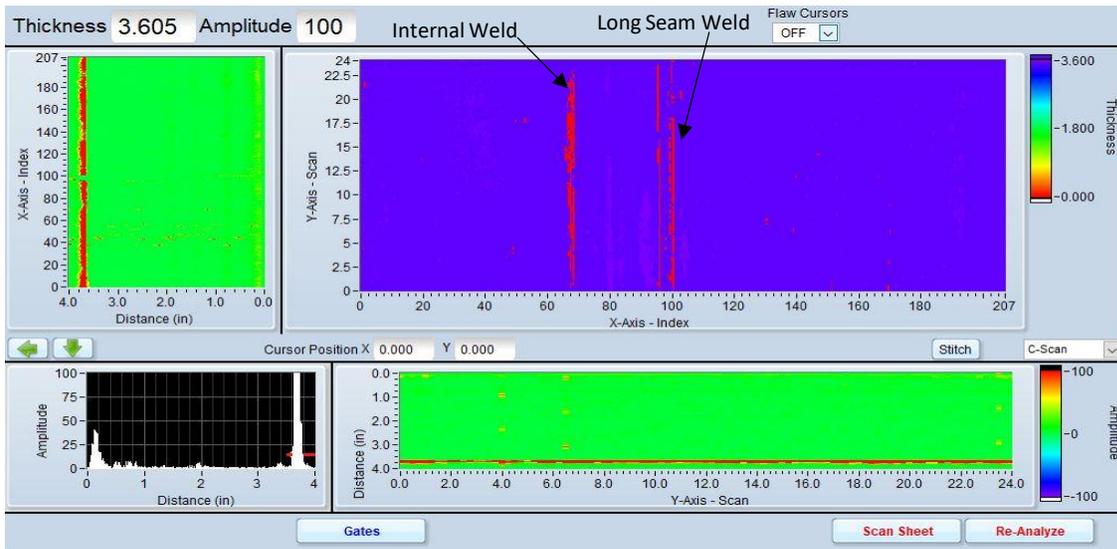
SCAN 3 (C SCAN)

| SCAN # | X START | X STOP | Y START | Y STOP | X-Incr. | Y-Incr | Readings | AVERAGE READING | MINIMUM THICKNESS | NOMINAL | % Wall Loss | Comments / Corrosion Mechanism |
|---|---|---|---|---|---|---|---|---|---|---|---|---|
| 3 | 0 | 207 | 0 | 24 | 0.5 | 0.25 | 40255 | 3.619 | 3.576 | 3.500 | 0.0% | No concerns |

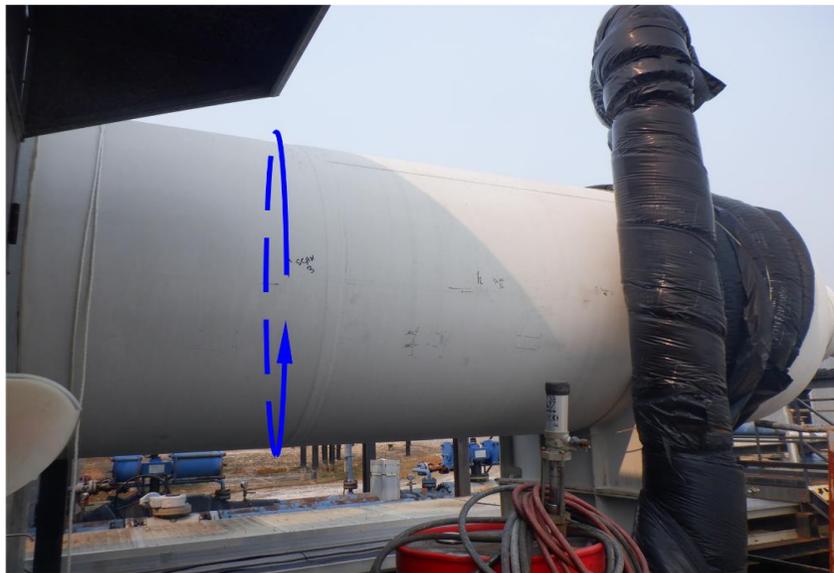
SCAN 3 LOCATION

SCAN 3 START LOCATION: 6" WEST FROM 2ND CIRC WELD (FROM EAST END), AND 29.5" DOWN FROM 1ST SHELL CAN (FROM EAST END) LONG SEAM WELD.

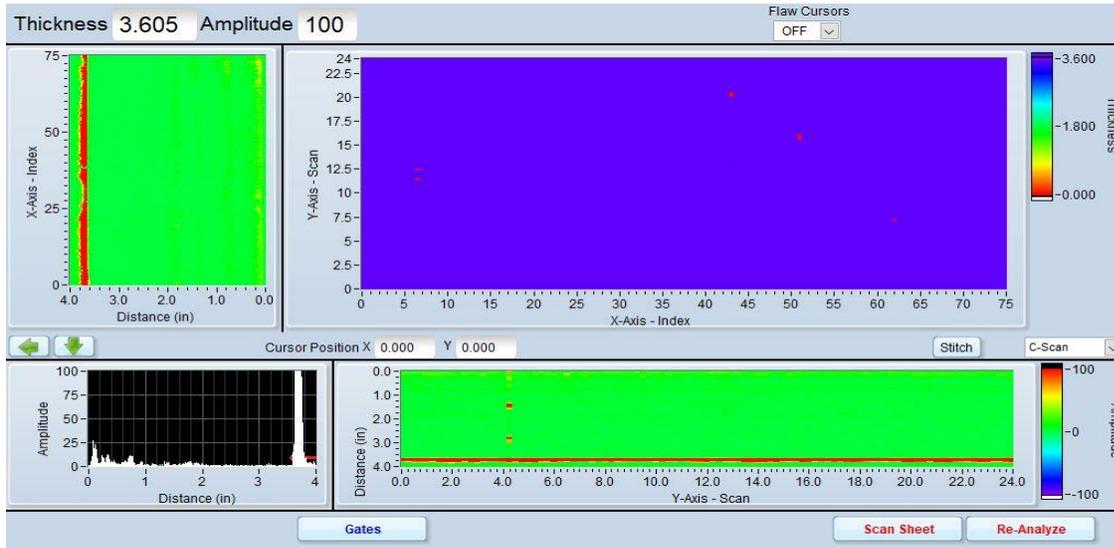
SCAN 4 (C SCAN)

| SCAN # | X START | X STOP | Y START | Y STOP | X-Incr. | Y-Incr | Readings | AVERAGE READING | MINIMUM THICKNESS | NOMINAL | % Wall Loss | Comments / Corrosion Mechanism |
|---|---|---|---|---|---|---|---|---|---|---|---|---|
| 4 | 0 | 75 | 0 | 24 | 0.5 | 0.25 | 14647 | 3.620 | 3.576 | 3.500 | 0.0% | No concerns |

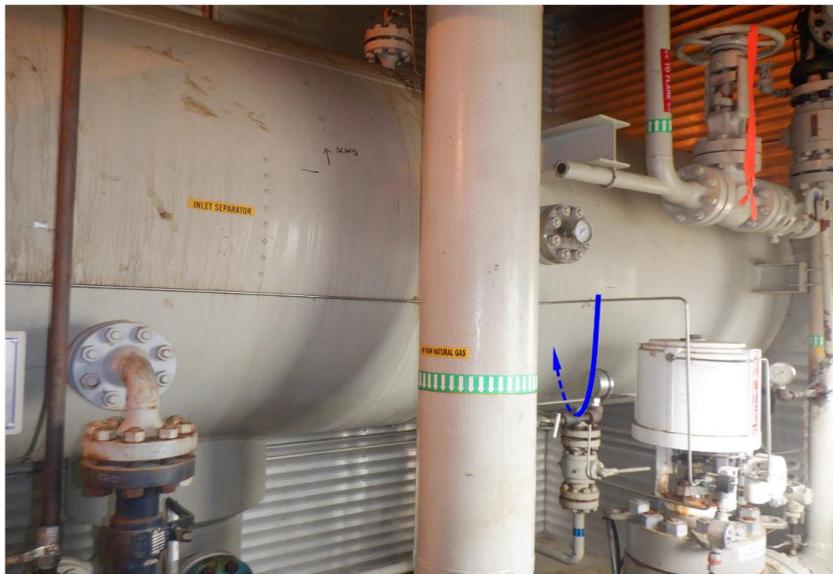
SCAN 4 LOCATION

SCAN 4 START LOCATION: 10" EAST FROM 3RD CIRC WELD (FROM EAST END), AND 42.5" DOWN FROM 3RD SHELL CAN (FROM EAST END) LONG SEAM WELD.

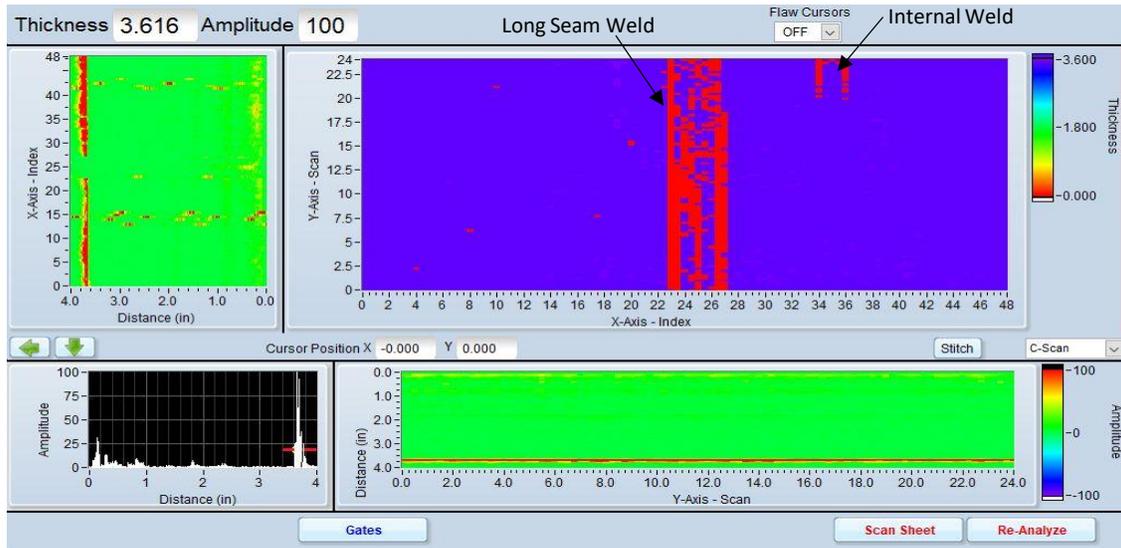
SCAN 5 (C SCAN)

| SCAN # | X START | X STOP | Y START | Y STOP | X-Incr. | Y-Incr | Readings | AVERAGE READING | MINIMUM THICKNESS | NOMINAL | % Wall Loss | Comments / Corrosion Mechanism |
|---|---|---|---|---|---|---|---|---|---|---|---|---|
| 5 | 0 | 48 | 0 | 24 | 0.5 | 0.25 | 9409 | 3.632 | 3.557 | 3.500 | 0.0% | No concerns |

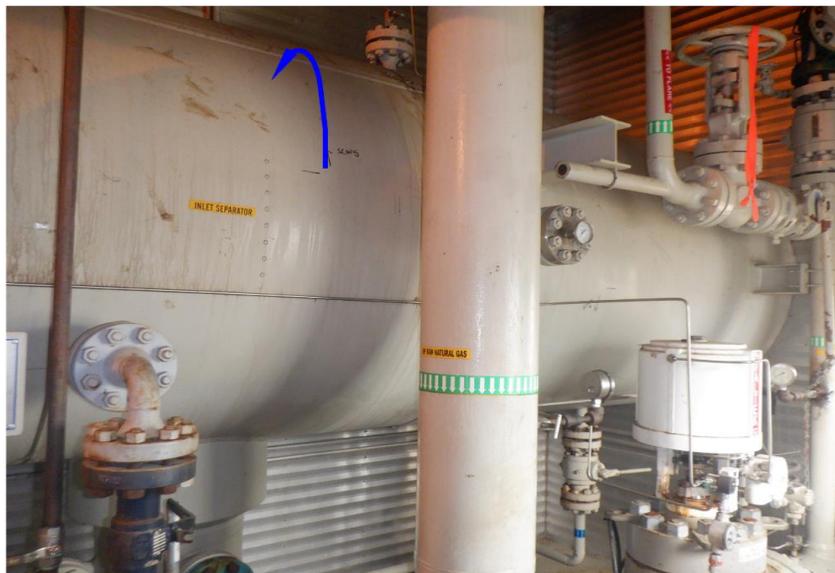
SCAN 5 LOCATION

SCAN 5 START LOCATION: 35" WEST FROM 3RD CIRC WELD (FROM EAST END), AND 20.5" DOWN FROM LONG SEAM WELD.

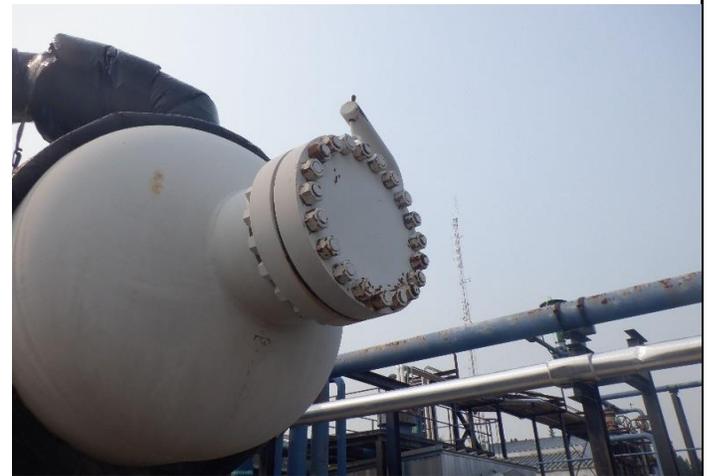
**MANWAY OVERVIEW**

| GENERAL INFORMATION | | | | | | | | | |
|--|---|---|---|---|---|---|---|---|---|
| A SWUT WAS CONDUCTED ON ALL ACCESSIBLE MANWAY TO SHELL WELDS OF THE INLET SEPARATOR C73651 AS REQUESTED BY THE CLIENT. | | | | | | | | | |
| NO RELEVANT INDICATIONS WERE LOCATED WITH SWUT. WELDS EXAMINED ARE ACCEPTABLE AS PER CODE. | | | | | | | | | |
