Pressure Vessel External Inspection

Date: July 11, 2021		Equip Name: Inlet Separator	
Inspector: Curtis Graham		Prov #: N/A	
Client/Owner: CNRL		S/N: 01150-201	
District/Region: Fort St John		Unit /Skid #: Inlet Separator C Skid	
Area: Ladyfern		Equip #: C73757	
Facility: Compressor		Location:	Surface: B-17-I/94-H-1
			UWI/DH: B-17-I/94-H-1
Component	Condition	Comment	
Nameplate	Concern	NCR - Admin / Regulatory: No A# found. Good condition. Securely attached and legible.	
Grounding	Acceptable	Vessel is grounded through skid.	
Foundation/Supports	Acceptable	Vessel is well supported on saddles, no concerns noted.	
Ladder/Platform	N/A		
Insulation/Cladding	N/A		
Shell	Acceptable	Shell is in good condition, no concerns noted.	
Heads	Acceptable	Heads are in good condition, no concerns noted.	
Nozzles/Threadolets	Acceptable	All nozzles are in good condition. No deflection, short bolting or other concerns noted.	
Piping/Valves	Acceptable	All associated piping is in good condition. All bolting is properly installed and secure. No leaks or other concerns noted.

AUT CORROSION MAPPING EXAMINATION REPORT

NON-DESTRUCTIVE EXAMINATION REPORT

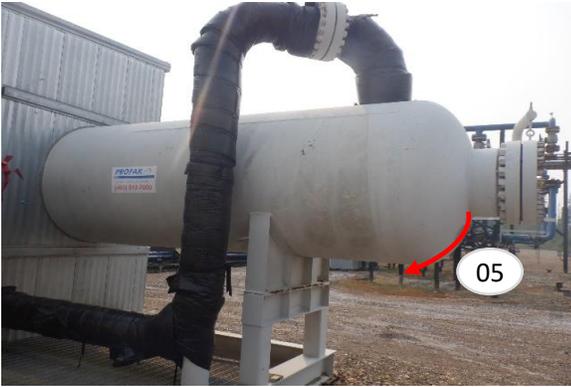
NORTH HEAD

TML	NOM	LOW	AVG	COMMENT
05	3.25" (Min)	3.445"	3.556"	NO CONCERNS LOCATED
10	3.25" (Min)	3.507"	3.560"	NO CONCERNS LOCATED

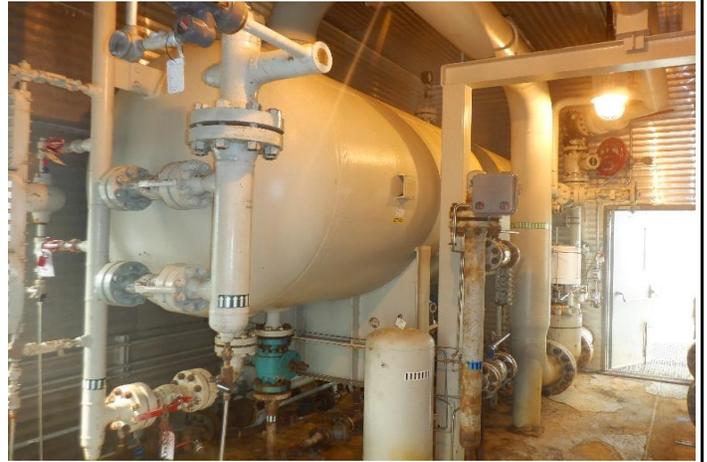
OVERVIEW

RESULTS:									
<p>NO INTERNAL CORROSION LOCATED IN THE AUT SCANNED AREAS.</p> <p>NO INTERNAL CORROSION LOCATED IN THE NORTH & SOUTH HEADS. SEE PG-2 FOR HEAD READINGS AND DESCRIPTIONS.</p> <p>SEE PAGE 3 FOR SCAN TEST RESULTS</p> <p>SEE PAGES 5 THROUGH TO 8 FOR C-SCANS, SCAN LOCATIONS AND DESCRIPTIONS.</p>									
TECHNICIAN:	Curtis Graham			ASSISTANT:	Darrin Robak				
SIGNATURE:				CLIENT:					
CGSB/SNT CERTS:	6560 UT II / MT II / PT II			SIGNATURE:

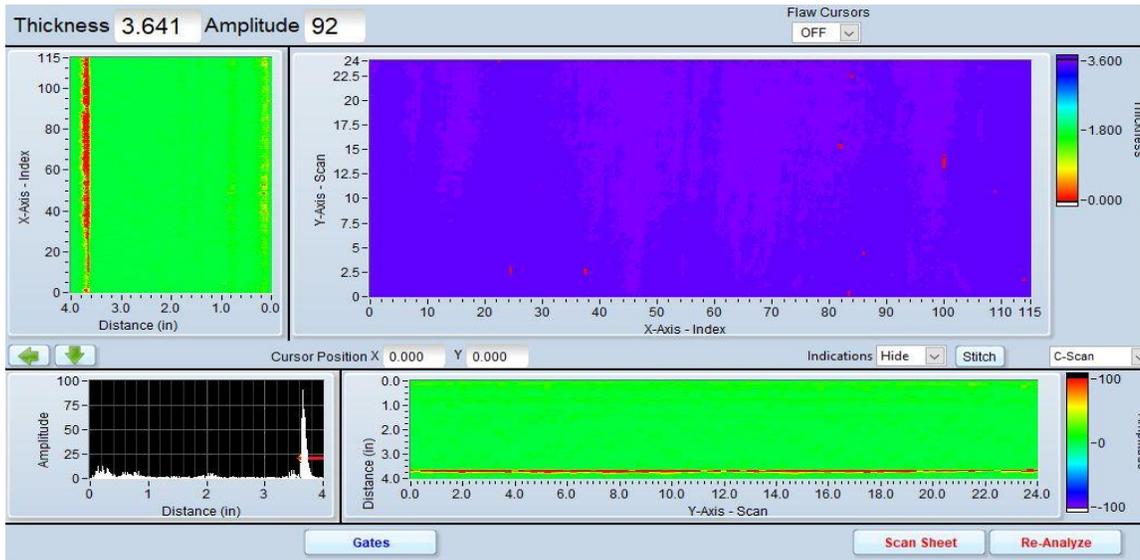
SCAN 1 (C SCAN)

SCAN #	X START	X STOP	Y START	Y STOP	X-Incr.	Y-Incr	Readings	AVERAGE READING	MINIMUM THICKNESS	NOMINAL	% Wall Loss	Comments / Corrosion Mechanism
1	0	115	0	24	0.5	0.25	22407	3.605	3.586	3.500	0.0%	No concerns
2	0	207	0	24	0.5	0.25	40255	3.621	3.582	3.500	0.0%	No concerns
3	0	207	0	24	0.5	0.25	40255	3.624	3.616	3.500	0.0%	No concerns
4	0	207	0	24	0.5	0.25	40255	3.624	3.594	3.500	0.0%	No concerns

NOTE: RED SECTIONS ARE DUE TO PROBE LIFTOFF (NRI'S).

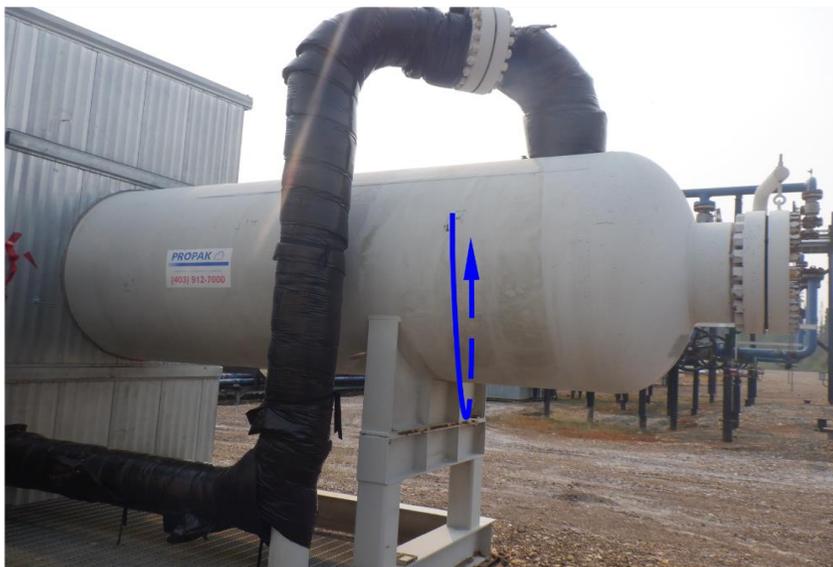
SCAN 1 LOCATION

SCAN 1 START LOCATION: 30" SOUTH FROM NORTH HEAD TO SHELL CIRC WELD, AND 14" DOWN FROM EAST LONG SEAM WELD.

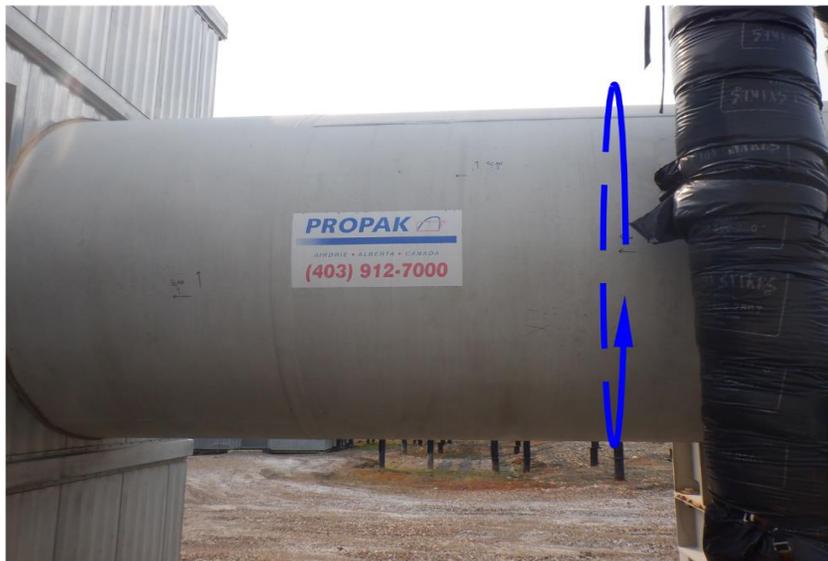
SCAN 2 LOCATION

SCAN 2 START LOCATION: 4" NORTH FROM 2ND CIRC WELD (FROM NORTH END), AND 28.5" DOWN FROM EAST LONG SEAM WELD.

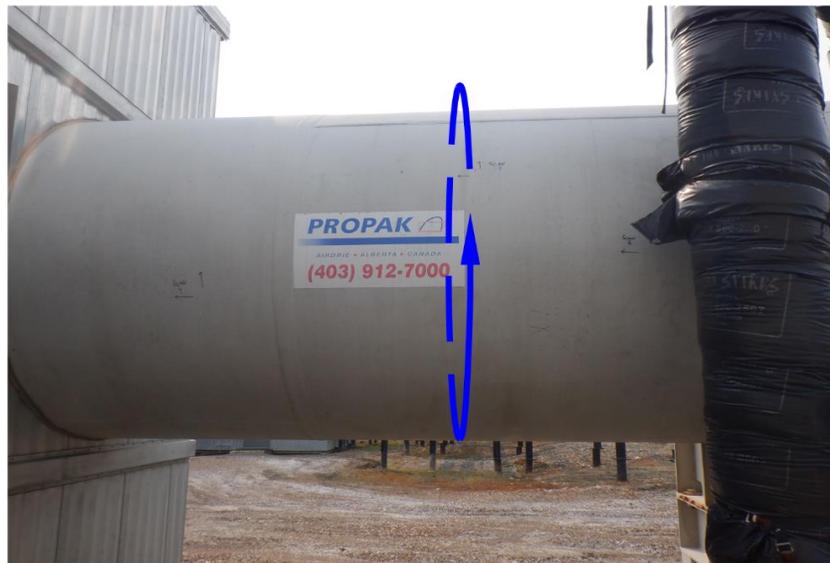
SCAN 3 LOCATION

SCAN 3 START LOCATION: 26" NORTH FROM 2ND CIRC WELD (FROM NORTH END), AND 15" DOWN FROM EAST LONG SEAM WELD.

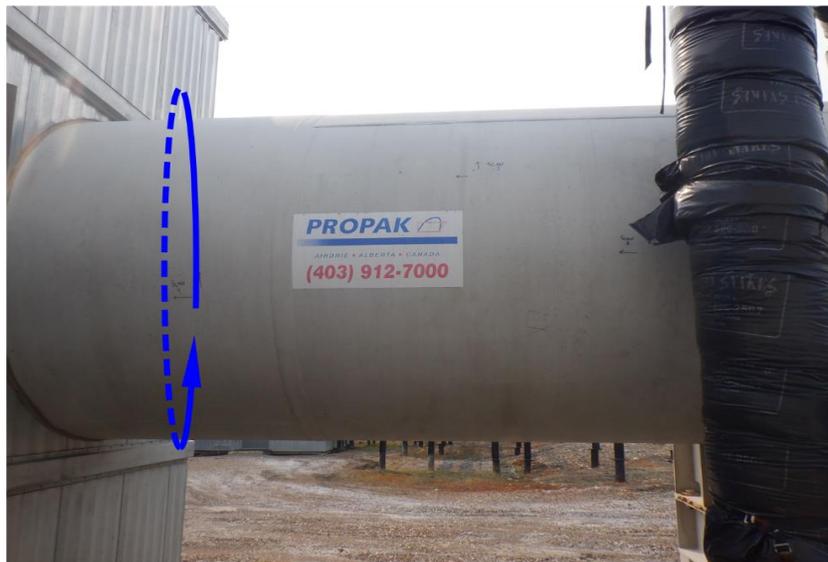
SCAN 4 LOCATION

SCAN 4 START LOCATION: 10" SOUTH FROM 2ND CIRC WELD (FROM NORTH END), AND 25.5" UP FROM LONG SEAM WELD.
