| <b>Client</b> | Canadian Natural Resources Ltd. | <b>Inspection Date</b> | Apr 20, 2020 | | |
| <b>Equipment Type</b> | Inlet Gas Cooler | <b>Location</b> | Narraway | | |
| <b>Tag/Equip.</b> | E-100 | <b>LSD</b> | AB 10-12-063-12W6 | | |

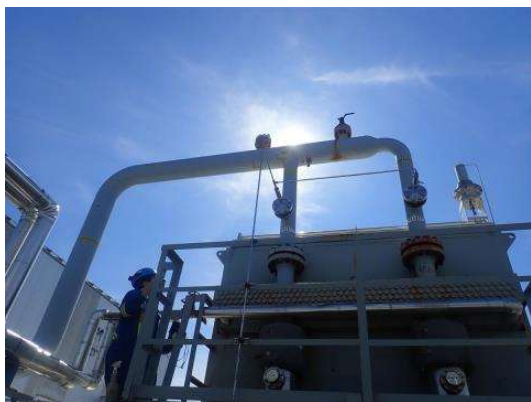
Figure: 1

The attached piping was in good condition.

The piping was sufficiently supported with no damage, distortion or undue stress evident.

The piping had welded joints and flanged connections that showed no signs of leakage.

Inlet Piping

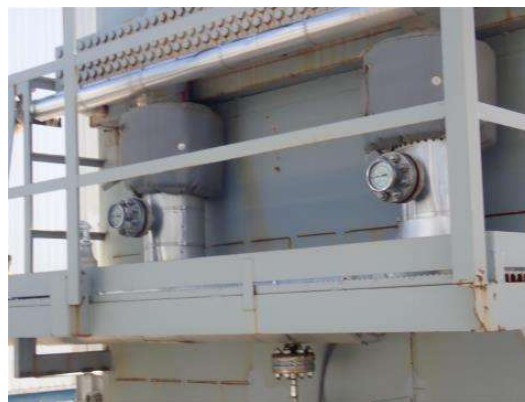
Figure: 2

Outlet Piping

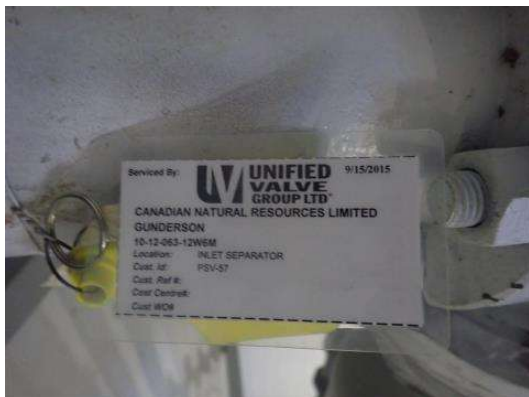
Figure: 3

The nameplate and service tag were securely attached and legible.

PSV Service Tag Front

Serial number on service tag and on PSV nameplate don't match.

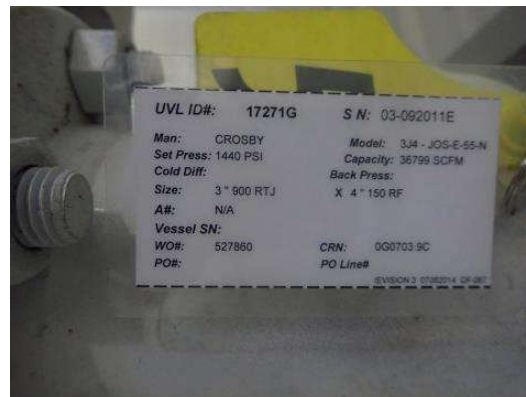
Figure: 4

| Comments | Serial number on service tag and on PSV nameplate don't match. | Client Reference | |

PSV Service Tag Back

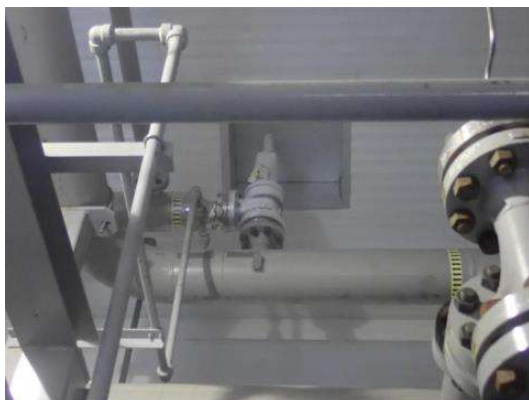
Figure: 5

The PSV was mounted in the vertical position and securely attached to the piping.

The PSV seal wire was attached and intact.

PSV General

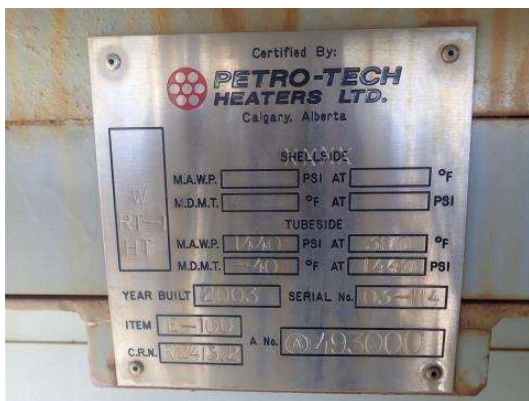
Figure: 6

The vessel nameplate was legible and securely attached to the vessel.

Vessel Nameplate

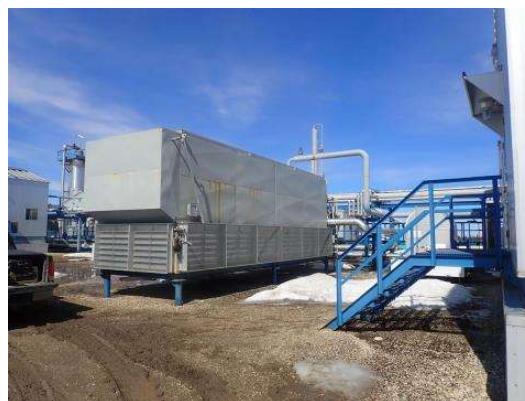
Figure: 7

The heads, shell, nozzles and bolting appeared to be in good condition.

There was no damage or distortion evident on the vessel surface.

The vessel was not insulated. It was painted and generally in good condition.

Vessel Overview

Based on the scope and results at the time of this inspection, the vessel is fit for service.

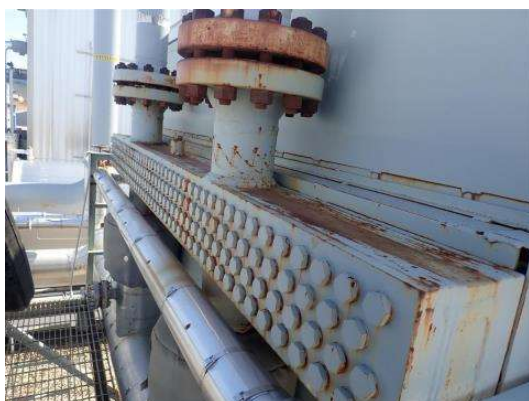
Figure: 8

Vessel Header

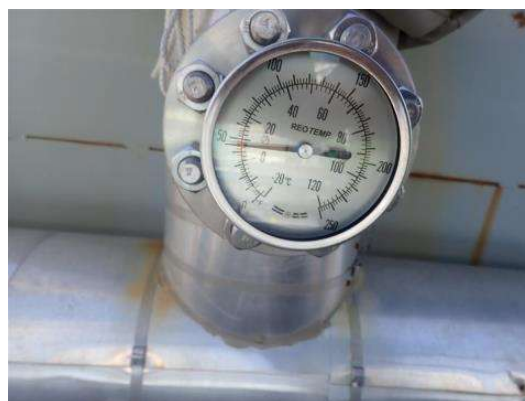
Figure: 9

The gauges were in good condition.

Vessel Gauge 1

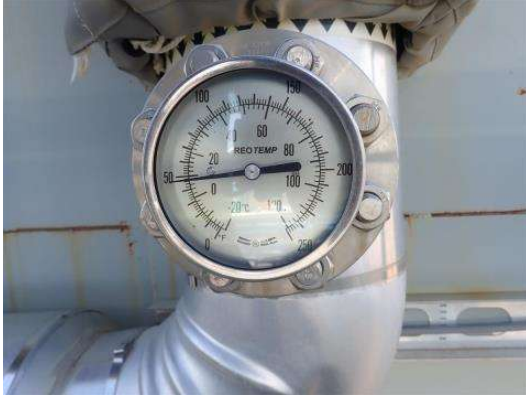
Figure: 10

Vessel Gauge 2
