| <b>Canadian Natural Resources Limited</b><br><b>GENERAL PRESSURE VESSEL INFORMATION</b> | | | | | | | <b>Job # 05.003694</b> |
| Facility: <b>Knopcik Gas Plant</b> | | | | Location (LSD): <b>09-10 -74-11 W6M</b> | | | |
| Vessel Name & Equipment Number: <b>Regeneration Gas Cooler</b> | | | | | | | |
| Status: <b>Operating</b> | | | | <b>Regulatory Inspection</b> | | | |

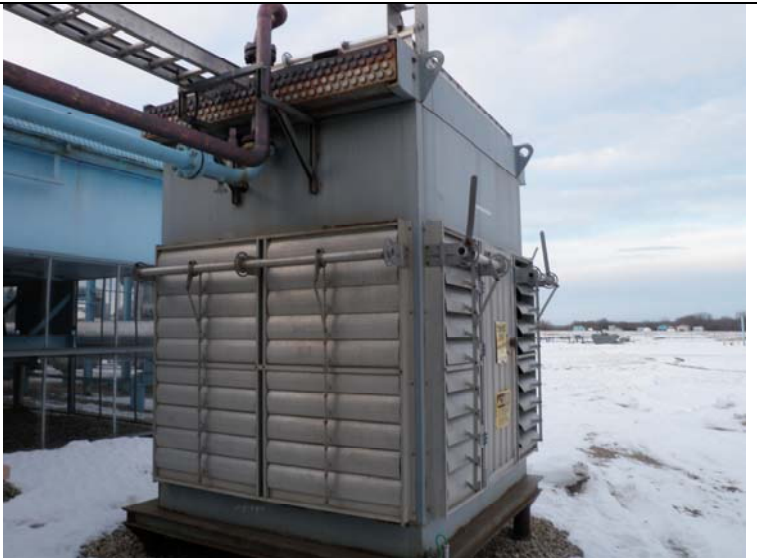
Overview

| External Inspection Items | G | F | P | N/A | Comments |
|---|---|---|---|---|---|
| <b>External Condition:</b> Assess paint condition, areas peeling, record any corrosion, damage, etc (record location, size and depth of corrosion or damage) | | X | | | Surface corrosion on header – no pitting. |

| External Inspection Items | G | F | P | N/A | Comments |
|---|---|---|---|---|---|
| <b>Recommendations or corrective actions : Vessel is Fit for Service or describe corrective actions required)</b><br>(MIC to review corrective actions with Operations, discuss with Chief Inspector where necessary, and get remedial action implemented)<br><b>Recommendations:</b> 1. Paint exterior surface of header box.<br><b>Summary:</b> This vessel is in good condition, visual external and ultrasonic corrosion survey carried out – no pitting detected.<br><b>Vessel is fit for service.</b> | | | | | |

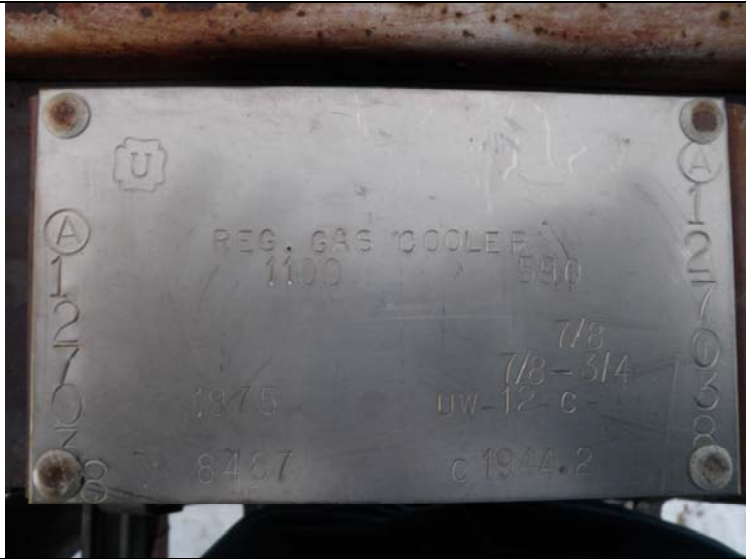
Data Plate

| <b>Canadian Natural Resources Limited</b><br><b>GENERAL PRESSURE VESSEL INFORMATION</b> | | | | | | | <b>Job # 05.003694</b> |
|---|---|---|---|---|---|---|---|
| Registration Number<br><b>A 127038</b> | | | | CRN Number<br>C 1944.2 | | | |
| Vessel serial number: 8487 | | | | Size: 5.75 in. x 9.5 in x 81.0 in. | | | |

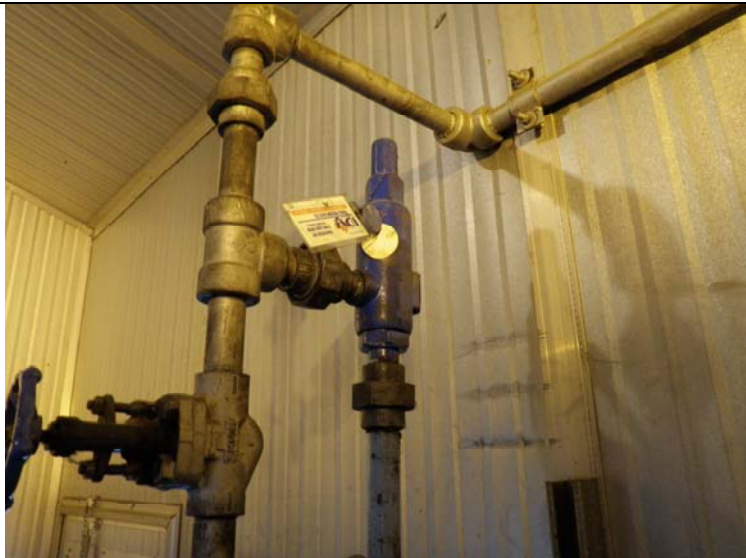
| External Inspection Items | G | F | P | N/A | Comments |
|---|---|---|---|---|---|
| <b>PSV:</b> Ensure PSV is set at pressure at or below that of vessel. | X | | | | Located on inlet piping – set at MAWP of vessel.<br>Seal intact.<br>No block valve.<br>Inlet and discharge piping is same size as orifice. |

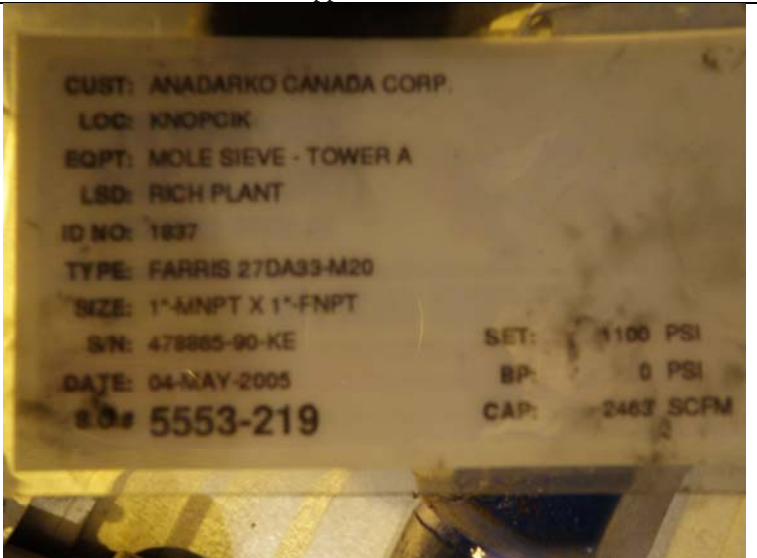
PSV Data Tag

| <b>Canadian Natural Resources Limited</b><br><b>GENERAL PRESSURE VESSEL INFORMATION</b> | | | | | | | <b>Job # 05.003694</b> |
|---|---|---|---|---|---|---|---|
| 1837 | Farris | 27DA33-M20 | 478865-90-KE | 1100 PSI | 2463 scfm | 1 x 1 | |
