Canadian Natural Resources Limited
GENERAL PRESSURE VESSEL INFORMATION **Job # 10.110056**

District: Grande Prairie AB.	Skid No.
Facility: Knopcik Gas Gathering	**Location (LSD): 102 / 06-02-74-11W6M**
Vessel Name Equipment Number: Line Heater	
Orientation: Horizontal	
Status: In Service	**Regulatory Inspection**

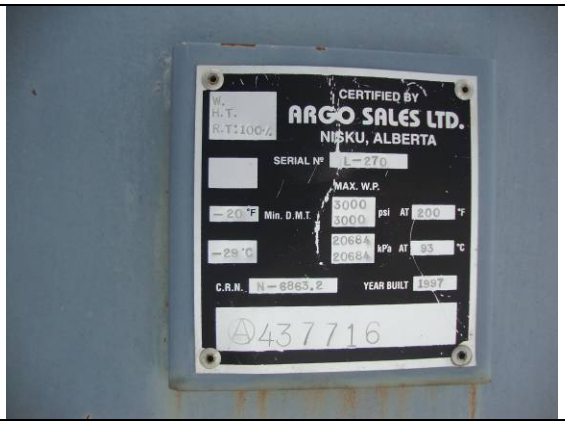
LSD	Vessel data plate

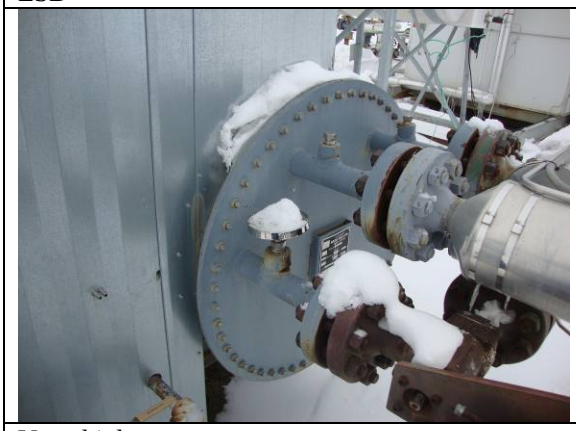
Vessel inlet	Vessel temperature gauge
