**Canadian Natural Resources Limited  
GENERAL PRESSURE VESSEL INFORMATION**

**Job # 10.113190**

<b>District: GP South</b>		<b>Skid No. 58757</b>				
<b>Facility: Hamburg Water injection</b>		<b>Location (LSD): 13-20-96-09 W6M</b>				
<b>Vessel Name &amp; Equipment Number: Free Water Knock Out</b>						
<b>Orientation: Horizontal</b>						
<b>Status: In Service</b>		<b>Regulatory Inspection</b>				
<b>PRESSURE VESSEL NAMEPLATE DATA</b>						
"A" or "G" or "S" (Sask.) or BC Registration Number. <b>A0435016</b>		CRN Number <b>A 2352.32</b>				
Vessel serial number: 2040 V100		Size: 8 ft x 38 ft approx				
Shell thickness: 31.7 mm		Shell material: SA 516 70N				
Head thickness: 30.7 mm		Head material: SA 516 70N				
Tube wall thickness:		Tube material:				
Tube diameter:		Tube length:				
Channel thickness:		Channel material:				
Design pressure	Shell: 2779 (403 psi)	Operating pressure	Shell:			
	Tubes:		Tubes:			
Design Temp.	Shell: 38°C	Operating temperature	Shell:			
	Tubes:		Tubes:			
X-ray: RT-1		Heat treatment: No

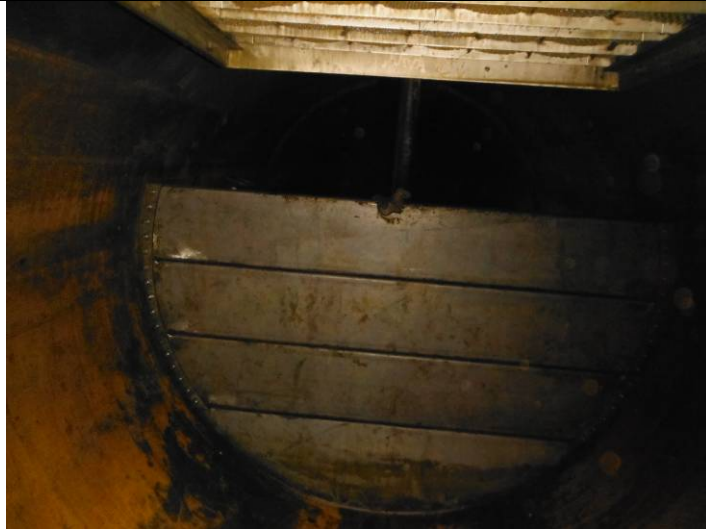
Weir plate

Internal Inspection Items	G	F	P	N/A	Comments
<b>Coating</b> Assess coating. Describe area coated, general condition of coating.				X	Vessel is not internally coated.
<b>Anodes.</b> How many, type, condition. % consumed. Are they being replaced?			X		Two anodes consumed 95% and 25% consumed. Will be replaced.
<b>Internal Piping</b> Is there any? If so, carbon or stainless steel. Describe condition, dents, corrosion, erosion, etc. Ensure supports are secure and any bolts are suitable for future use.	X				4 inch gas draw stem piping is carbon steel and in good condition. No corrosion or mechanical damage.
<b>Vortex Breaker</b>	X				Three stainless steel vortex breakers are bolted in place and are in good condition.
<b>Baffles, deflector plates, Weir.</b> If present, describe condition. Look closely at welds attached to vessel wall.	X				Inlet deflector plate and weir plate are stainless steel and bolted securely to shell. No damage.

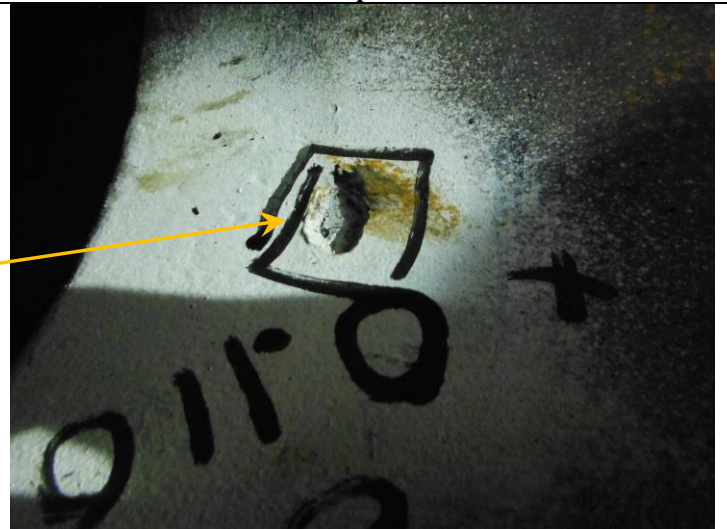
North 14 inch manway - Isolated pit 5/8 inch dia. x 0.110 inch depth

Pit excavated to 0.350 inch depth

Final repair MT carried out – No cracking detected.
