# VESSEL INSPECTION SUMMARY

Report #: **137854-WF-1**  
Inspect Date: 05/28/2009  
Page: 1 of 2  
IRISNDT #: 137854

Client: CNRL District: Bonneville Heavy Oil Field: Frog Lake  
Facility: 06-32-055-03W4 Unit: N/A LSD: 06-32-055-03W4  
Jurisdiction #: A0218208 Equip Tag #: N/A Serial #: 26978A  
CRN #: C4936.23 Nat'l Bd #: N/A Year Built: 1985  
Manufacturer: Western Rockbit LTD Equipment Description: Propane Bullet  
Status: Out Of Service Date Removed From Service: Service: Unknown  
MAWP Shell 1724 kPa @ 66 °C Height/Length: 720 in. Code Stamp: ☒ Y ☐ N  
MAWP Tube Select @ Pick Size/Diameter: 108 in. O.D. Insulated: ☐ Y ☒ N  
Support Type: Saddle RT: 2 Volume: ft<sup>3</sup> / m<sup>3</sup> PWHT: ☐ Y ☒ N  
C.A. 0 Coated ☐ Y ☒ N Clad: ☐ Y ☒ N Manway: ☒ Y ☐ N

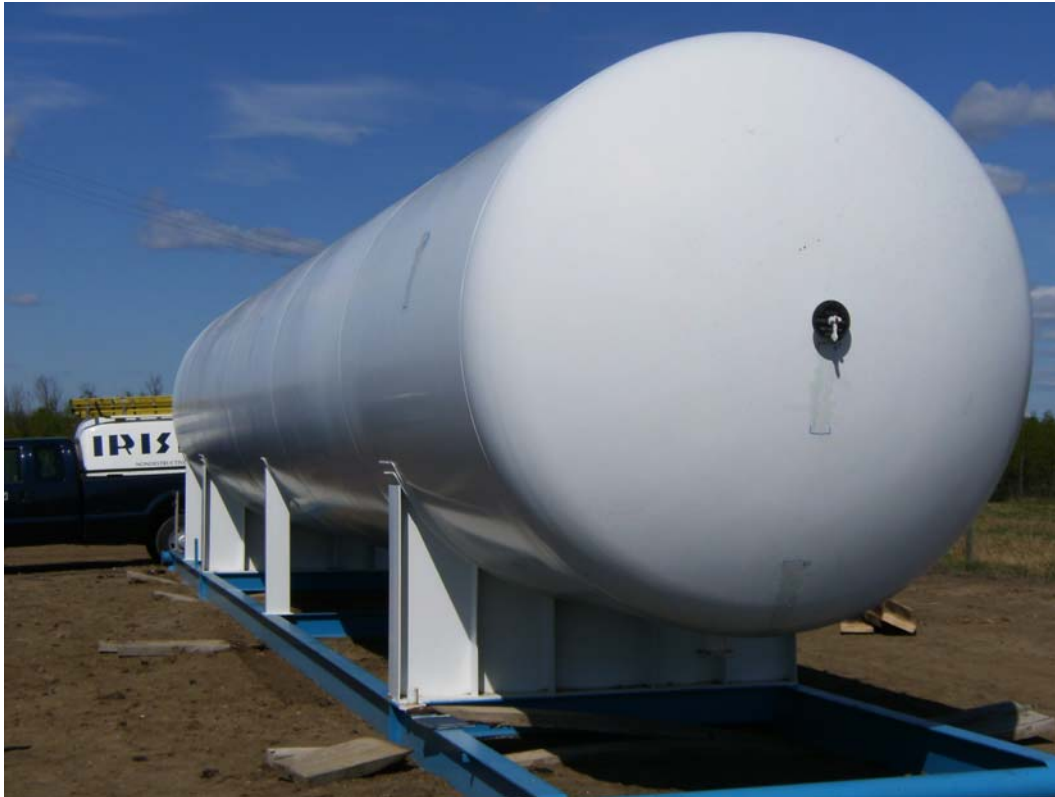
A0218208\_Propane Bullet\_28May09

- The vessel is out of service and is scheduled to be moved to a new location after inspection. No evidence of prior process leaks is noted.
- The paint on the shell and nozzles is intact with the exception of isolated areas on the nozzle flanges.
- The saddle and leg supports are secure and level.
- No PSV's are present on the vessel.
- No piping is attached to the vessel.
- The temperature, pressure and capacity gauges are clear and visible.
- External UT was carried out with no significant wall losses noted.
