CLIENT	CANADIAN NATURAL RESOURCES LTD	
FACILITY	NORTH TONY FIELD	
	LSD 10-10-63-20 W5M	
ITEM	SEPARATOR	
BY: NR	DATE: 05/2008	DWG.# 72

**EQUIPMENT:** SEPARATOR PIPING

**Canadian Natural Resources Limited  
GENERAL PRESSURE VESSEL INFORMATION**

District: Grande Prairie, AB	Skid No.
Facility: North Tony Creek Gas Gathering	Location (LSD): 10-10-63-20-W5M
Vessel Name Equipment Number: Test Separator	
Orientation: Vertical	
Status: Not operating	<b>Regulatory Inspection</b>

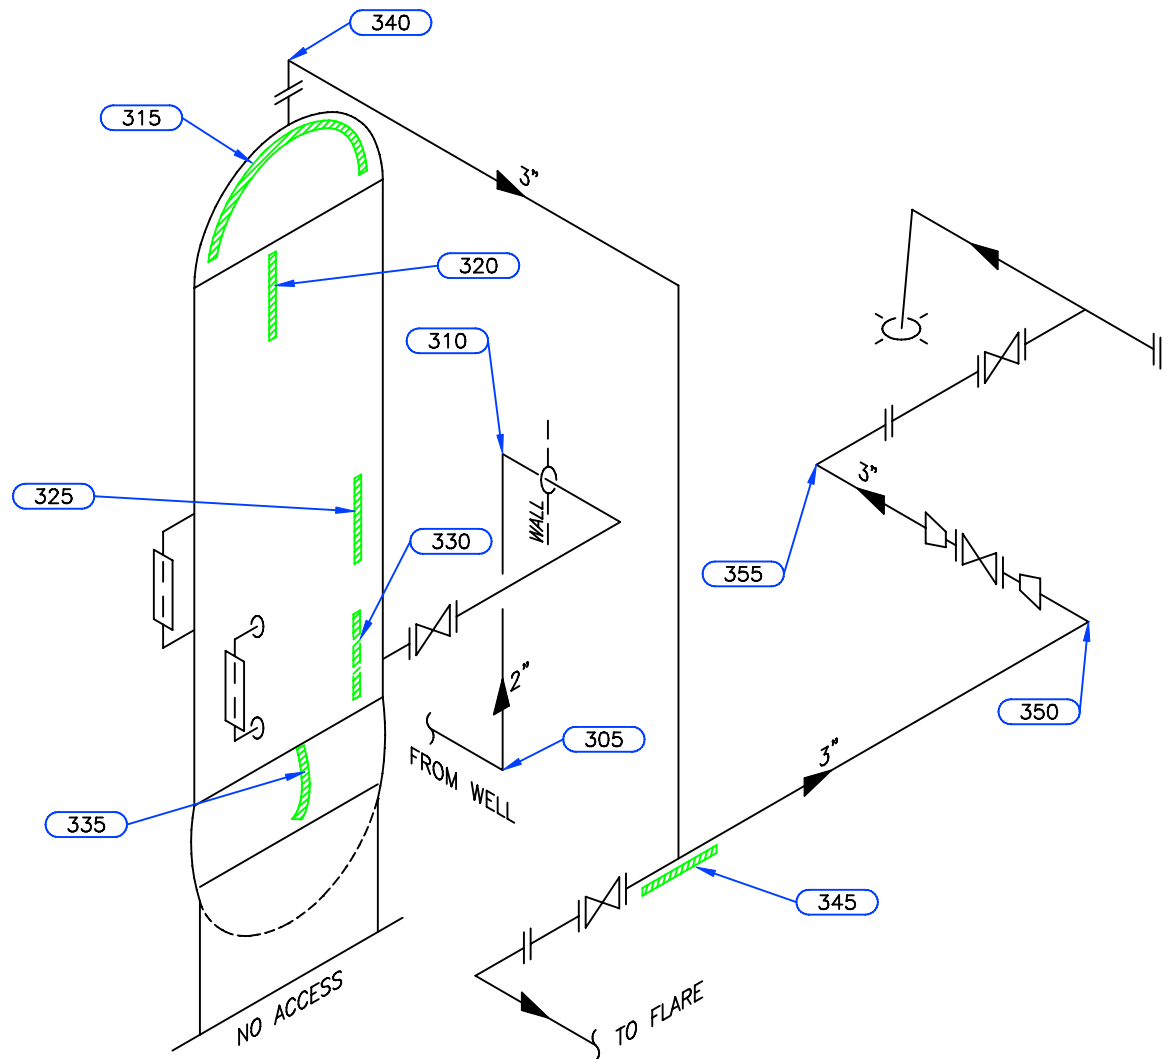
**PSV DATA**  
 MFG: FARRIS  
 MODEL: 24700L  
 SERIAL: CE-10573-KC  
 SET PRES: 4895 kPa  
 CAPACITY: 845 scfm  
 SERVICED BY: N/S  
 SERVICE DATE: N/S  
 SIZE: 1"x1"  
 CODE STAMP: UV/NB  
 BLOCK VALVE: NO  
 CRN: OG254.2C  
 LOCATION: TOP HEAD
