Client	Canadian Natural Resources Ltd.	Inspection Date	Jul 2, 2019		
Prov. Reg. #	AB 0662699	Inspection Type	VE / UT		
Equipment Type	Horizontal Glycol Cooler	Location	Gold Creek		
Tag/Equip.		LSD	AB 13-26-067-05W6		
Status	In Service	Downhole LSD			
Manufacturer	Calhex Industries Ltd	Area			
Serial Number	16-1139	Year Built	2016		
CRN #	Y2702.2	Service	Glycol		
Comp/Unit Id	Glycol Area	Manway	None		
Nat.Board #		Coating			
Interim Insp'n		Interim Type			
Next Thorough Insp	2024	Next Insp Type	VE / UT		
Length		Height			
Volume		Client Reference			
Owner	Canadian Natural Resources Ltd.	RT		HT	YES
Foreman	Chris Maxsom	RAE Job No.	8364		
ABSA	Plant: H Vessel: T Process: H Special: B	ASME	Sec. VIII div. 1		
History Log

Report No: KM004790

RAE Engineering and Inspection Ltd 4810 - 93 Street Edmonton, AB, T6E 5M4 ph: 780-469-2401 fx: 780-468-2422		Inspection Date: 2-Jul-19	Ultrasonic Thickness Examination
			Page: 1 of 4	
	Client: Canadian Natural Resources Ltd.		RAE Report #: 19-8364-LC-UT-65	
Address: Suite 2500, 855-2St., SW, Calgary, AB, T2P4J8		Project #: 8364		
Client P.O.#: NA		Location/LSD: Gold Creek / 13-26-067-05 W6		
Client Representative: NA		Procedure: NDE-701B UT-1 REV.

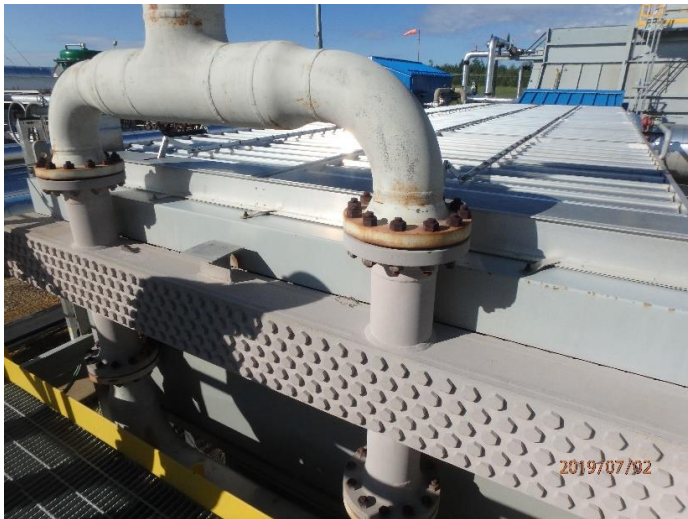
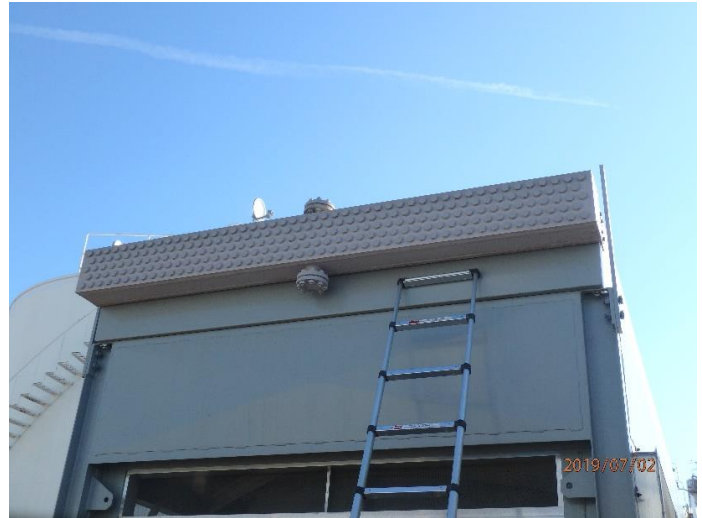
**Overall View of Equipment**

The cooler was located outside of any building structures. The cooler was identified by it's A/serial number. The cooler was in good condition. No dents or damage evident on the surface of the cooler. This cooler was mounted horizontally. The louvers appeared to be in good operating condition. The cooler was supported by the cooler housing.
