**Canadian Natural Resources Limited
GENERAL PRESSURE VESSEL INFORMATION**

Job # 10.110452

District: Fort St John, B.C.	Skid No.
Facility: Flat Rock Compressor Station	Location (LSD): 5-2-85-17 W6M
Vessel Name Equipment Number: Treater	
Orientation: Horizontal	
Status: In Service	Regulatory Inspection

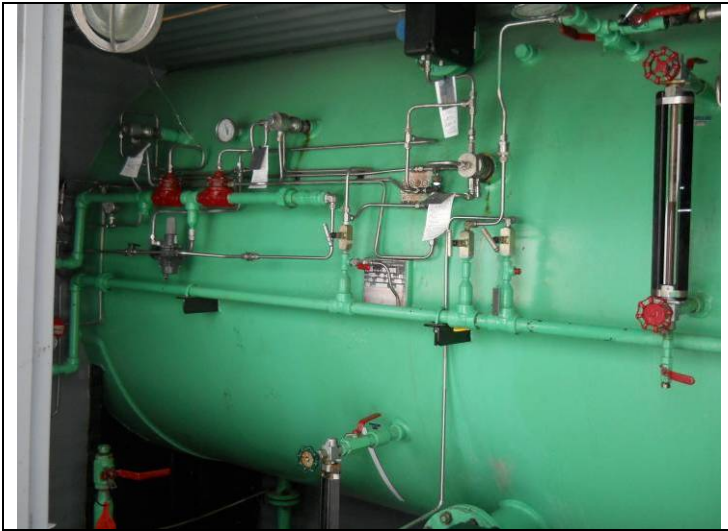
Water Dump Line

Valving Ensure no leaks are visible. Valves are properly supported and chained if necessary.	X				Well supported – no leaks.
PSV Ensure PSV is set at pressure at or below that of vessel. Discharge piping is same size as inlet to valve and is properly supported and routed. Ensure no block valves between PSV and vessel or if there are they are locked open.	X				PSV is set below MAWP of vessel. PSV Discharge piping is equal to inlet piping and is properly supported and routed. Car Seals Intact. Location: Top shell
NDE methods Was UT/ MPI done on vessel (MI coordinator to review results)	X				Ultrasonic corrosion survey carried out, metal thickness detected below nominal minus corrosion allowance. On Water dump piping
<p>Recommendations or corrective actions : Vessel is Fit for Service or describe corrective actions required) (MIC to review corrective actions with Operations, discuss with Chief Inspector where necessary, and get remedial action implemented)</p> <p>Recommendations: 1) Replace Water Dump spool to fiber glass connection.</p> <p>Summary: This vessel is in good condition, visual external and ultrasonic thickness inspection carried out – metal thickness detected below nominal minus corrosion allowance on water dump spool *replace. Review UT Survey</p> <p>Vessel is fit for service.</p>

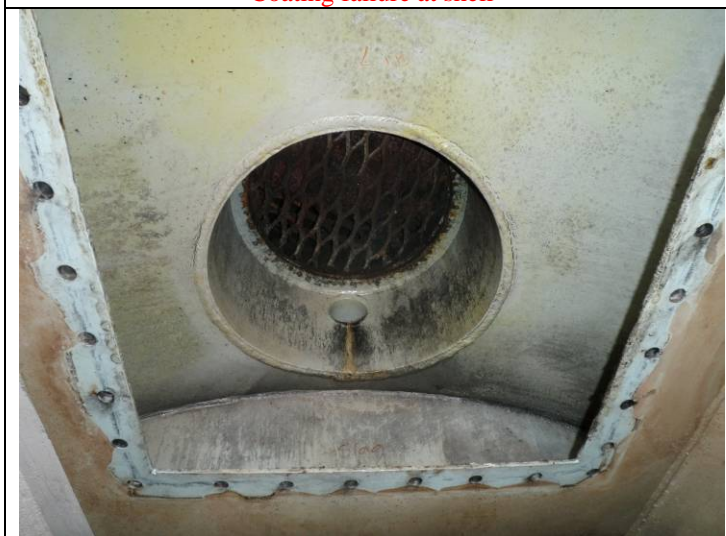
Coating Failure - surface corrosion to depth of 0.010 inch

Internal Inspection Items	G	F	P	N/A	Comments
Coating Assess coating. Describe area coated, general condition of coating.		X			Coating is in fair condition. Some minor failures at manways, shell and nozzles. Surface corrosion to depths of 0.010 inches at failed locations. <u>These coating failures were patched with Davoc #142</u>
Anodes. How many, type, condition. % consumed. Are they being replaced?	X				2 Anodes measuring 42 x 3 inches are installed in Treater. Consumption of approximately 10 %. Existing anodes will be installed.
Internal Piping Is there any? If so, carbon or stainless steel. Describe condition, dents, corrosion, erosion, etc. Ensure supports are secure and any bolts are suitable for future use.	X				Internal piping is in good condition. No signs of deflection. Well supported.
Trays How many? Type of material. Are valves in place? Check for erosion/ corrosion; wear on tray valve legs. Cleanliness?				X	No trays.

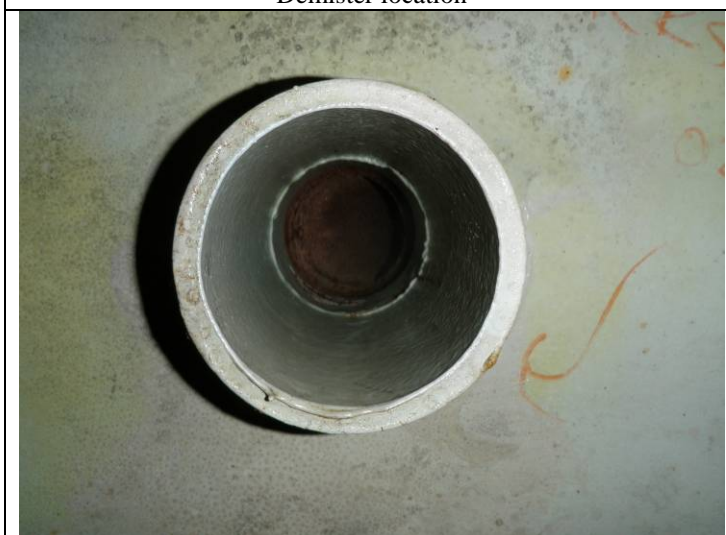
Demister pad - dirty and corroded

Demister pad Is it in place? Is it clean? If any corrosion is apparent in vessel, lift pad and check top head for corrosion.			X		Dirty and corroded.
Welds Inspect all welds, including attachment welds. Record all service-related damages and if there is any discuss with Chief Inspector before closing.	X				Good condition, no corrosion or pitting.
Repairs Required. If yes, ensure procedure and copy of AB 40 is on file, and one sent to local ABSA, and Chief Inspector	X				Patch repairs to coating were carried out.
NDE Was any NDE done. (MI coordinator to review results)				X	No internal NDE at this time.
Recommendations or corrective actions : Vessel is Fit for Service or describe corrective actions required) (MIC to review corrective actions with Operations, discuss with Chief Inspector where necessary, and get remedial action implemented) Recommendations: Replace demister pad. Plan for possible complete coating of vessel next outage. Summary: This vessel is in good overall condition, visual internal carried out. Vessel is fit for service

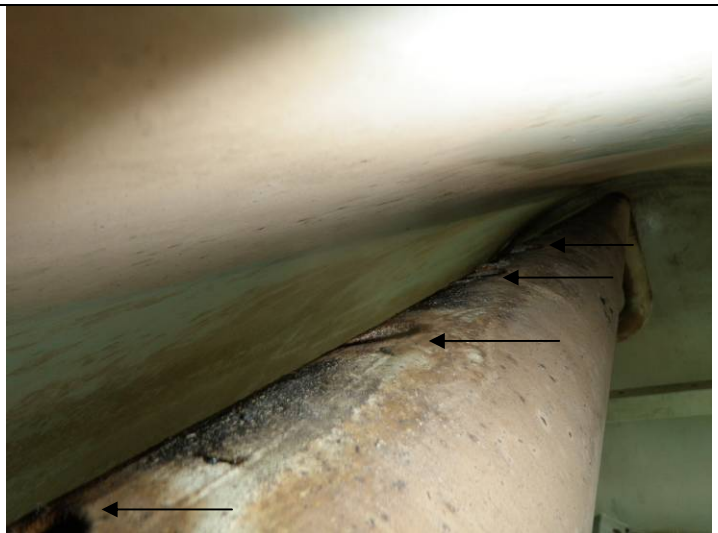
Upper shell and inlet piping

Baffles, deflector plates, etc. If present, describe condition. Look closely at welds attached to vessel wall.	X				Inlet deflector plating is intact. No signs of erosion. No damage or distortion. Coating intact.
South Head Note all corrosion, erosion or mechanical damage. (If vessel is horizontal identify direction of this head)	X				Head is in good condition. No corrosion or no pitting. No signs of damage or distortion.
North Head Note all corrosion, erosion or mechanical damage. (If vessel is horizontal identify direction of this head)	X				Head is in good condition. No corrosion or no pitting. No signs of damage or distortion.
Shell Sections Record number of shell sections. Record location, size and depth of all erosion, corrosion or mechanical damage. Describe general condition. If any corrosion greater than corrosion allowance is observed in either shell or head, discuss with Chief Inspector before closing vessel.	X				Shell sections are in good condition. No signs of damage or distortion. No signs of erosion or corrosion.
