**Canadian Natural Resources Limited
GENERAL PRESSURE VESSEL INFORMATION**

Job # 05.01610

District: Fort St John, B.C.	Skid No.
Facility: Flat Rock Compressor Station	Location (LSD): 5-2-85-17 W6M
Vessel Name Equipment Number: Inlet Contactor	
Orientation: Vertical	
Status: In Service	Regulatory Inspection

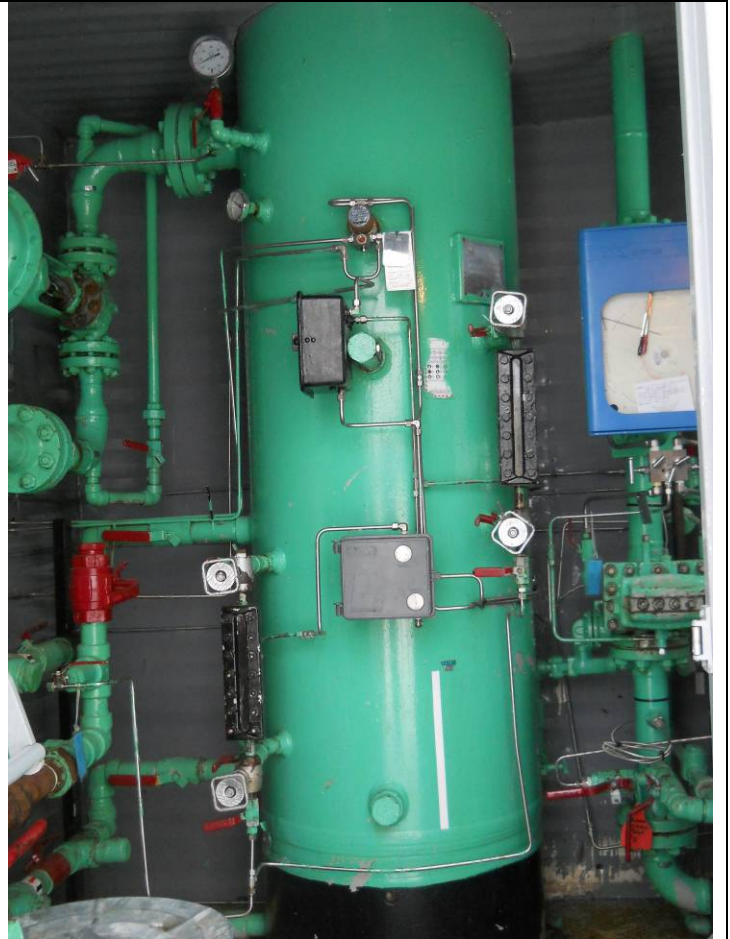
External Inspection Items	G	F	P	N/A	Comments
Insulation Verify sealed around manways, nozzles, no damage present, and there is no egress of moisture.	X				No Insulation present. Roof seal is broken
External Condition Assess paint condition, areas peeling, record any corrosion, damage, etc (record location, size and depth of corrosion or damage)	X				Paint is in good overall condition – no exposed metal
Leakage Record any leakage at flanges, threaded joints, weep holes on repads, etc.	X				No leaking detected.
Saddle/skirt Assess condition of paint, fire protection, and concrete. Look for corrosion, buckling, dents, etc. Look at vessel surface area near supports. Verify no signs of leakage at attachment to vessel and attachment welds are acceptable. Ground wire attached?	X				Skirt is in good condition – no buckles or distortion. Internally skirt is corroding Paint intact – with little to no corrosion. Vessel grounded through the skid package. No signs of leakage.

Roof seal

Recommendations: 1) Sandblast and paint under skirt.2) Repair roof seal
