VESSEL INSPECTION SUMMARY

Report #: **127020-WF-06**
Inspect Date: 06/07/2007
Page: 1 of 2
IRISNDT #: 127020

Client: CNRL District: Medicine Hat - West Field: 09-17-11-16W4
Facility: Taber Unit: _____ LSD: 09-17-11-16W4
Jurisdiction #: A0161747 Equip Tag #: _____ Serial #: L-8-143
CRN #: B-5946.2 Nat'l Bd #: _____ Year Built: 1980
Manufacturer: Natco Equipment Description: Horizontal Group Treater
Status: Out Of Service Date Removed From Service: _____ Service: Sour
MAWP Shell 345 kPa @ 93 °C Height/Length: 9144 mm Code Stamp: ☒ Y ☐ N
MAWP Tube _____ Select @ _____ Pick Size/Diameter: 2438 mm I.D. Insulated: ☒ Y ☐ N
Support Type: Saddle RT: 2 Volume: _____ ft³ / m³ PWHT: ☐ Y ☒ N
C.A. _____ Coated ☒ Y ☐ N Clad: ☒ Y ☐ N Manway: ☒ Y ☐ N

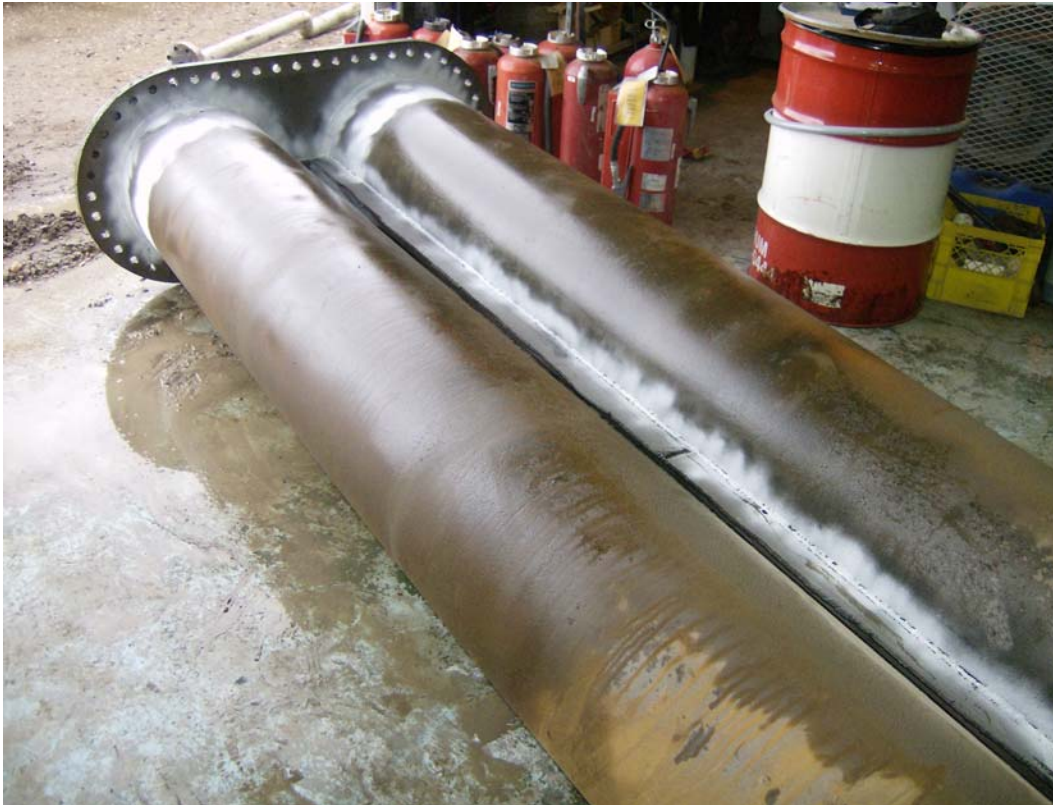
A0161747_Group Treater Fire Tube_06Jun07

- The first 9 inches of the external/internal surface of the pipe is corroded and pitted on the product side of the tube sheet to a depth of 0.100".
- The tube sheet on the product side is corroded and pitted up to a 0.110" deep.

- There was light pitting found on the rest of the external piping up to a depth of 0.020".
- One of the slip-on flange fillet welds was holed through for seven inches around the circumference. The original fillet weld on the OD of the flange is of very poor quality with little to no fusion or reinforcement in many areas.

- MT was carried out on all accessible welds with no indications noted.
- A spare fire tube previously repaired and inspected was selected to replace the fire tube described above.

- The fire tube is to be sent to East End Iron for repairs.

- The building wall is to be properly sealed to the vessel shell to prevent environmental deterioration.
- The external surface of the shell is to be repainted as required.
- The fillet welds of the slip-on flanges for the fire tube are to be repaired.
- The deeply pitted sections of pipe for the fire tube are to be replaced.
- The pitted area of the tube sheet is to be ground smooth to assist surface condition and is to be considered for weld overlay.
