**Canadian Natural Resources Limited
GENERAL PRESSURE VESSEL INFORMATION**

Job# 10.180528

District: Fort St John, BC	Skid No.
Facility: South Buick Compressor Station	Location (LSD): d-78-I / 94-A-11
Vessel Name Equipment Number: Oil Treater	
Orientation: Horizontal	
Status: In Service	Regulatory Inspection

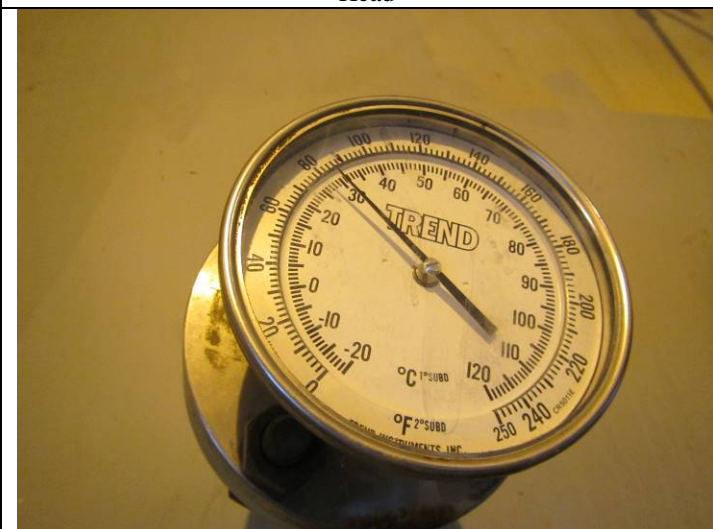
Anchor Bolts Hammer tap to ensure secure. Look for cracking in treads or signs of deformation.	X				Saddle firmly bolted to skid deck.
Concrete foundation Check for cracks, spalling, etc.				X	Steel pilings
Ladder / Platform Describe general condition, ensure support is secure to vessel, and describe any hazards.				X	No ladder or platform
Nozzle Assess paint, look for leakage, and ensure stud threads are fully engaged. Record any damage, deflection, etc. Are nozzles gusseted?	X				Paint in good condition – all studs fully engaged to nuts – no short bolts. No deflection, corrosion or leaks. No gussets.
Gauges Ensure gauges are visible, working, no leakage, and suitable for range of MAWP/ Temp.	X				Pressure gauge: No pressure gauge. Temp gauge: 0-250DegF
External Piping Ensure pipe is well supported. All clamps, supports, shoes, etc. in place. Look for evidence of structural overload, deflection, etc. Paint condition, external corrosion?	X				Well supported, no deflection, all clamps in place. Painted piping in good condition – no exposed metal – no corrosion. Insulated piping – cladding intact – no exposed metal – no wet insulation.

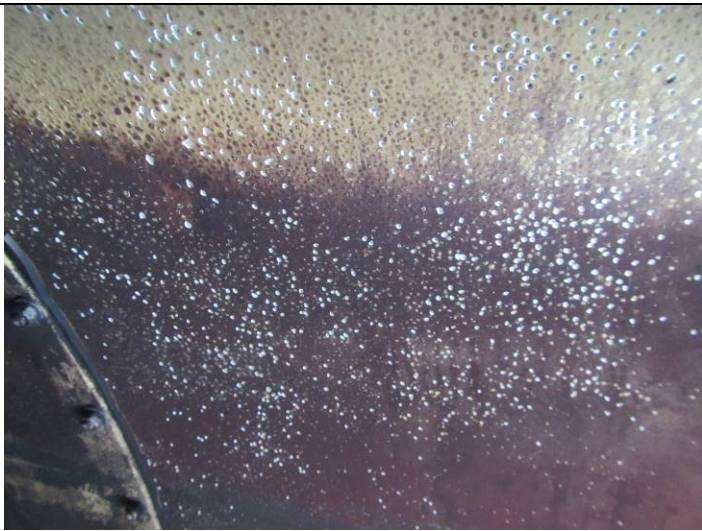
Bottom shell overview

Baffles, deflector plates, etc. If present, describe condition. Look closely at welds attached to vessel wall.	X				Several weirs and screens in place – good overall condition – mechanical damage – no damaged coating – attachment welds in good condition
Back Head Note all corrosion, erosion or mechanical damage. (If vessel is horizontal identify direction of this head)	X				Head is in good condition, completely coated – no corrosion / erosion or mechanical damage
Front Head (fire tube) Note all corrosion, erosion or mechanical damage. (If vessel is horizontal identify direction of this head)	X				Head is in good condition – no corrosion / erosion or mechanical damage – a few minor chips in the coating were patched
Shell Sections Record number of shell sections. Record location, size and depth of all erosion, corrosion or mechanical damage. Describe general condition. If any corrosion greater than corrosion allowance is observed in either shell or head, discuss with Chief Inspector before closing vessel.	X				Shell is in good overall condition – no corrosion / erosion or mechanical damage
