Field Inspection Report

Client	CNRL			Date of Inspection	July 12, 2011			
Prov. Reg.#	A2864631			Inspection Type	VE, UT			
Equipment	Test Separator			Location	Taber Battery			
Tag/Equip. #	V 110			LSD	06-24-010-17W4M			
Vessel Status	NOT In Service			Comp./Unit #				
Manufacturer	West Fab Industries Limited.			MAWP / Temp	285 PSIG @ 100 F			
Serial #	WF 93246	CRN #	M 0788.2	MDMT@ Pressure	-20 F @ 285 PSIG			
Corrosion Allowance		Shell Material	SA516-70	Shell Thickness	0.500"			
Year Built	1993	Head Material	SA516-70	Head Thickness	0.490"			
Diameter	48" OD	Length		Height	RT	RT-3	HT	
Service	Sour	Next Inspection		Next Insp. Type				
ASME Stamp	No	Next Inspection		Next Insp. Type				
PSV Tag #		CRN#		Set Pressure				
Manufacturer				NB#		ASME Stamp		
Type/Model		Serial #		Inlet Size				
Capacity		Service Company		Outlet Size				
Service Date				Next Service Date				
Valve Location	On Vessel On Piping Vents to Flare Vents to Atmosphere	Valve Connection	Threaded Flanged Welded	ABSA CODE TYPE

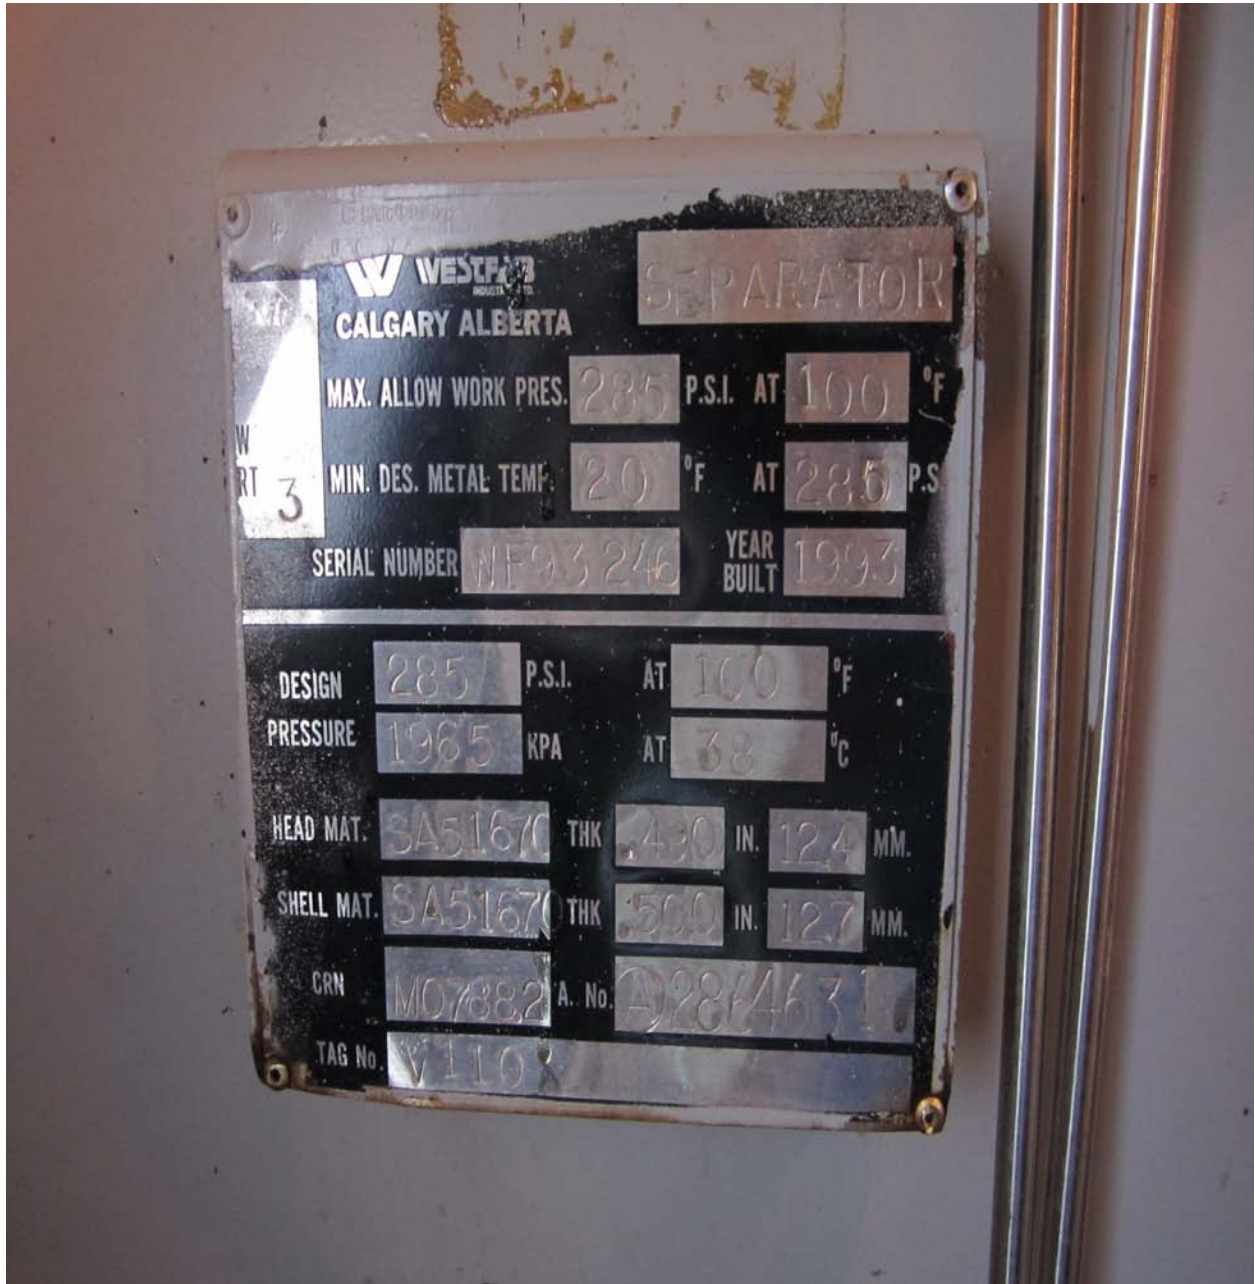
A2864631_Name plate_16July2011

- Name plate was intact and readable.
- Paint was in good condition with no external corrosion or erosion.
- External insulation was in good shape.
- Wall to shell interface seal was in good shape with no signs of corrosion.
