11-30-039-21W4M
 Flare Knock Out
 A3066599 LM 3023
 REPORT # A#3066599_GRADY INSPECTION LTD VE VI UT INSP_6NOV2018

PRESSURE EQUIPMENT			
DISTRICT	SHELL TUBE		
FACILITY	MAWT	200	F
A#	A3066599	YR	1995
		MAWP	51
			psi
SERIAL #	LM 3023	PSV	
		psi	
CRN	M7022.2	PSV CRN	
EQUIP#		SERVICED	
STATUS	OUT OF SERVICE	UNIT	
MANUFACTURER	Natco Canada		
DH LSD	L	24 Ft	OD 6 Ft

External Inspection - (Vessel)

Internal Inspection - (Vessel
LSD 11-30-039-21W4M
Jur # A3066599
Serial # LM 3023

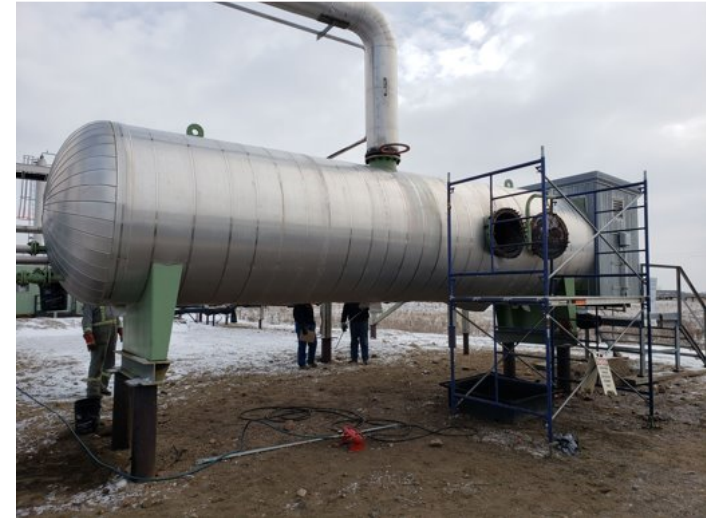
Overview

Inspection Summary: Vessel is in good visual condition.

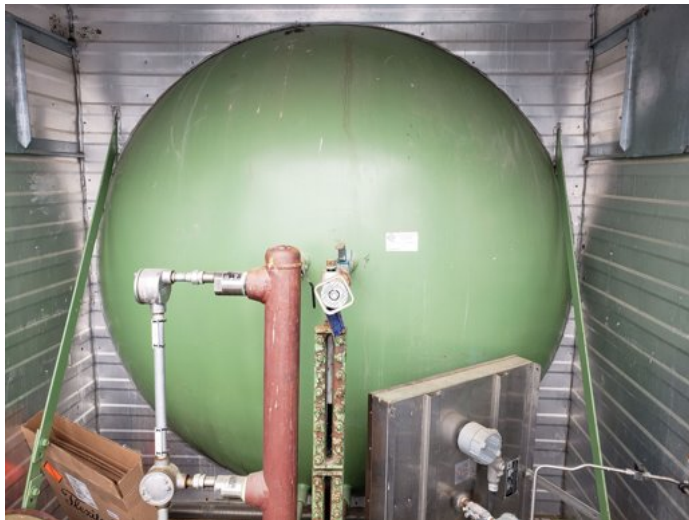
South Head

Due to the vessel being out of service for over a 5 year period and half full of fluid, a corrosion fluid line has developed at the 3:00 & 9:00 positions of the shell sections and both heads. Maximum pitting found along this area was 2.55 mm.

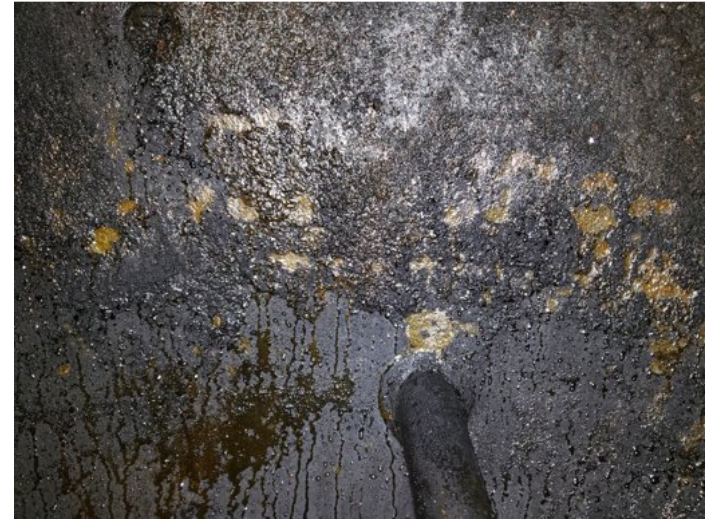
North Head

In addition a corrosion line has formed along the 6:00 position of the vessel. The corrosion is limited to the North and Center can sections. A maximum pit depth of 2.85 mm was found at the North end of the vessel. (Limited access due to the coil position).

Recommendations: Addition of extra inspection ports vertically on the shell and head recommended to monitor existing corrosion lines.
