MATRIX INSPECTION

VESSEL INSPECTION SUMMARY

Report #: **137922-WF-1**
 Inspect Date: 08/22/2009
 Page: 1 of 10
 IRISNDT #: 137922

Treater – A0403456

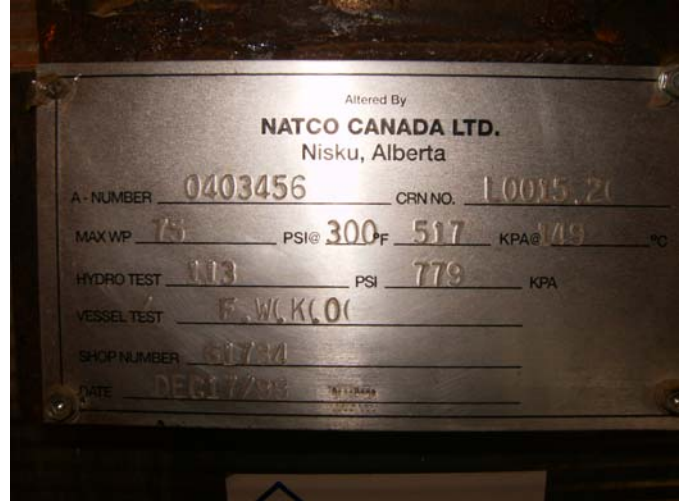
Figure 002_Repair Nameplate_22Aug10

- The corroded areas to be welded were cleaned to sound metal and inspected with MT and UT prior to welding. No rejectable indications were noted; refer to IRISNDT report# 137922-MT-WF-01 & 137922-UT-WF-01 for details.
Murland Projects Inc completed all repair work.
The nozzle projections were preheated to 180F prior to welding. The weld overlay was completed with E-7018 electrodes. The weld cap was blended flush with the adjacent parent material of the nozzles. All repair work on the nozzles was visually acceptable.
All welding was inspected with MT 12 hours after welding was completed. The MT was carried out by Team inspection. No rejectable indications were noted; refer to Team report #MT-262-BG for details.
No hydrostatic test was required. Refer to the attached photos and drawing for details.
