COMPANY	CNF	CNRL							June 28	une 28 2016				
<b>FACILITY</b> Ga		Gainsborough West					<b>LSD</b> 13-31-03		2-30 W1M					
EMERALD	1BER	ER					COMPANY IDENTIFICATION #				S4314			
VESSEL DATA														
<b>DESCRIPTION</b> Treater					MAN	MANUFACTURER			Kansteel					
MFG. DAT	1988					NB#/	NB#/A#/S#		S#28388					
SERIAL#	4787					CRN#		A0241.342						
UNIT NUMBER(S#)		4314			1 1		STAT	STATUS		active				
MAWP SHELL	50	kpa	⊠ p	si @ Temp	210	С	⊠ F	MDMT		□С □F		@		kpapsi
MAWP TUBE		kpa	□р	si @ Temp		С	F					<u> </u>		кра <u></u> _рзі
PSV INFO	DRMAT	ON		N/A	4			2 <sup>NI</sup>	PSV			X	N/A	
MANUFACTURER Taylor				LOCATION	Top shell		MANUFACTURER			LOCATION				
SERIAL#		43106-8 <b>CRN #</b>		CRN#	OG1315.2C		SERIAL#				CRN#			
MODEL#				PSV #	7946		MODEL#				PSV #			
SET PRESSURE		50 psi CAPACITY		CAPACITY	1478 scfm		SET F	SET PRESSURE				CAPACITY		
INLET SIZE		3"			3"		INLET SIZE				OUTLET SIZE			
LAST SERVICE				SERVICE INTERVAL			LAST	LAST SERVICE				SERVICE INTERVAL

### **INTERNAL VISUAL INSPECTION**

# EMERALD BOILER AND PRESSURE VESSEL INSPECTIONS INC. PRESSURE VESSEL INSPECTION REPORT EXTERNAL VISUAL INSPECTION

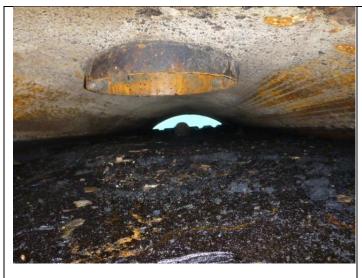
Spill over baffle corrosion
