Tank External Inspection Report

| Description: | 1000 BBL Emulsion Tank | | | | |
| Serial #: | G-97-338-107 | Equipment #: | C83936 | Status: | Operating |

Tank Internal Inspection Report

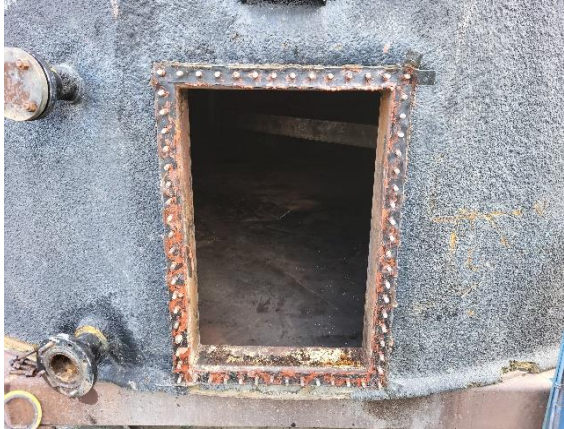
Manway overview

| Serial #: | G-97-338-107 | Equipment #: | C83936 | Inspection Date: | |
|--|---|--|---|---|--|
| MANWAY & COVER | Good | Coated - no damage. | | | |

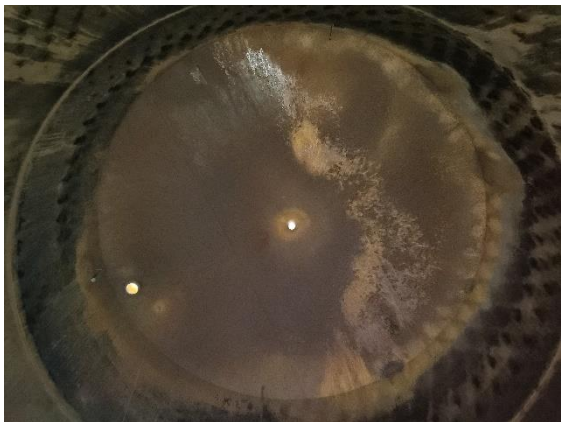
Tank deck overview

| Serial #: | G-97-338-107 | Equipment #: | C83936 | Inspection Date: | |
|--|---|--|---|---|--|
| DECK | Good | No corrosion or mechanical damage. | | | |

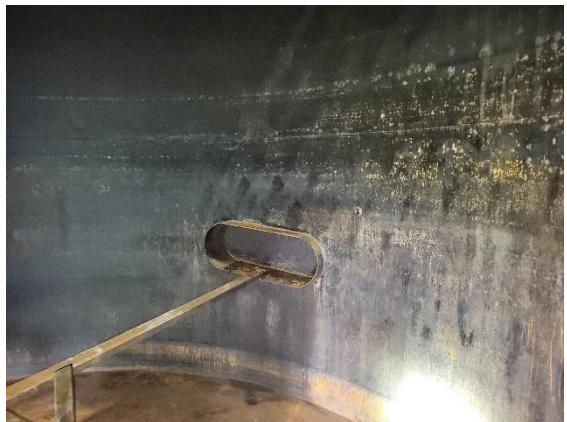
Side shell overview

| Serial #: | G-97-338-107 | Equipment #: | C83936 | Inspection Date: | |
|--|---|--|---|---|--|
| SHELL | Good | No corrosion or mechanical damage. | | | |

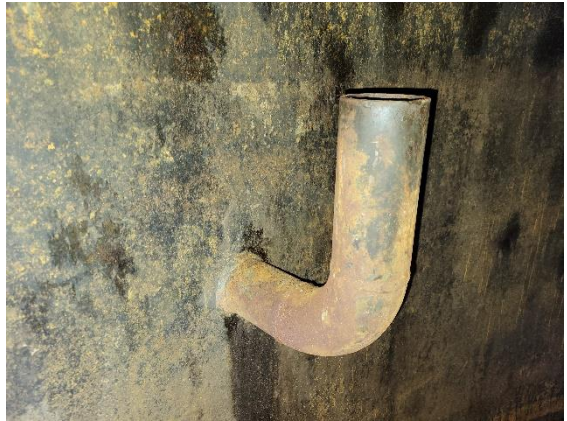
Piping overview

| Serial #: | G-97-338-107 | Equipment #: | C83936 | Inspection Date: | |
|--|---|--|---|---|--|
| INTERNAL PIPING | Good | No damage or deflections. | | | |

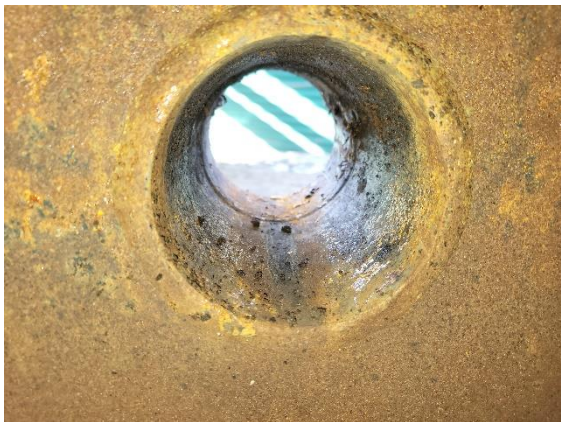
Nozzle overview

| Serial #: | G-97-338-107 | Equipment #: | C83936 | Inspection Date: | |
|--|---|--|---|---|--|
| NOZZLES | Good | Unobstructed - no corrosion. | | | |
