**Canadian Natural Resources Limited
GENERAL PRESSURE VESSEL INFORMATION Job # 10.110451**

District: Fort St John, B.C.	Skid No.
Facility: Flat Rock Battery	Location (LSD): 15-20-85-17 W6M
Vessel Name Equipment Number: Treater	
Orientation: Horizontal	
Status: In Service	Regulatory Inspection

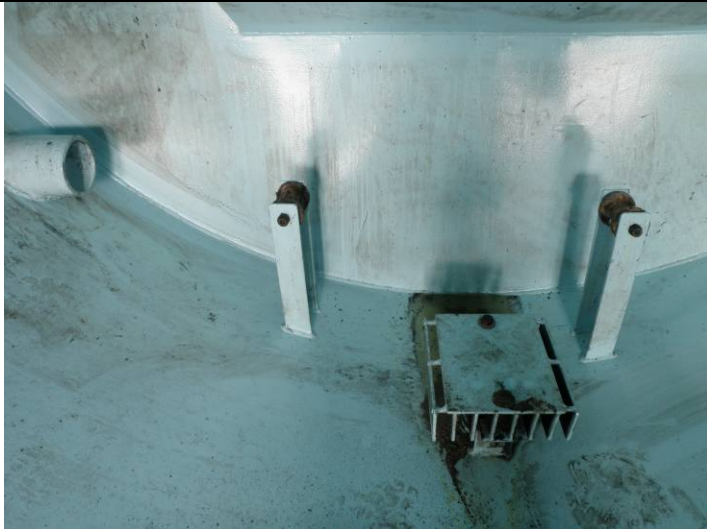
Demister pad Is it in place? Is it clean? If any corrosion is apparent in vessel, lift pad and check top head for corrosion.	X				Clean and intact.
Welds Inspect all welds, including attachment welds. Record all service-related damages and if there is any discuss with Chief Inspector before closing.	X				Good condition, no corrosion or pitting.
Repairs Required. If yes, ensure procedure and copy of AB 40 is on file, and one sent to local ABSA, and Chief Inspector	X				Patch repairs to coating were carried out.
NDE Was any NDE done. (MI coordinator to review results)	X				MPI performed on Fire Tube welds. Cracking found, excavated and rewelded. MPI carried out at repairs with no cracking found.
Recommendations or corrective actions : Vessel is Fit for Service or describe corrective actions required) (MIC to review corrective actions with Operations, discuss with Chief Inspector where necessary, and get remedial action implemented) Recommendations: None. Summary: This vessel is in good overall condition, visual internal carried out. Vessel is fit for service

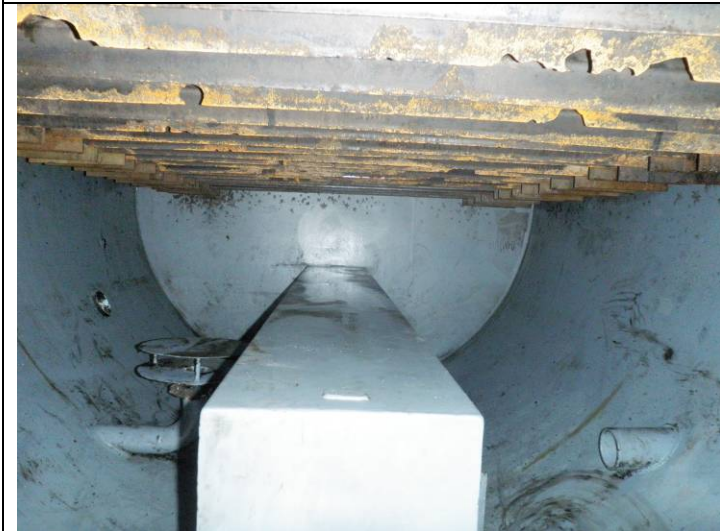
Overview (erosion on electroplating – no longer in service)

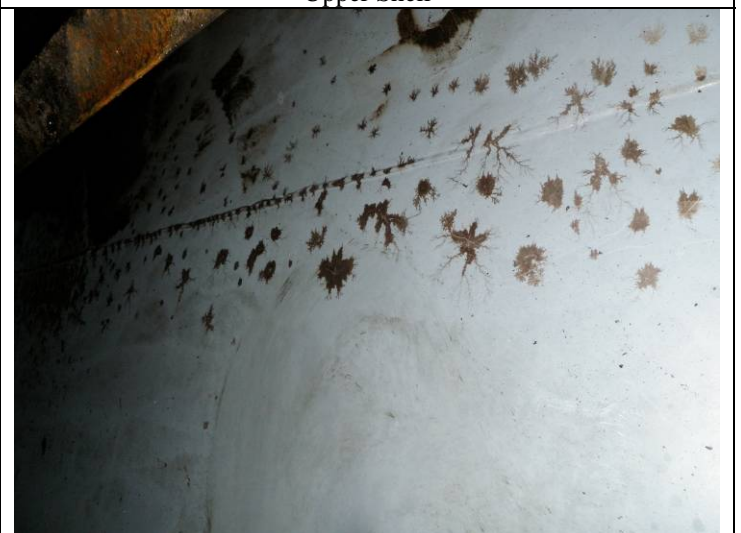
South Head Note all corrosion, erosion or mechanical damage. (If vessel is horizontal identify direction of this head)	X				Head is in good condition. No corrosion or no pitting. No signs of damage or distortion.
North Head Note all corrosion, erosion or mechanical damage. (If vessel is horizontal identify direction of this head)	X				Head is in good condition. No corrosion or no pitting. No signs of damage or distortion.
Shell Sections Record number of shell sections. Record location, size and depth of all erosion, corrosion or mechanical damage. Describe general condition. If any corrosion greater than corrosion allowance is observed in either shell or head, discuss with Chief Inspector before closing vessel.	X				Shell sections are in good condition. No signs of damage or distortion. No signs of erosion or corrosion. Signs of bio-fouling on shell. This is surface only and is not penetrating the coating.

Bio-fouling on weir – surface only
