**Magnetic Particle  
 Inspection Report**

MT\_87-3568-0\_jun2013

Client: Devon Canada Corporation		Equipment Owner: Devon		Date: June 11, 2013	
Item Inspected: Both Fire Tubes from Treater			Acceptance Code: ASME VIII, Div 1		
Location: Valhalla Oil Battery 10-14-76-10 w6m					
Procedure: MT-01	Surface Preparation: Sand Blasted	Method: Wet Continuous	Light Source: 3 x C cell Halogen		
Equipment: AC Yoke	Manufacturer: Magnaflux	Serial # HY-10	Cal. Due: Oct 1, 2013	Cal Std: ASME 10 lbs S/N: A392	
Contrast Paint: Magnaflux WCP-2	Batch# 02269	Black Light: None	Cal. Due: N/A	Serial # n/a	
Wet Particles: Magnaflux 7HF	Batch# 00116	Particles: N/A	Batch # N/A	Temp: 10-20'C

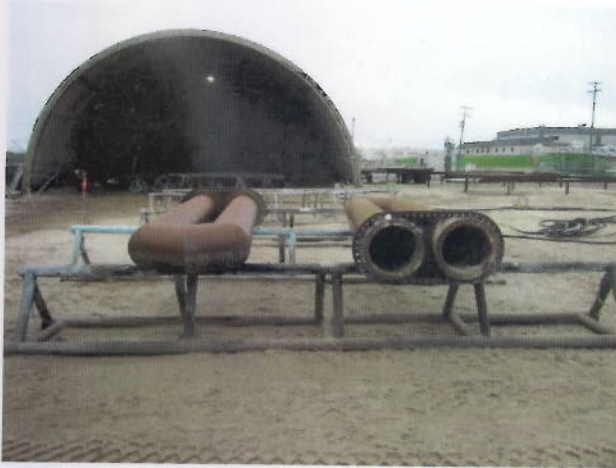
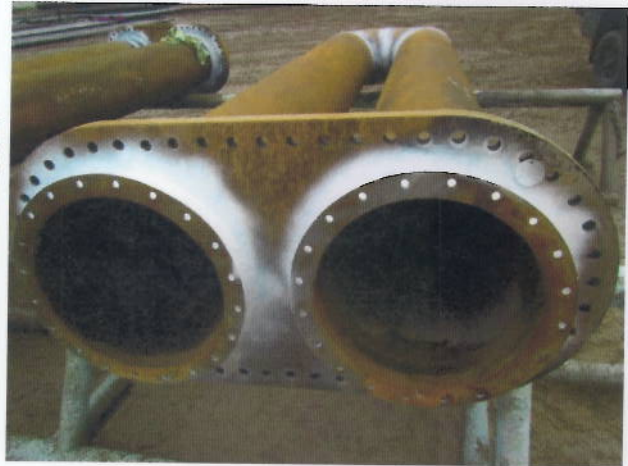
**Overview**

**Results:** There was three small cracks detected in tube #1, All three cracks were found in one location and were removed by lightly sanding the weld. There was one crack found on tube #2 which was also removed by lightly sanding. No other cracking or linear indications detected on any of the welds on both fire tubes.

These fire tubes were left in the rain overnight after sandblasting and were covered with a wet thick rust. The surface of these tubes were cleaned as much as possible with rags and a wire brush but the visual inspection was still limited. There is areas of corrosion and pitting on all sides of both fire tubes. The average depth of the pitting on tube 1 is 0.53mm . The deepest pit found on tube 1 was 1.05mm. The average depth of the pitting on tube 2 is 0.22mm . The deepest pit found on tube 2 was 0.47mm.

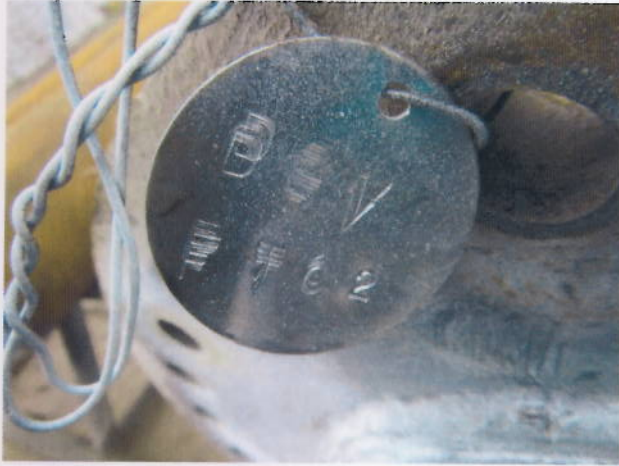
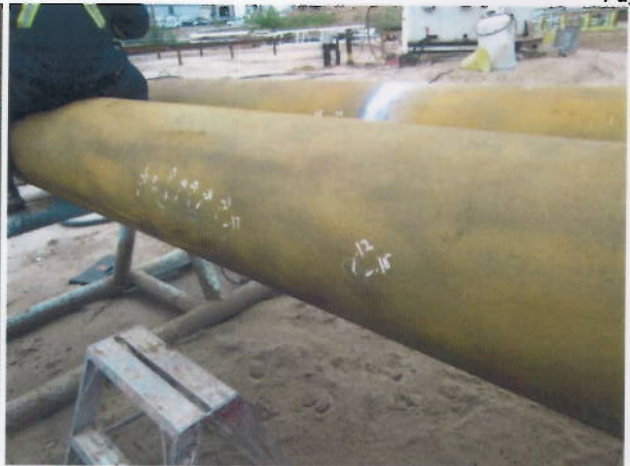
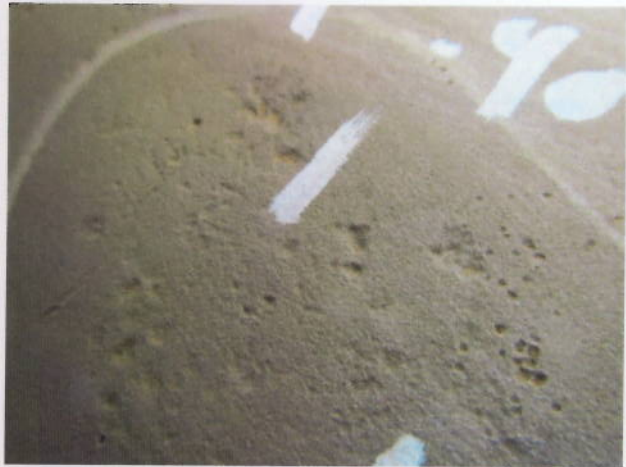
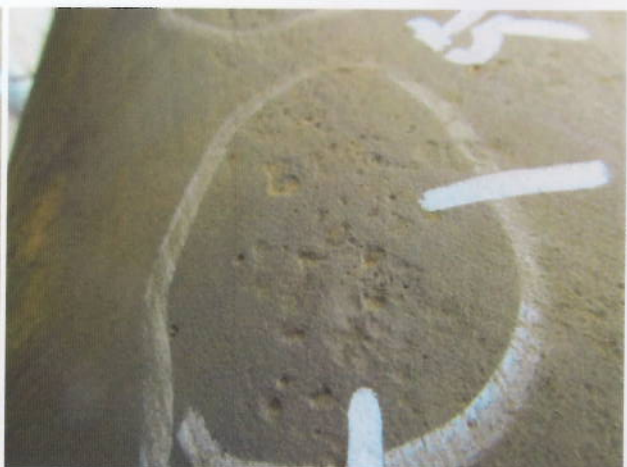
Crack found on the front of the flange to tube weld. Crack was removed.
