**Canadian Natural Resources Limited  
GENERAL PRESSURE VESSEL INFORMATION**

**Job 10.116529**

District: <b>Grande Prairie, AB</b>	Skid No.
Facility: <b>LaGlace North Oil Battery</b>	Location (LSD): <b>10-14-76-10 W6M</b>
Vessel Name Equipment Number: <b>Oil Treater</b>	
Orientation: <b>Horizontal</b>	
Status: <b>In Service</b>	<b>Regulatory Inspection</b>

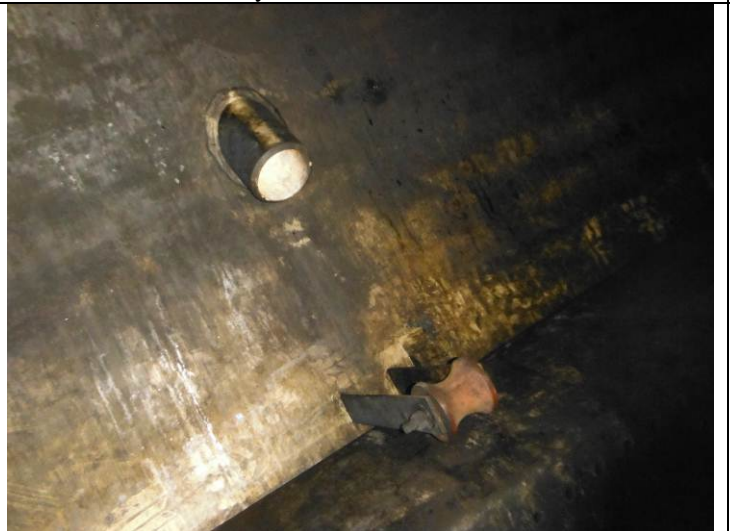
New firetube support – MT ok

<b>Welds</b> Inspect all welds, including attachment welds. Record all service-related damages and if there is any discuss with Chief Inspector before closing.	X				<b>Through-wall in firetube support weld. ll welds area in</b>
<b>Repairs Required.</b> If yes, ensure procedure and copy of AB 40 is on file, and one sent to local ABSA, and Chief Inspector	X				<b>Repair firetube support structure.</b>
<b>NDE</b> Was any NDE done. ( MI coordinator to review results)		X			<b>Magnetic particle inspection carried out on fire tube. 12 inch crack detected on firetube. Reference MT report.</b>
<p><b>Recommendations or corrective actions : Vessel is Fit for Service or describe corrective actions required)</b>  (MIC to review corrective actions with Operations, discuss with Chief Inspector where necessary, and get remedial action implemented)  <b>Recommendations: 1.Repair fire tube and firetube support structure using an approved CNRL repair procedure.</b>  <b>Summary:</b> This vessel is in good overall condition, visual internal carried out.  <b>Vessel is fit for service</b></p>
