Client	Petronas Energy Canada Ltd.	Inspection Date	Nov 4, 2014		
Prov. Reg. #	AB 0586305 BC BPV-048528	Inspection Type	VE / UT		
Equipment Type	Glycol Contactor	Location	Graham		
Tag/Equip.		LSD	AB C-087-F/094-B-08		
Status	Not In Service	Downhole LSD			
Manufacturer	lfc Industrial Fabrication Corporation	Area	Cypress A		
Serial Number	18089-01	Year Built	2007		
CRN #	U0772.21	Service	Sweet		
Comp/Unit Id	Dehy #1	Manway	None		
Nat.Board #		Coating	No		
Interim Insp'n		Interim Type			
Next Thorough Insp		Next Insp Type	VE / UT		
Length		Height			
Volume		Client Reference	1006102		
Owner	Petronas Energy Canada Ltd.	RT	1	HT	YES
Foreman	SBU	RAE Job No.	4934		
ABSA	Plant: H Vessel: P Process: G Special: B	ASME	Sec. VIII div. 1		
History Log	BC Design Registration - dated February 18, 2009 - entered December 8, 2017. PSV Service Report - dated October 14, 2014

RAE Engineering and Inspection Ltd 4810 - 93 Street Edmonton, AB, T6E 5M4 ph: 780-469-2401 fx: 780-468-2422	Inspection Date:	4-Nov-14	Ultrasonic Thickness Examination
		Page:	1 of 4	
Client:	Progress	RAE Report #:	14-4934-LC-UT-05	
Address:	Suite 1200, 205-5th Ave, SW, Calgary, T2P2V7	Project #:	4934	
Client P.O.#:	NS	Location/LSD

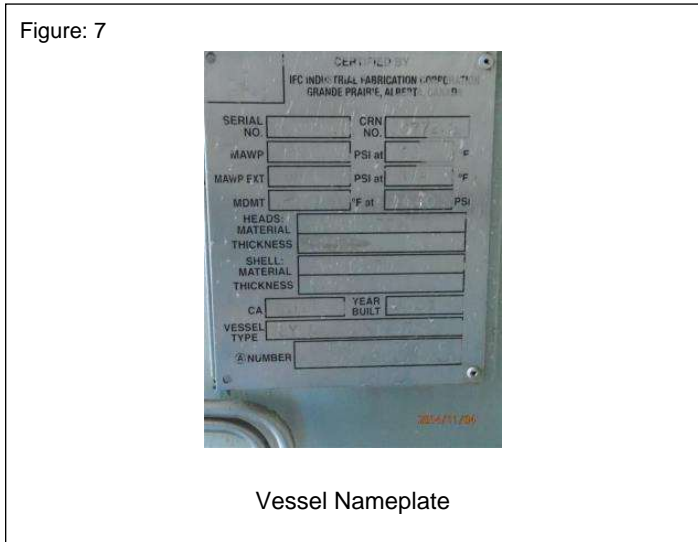
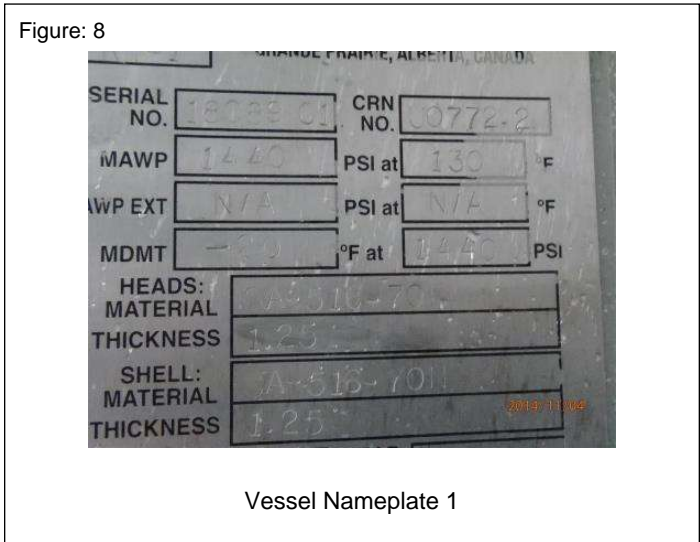
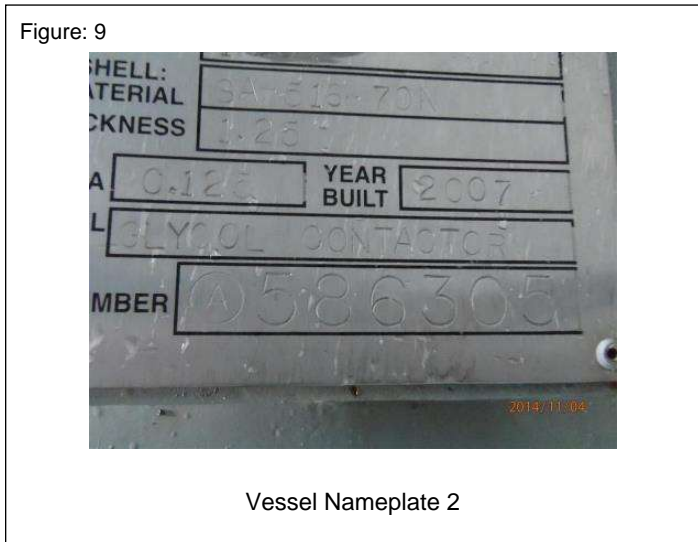
The vessel is located partially inside a building. The nameplate was legible and securely mounted to the vessel. The heads and shell appeared to be in serviceable condition. The vessel is not insulated. The vessel was fully painted and the paint was in serviceable condition. There was minor scattered corrosion visible on the vessel surfaces. There was no damage, distortion, or stress evident on piping connections. The vessel was vertical and adequately supported by a skirt which was bolted to the floor. There are no structural attachments on vessel.
