CLIENT	CANADIAN NATURAL RESOURCES LTD	
FACILITY	GOLD CREEK FIELD LSD 04-30-68-05 W6M	
ITEM	LINE HEATER	
BY: IM	DATE: 08/2016	DWG.# 161

**Canadian Natural Resources Limited
GENERAL PRESSURE VESSEL INFORMATION**

Job 4019962

District: Grande Prairie, AB	Skid No.
Facility: Gold Creek Field	Location (LSD): 04-30-68-05 W6M
Vessel Name Equipment Number: Line Heater	
Orientation: Horizontal	
Status: Not in service	Integrity Inspection

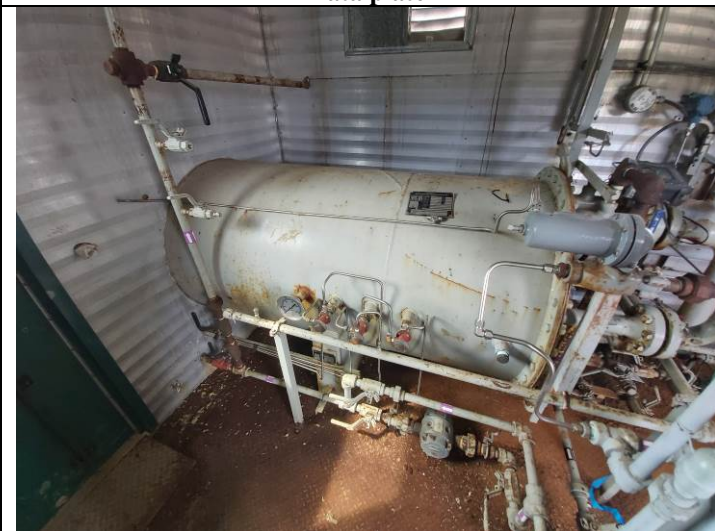
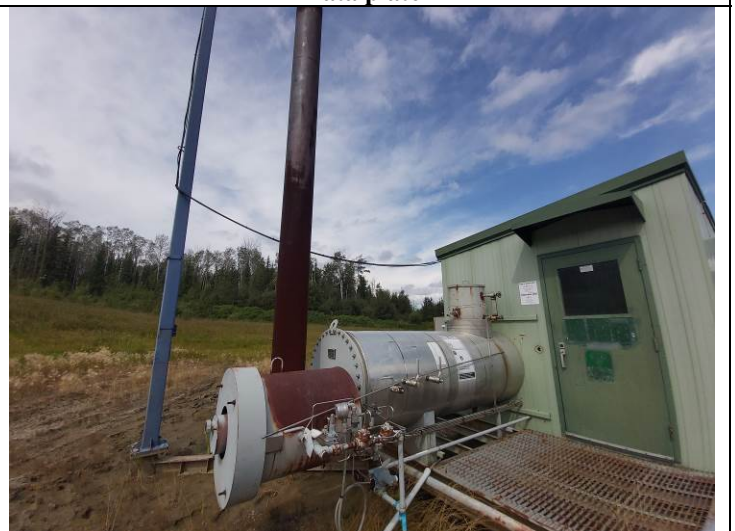
Overview

External Inspection Items	G	F	P	N/A	Comments
Insulation Verify sealed around manways, nozzles, no damage present, and there is no egress of moisture.		X			Shell is 50% insulated and in fair condition – dents and compressed cladding to 20% of area. Egress of moisture detected at west saddle.
External Condition Assess paint condition, areas peeling, record any corrosion, damage, etc (record location, size and depth of corrosion or damage)	X				Paint is in condition – no exposed metal.
Leakage Record any leakage at flanges, threaded joints, weep holes on repads, etc.	X				No leaks observed.
Saddle/skirt Assess condition of paint, fire protection, and concrete. Look for corrosion, buckling, dents, etc. Look at vessel surface area near supports. Verify no signs of leakage at attachment to vessel and attachment welds are acceptable. Ground wire attached?	X				Saddle: No buckling or dents. No evidence of corrosion at saddle to shell area – no leaks. Ground wire attached to skid
