A0438939_Name plate_28Mar2012

Field Inspection Report

Client	CNRL		Date of Inspection	March 28, 2012					
Prov. Reg.#	A0438939		Inspection Type	VE & UT					
Equipment	Line Heater		Location	5-21					
Tag/Equip. #			LSD	05-21-012-14W4M					
Vessel Status	In Service		Comp./Unit #						
Manufacturer	Plains Oil Ltd.		MAWP / Temp						
Serial #	2133CB3	CRN #	N 9595.213	MDMT@ Pressure					
Corrosion Allowance	1.6mm	Shell Material	SA106B	Shell Thickness					
Year Built	1998	Head Material	SA106B	Head Thickness					
Diameter	60" OD / 30" OD	Length		Height		RT	RT-1	HT	Yes
Service	Sour	Next Inspection		Next Insp. Type					
ASME Stamp	No	Next Inspection		Next Insp. Type					
PSV Tag #		CRN#		Set Pressure					
Manufacturer			NB#		ASME Stamp				
Type/Model		Serial		Inlet Size					
Capacity		Service Company		Outlet Size					
Service Date			Next Service Date						
Valve Location	On Vessel On Piping Vents to Flare • Vents to Atmosphere	Valve Connection	Threaded Flanged Welded	ABSA CODE TYPE

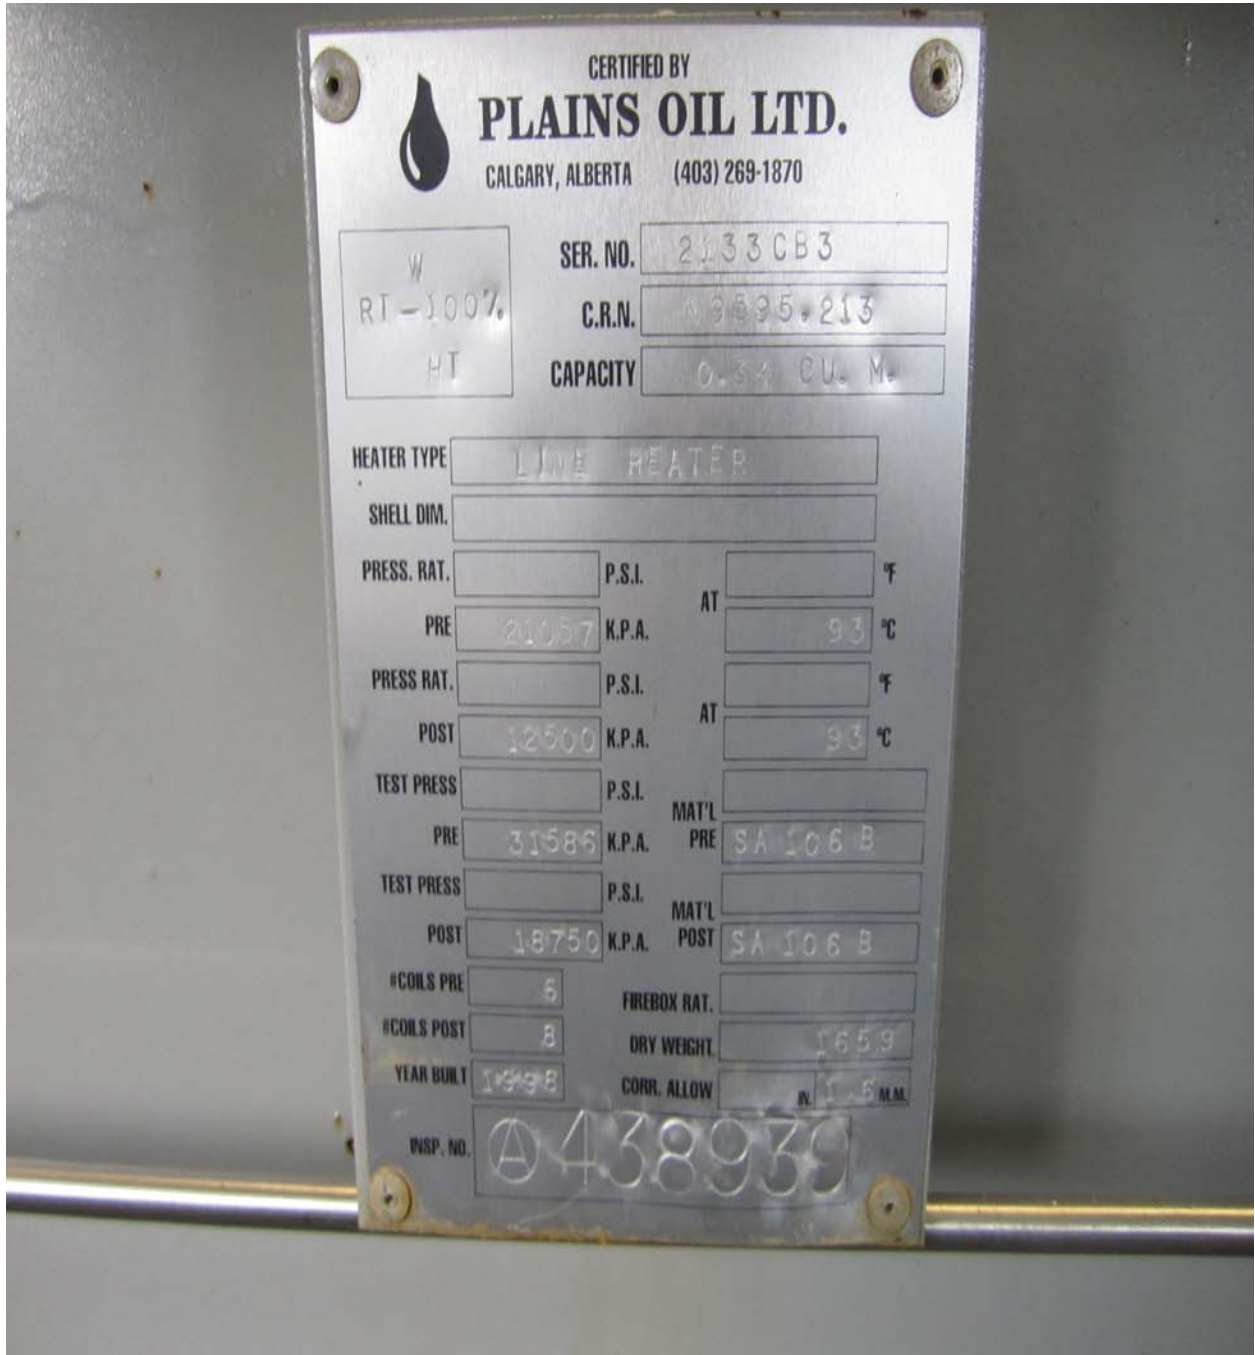
- Name plate was attached and readable.
- External paint was in fair condition with slight external corrosion present at TML 50.
- Slight surface corrosion in form of rusting.
