**Canadian Natural Resources Limited  
GENERAL PRESSURE VESSEL INFORMATION**

**Job # 05.002851**

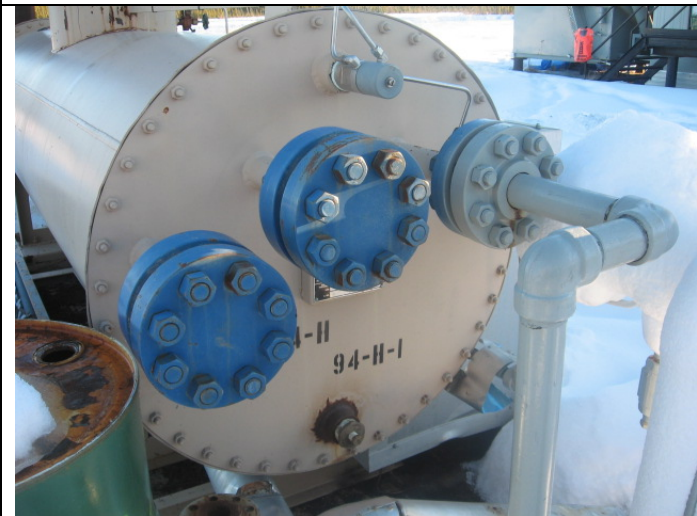
Inlet piping frozen up.

<b>Anchor Bolts:</b> Hammer tap to ensure secure. Look for cracking in treads or signs of deformation.	X				Firmly welded to skid deck.
<b>Concrete foundation:</b> Check for cracks, spalling, etc.				X	
<b>Ladder / Platform:</b> Describe general condition, ensure support is secure to vessel, describe any hazards.				X	
<b>Nozzle:</b> Assess paint, look for leakage, and ensure stud threads are fully engaged. Record any damage, deflection, etc. Are nozzles gusseted?	X				Threaded fittings - fully engaged. Bolted fittings fully engaged to nuts. No deflection of nozzles. No gussets.
<b>Gauges:</b> Ensure gauges are visible, working, no leakage, and suitable for range of MAWP/Temp.	X				Pressure gauge: No pressure gauge. Temperature gauge: 0 to 250 deg F. Within operational parameters for service.
<b>External Piping:</b> Ensure pipe is well supported. All clamps, supports, shoes, etc. in place. Look for evidence of structural overload, deflection, etc. Paint condition, external corrosion?	X				Piping is not well supported – threaded into heater and lays on ground. Accumulator discharge is not supported and does not discharge to pop tank but to atmosphere. <b>Inlet piping is not insulated and has a large amount of ice built up on it – should be insulated.</b> <b>Glycol inlet pump is not supported and is lying on ground.</b>
