# Pressure Equipment Static Data

## Pressure Vessel External Inspection

## Pressure Vessel Internal Inspection

# UT CORROSION SURVEY REPORT READINGS

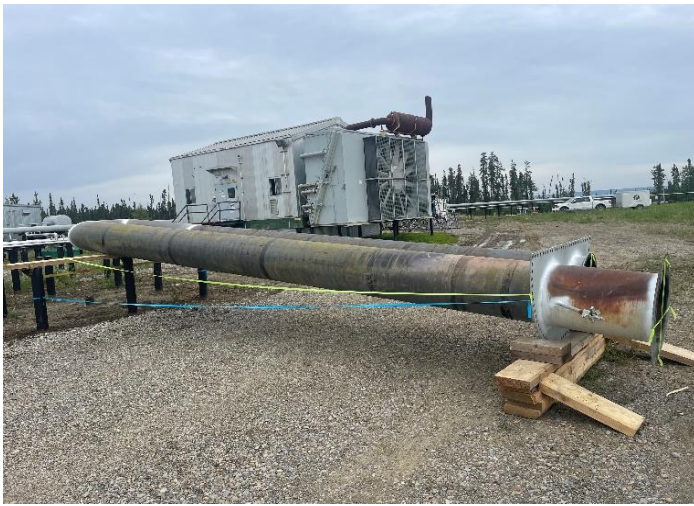
FIRETUBE OVERVIEW

<b>NDE Methods</b>	Acceptable	MT and UT was completed on the 24" firetube. No visible significant surface indications noted during MT. Minor internal wall loss noted on the stack side tube at the 5-7 o'clock position of tube. UT thickness readings were taken on all accessible return bends of the process coils. No significant wall loss noted at time of inspection.	
<b>Inspection Summary</b>	Line Heater is in good overall condition. Minor corrosion noted at the 6 o'clock position of shell at the back end of line heater. The deepest corrosion was 0.020" measured with a pit gauge. There was no other significant corrosion or mechanical damage noted.		
	Thief hatch seal was cracked and damaged. No relevant surface indications noted during Firetube MT inspection. No significant wall loss noted during process coil return bend UT.		
	Inspection of the internal upper surfaces of line heater was limited due to the process coils.

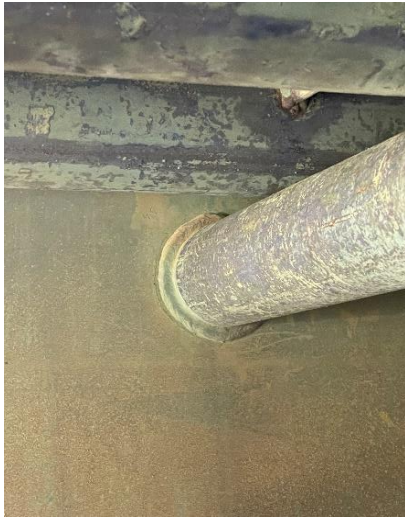
TYPICAL PROCESS COIL SUPPORT TO SHELL WELD

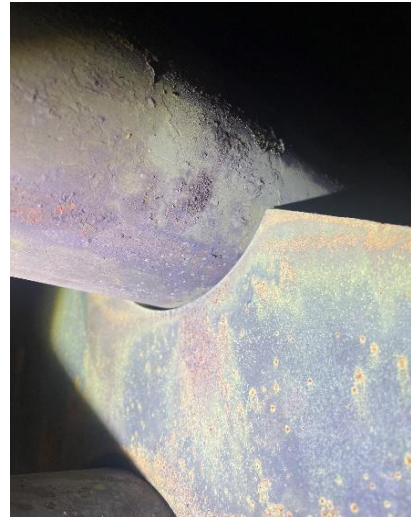
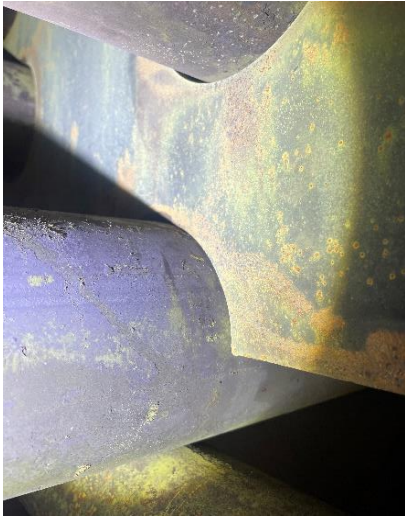
<b>Heads</b>	Acceptable	Both heads were in good overall condition. There was no visible corrosion or mechanical damage noted during inspection. Inspection was limited on the top surface area of the back head due to the process coils.	
<b>Manway</b>	Acceptable	Firetube opening is the manway for the line heater. No visible concerns at time of inspection.	
<b>Nozzles</b>	Acceptable	All accessible nozzles were free of corrosion, mechanical damage or any deflection. Accessible nozzles are in good overall condition.	
<b>Gasket Surfaces</b>	Acceptable	The gasket seating surfaces on the firetube tube sheet and the line heater shell flange were in good overall condition. There was no visible corrosion or mechanical damage. No sealing concerns at this time.	
<b>Internals</b>	Acceptable	All accessible internals including firetube support brackets, fuel gas coil, process coil support brackets, and the process coils were securely in place. There was no visible corrosion or mechanical damage noted. There was no visible fretting at any of the process coil to support plate interfaces.

TYPICAL PROCESS COIL/ PLATE INTERFACE

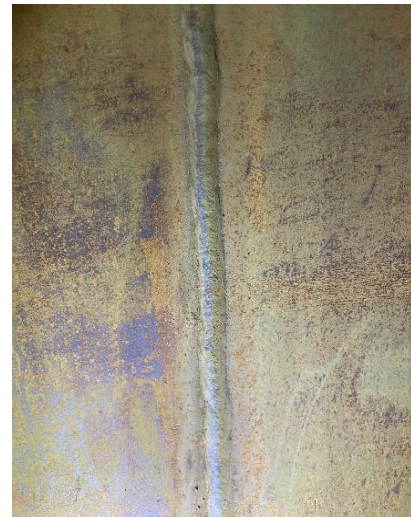
<b>Welds</b>	Acceptable	Accessible welds were in good condition. There was no visible corrosion. All accessible welds had full profile and had the same general appearance as the HAZ and the parent material.	
<b>Coating</b>	N/A		
<b>Firetube</b>	Acceptable	24" Firetube was in good overall condition. There was no significant corrosion or mechanical damage noted. Minor corrosion noted inside the stack side tube at the 5-7 o'clock position. There was no visible hot spots or deformation noted during inspection.	
<b>Tubesheet</b>	Acceptable	Firetube tubesheet is in good overall condition. There was no visible corrosion, mechanical damage, or deflection noted at time of inspection.	
<b>Tube Bundle</b>	N/A		
<b>Other</b>	Observation	Thief hatch is in good overall condition and was in good working order. Minor corrosion noted in nozzle neck. All corrosion was less than 0.020" deep. Hatch seal is in poor condition and needs to be replaced.

TYPICAL WELD SEAM CONDITION
