VESSEL INSPECTION REPORT

CLIENT	CNRL 2500, 855 - 2nd Street SW Calgary, Ab T2P 4J8	Inspec Date m/d/y	11/22/2012
CLIENT REP	KYLE HUCULAK MEDICINE HAT	Client Work Order	
		Client Cost No	
		Facility	RAHLSTON BATTERY
		LSD	05-14-018-09W4M

A Number	A0191862	Eq Number		Equipment	Treater
Ser Number	81-7900-A	Alt Jur #		CRN	E1466.2
MDMT		MAWP	517 kPa	MAWT	93 C
Year Built	1981	Radiography	RT1	PWHT	No
Shell Thick	12.7 mm	Shell Material	SA-516 70	Cor Allow	3.18 mm
Head Fire	28.57 mm	Head Nonfire	15.87 mm	Head Material	SA-516 70

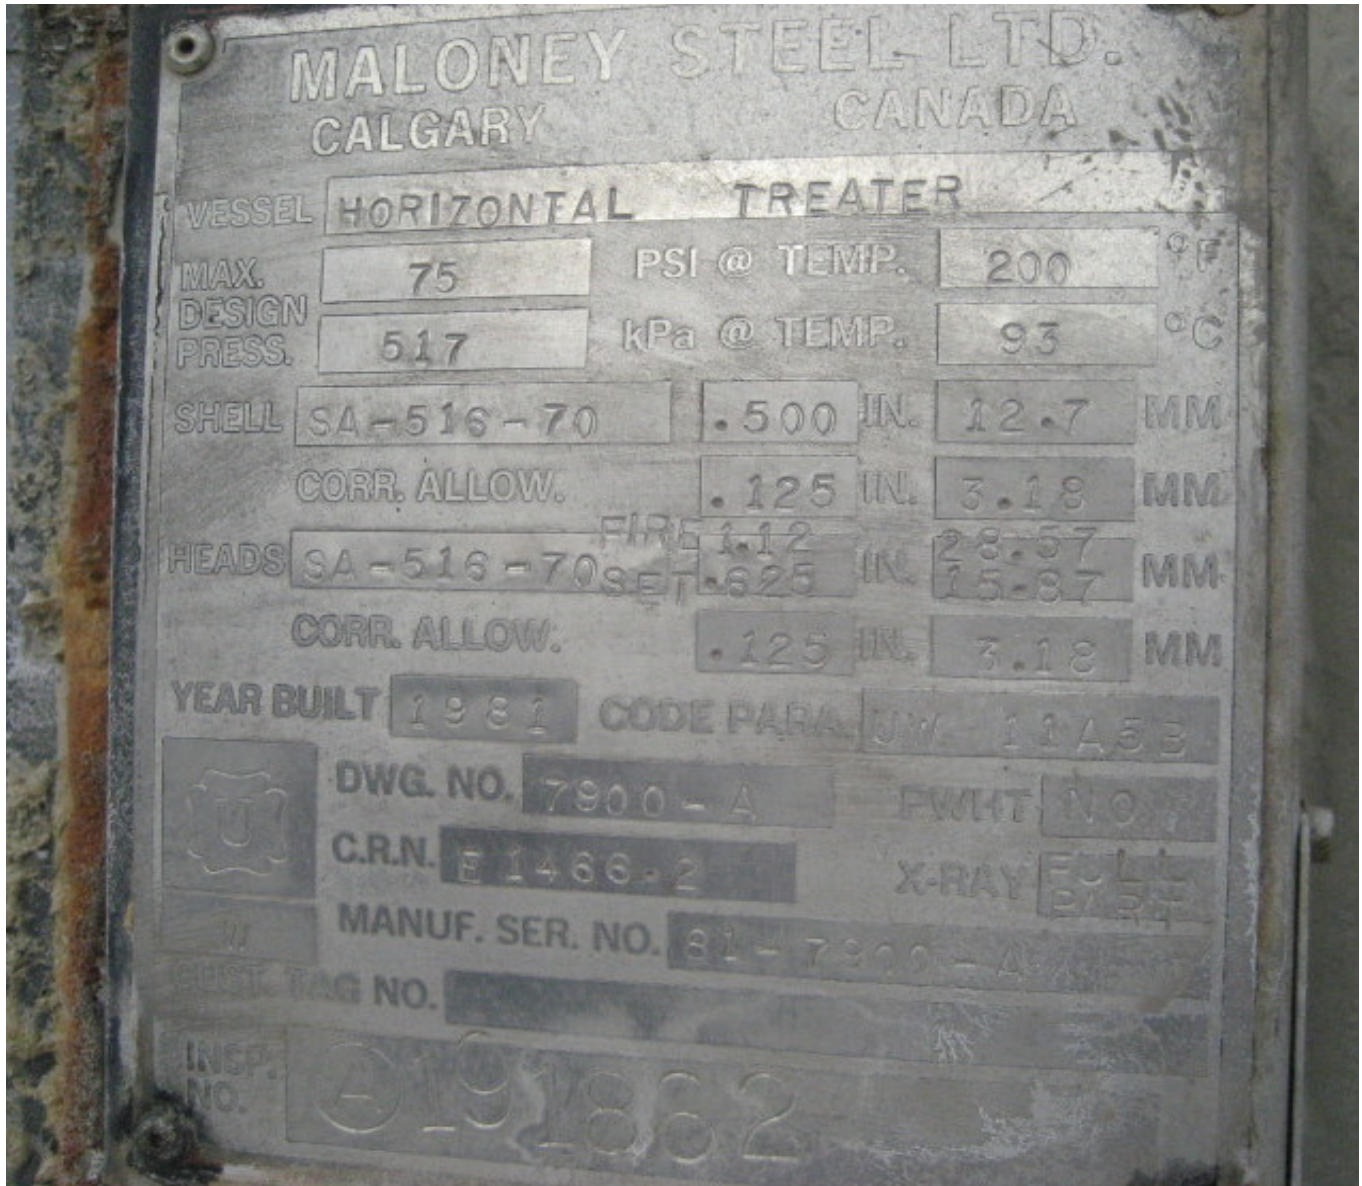
Only firetube end of vessel was internally inspected. Minow coating repairs. Liquid out nozzle at vortex breaker found filled with what appeared to be scale. Scale was chipped out. Operations was informed.
